## Item #14096207 - 2016 Skyjack SJ61T 4WD Diesel Telescopic Boom Lift

# Inspection Report

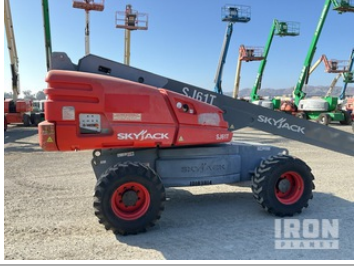
| Paint | No visible damage | |

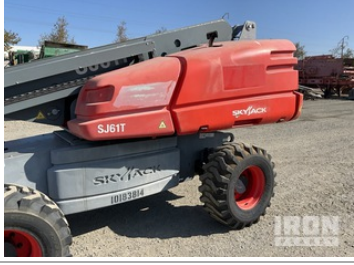
| Body Panels | No visible damage or missing components | |

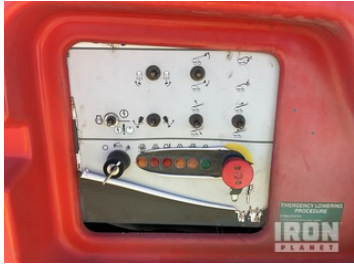
| Control Station Ground | | |
|---|---|---|
| Function Controls | ★★★★☆ | |

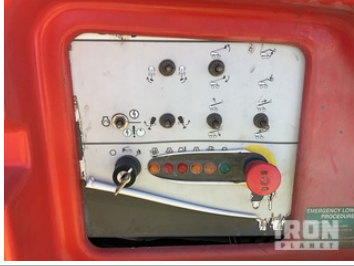
| Control Station Ground | | |
|---|---|---|
| Oil Pressure | The fault indicator shuts off after the engine oil pressure rises. | |

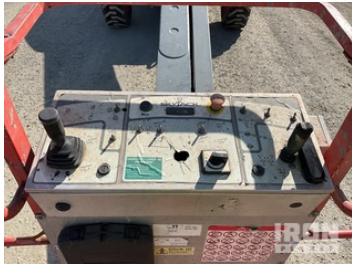
| Item | Assessment | Photo |
|---|---|---|
| Control Console | No visible damage or missing components | |

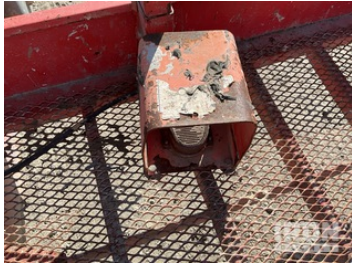
| Item | Assessment | Photo |
|---|---|---|
| Safety Control Hand/Foot Switch | ★★★★☆<br>Operational | |

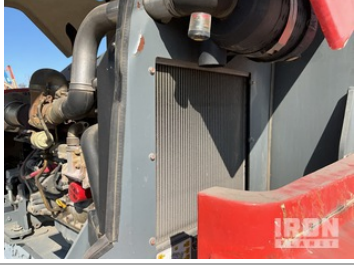
| Engine | | |
|---|---|---|
| Radiator | ★★★★☆ | |

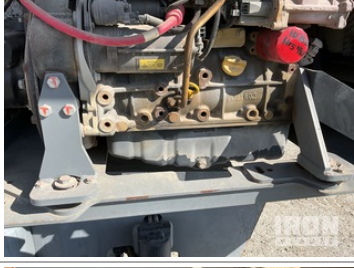
| Engine | | |
|---|---|---|
| Oil Leaks | No dripping leaks | |

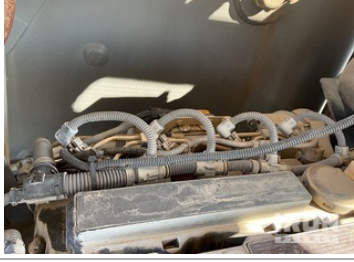
| Engine | | |
|---|---|---|
| Fuel Leaks | No dripping leaks | |

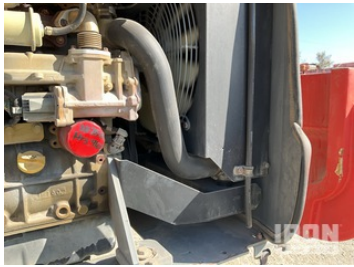
| Cooling System Leaks | No dripping leaks | |

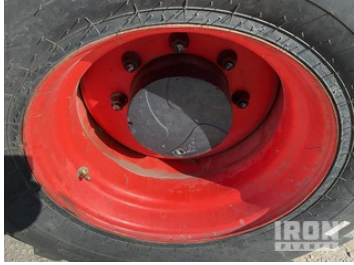
| Item | Assessment | Photo |
|---|---|---|
| Left Front Final Drive | ★★★★☆ | |

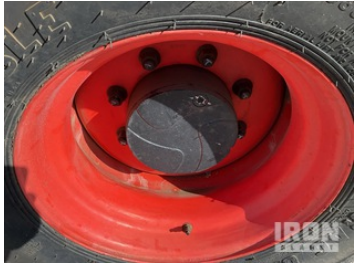
| Item | Assessment | Photo |
|---|---|---|
| Left Rear Final Drive | ★★★★☆ | |

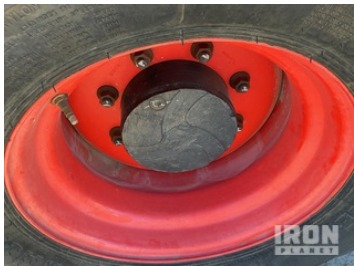
| Item | Assessment | Photo |
|---|---|---|
| Right Rear Final Drive | ★★★★☆ | |

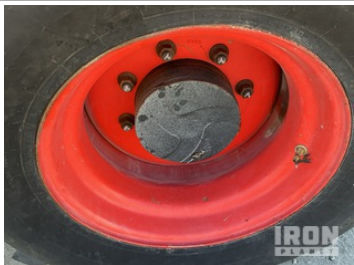
| Item | Assessment | Photo |
|---|---|---|
| Right Front Final Drive | ★★★★☆ | |

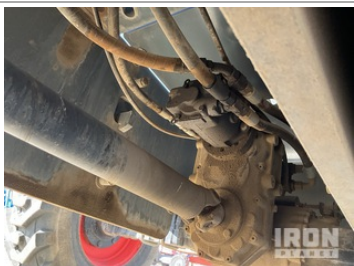
| Item | Assessment | Photo |
|---|---|---|
| Front Center Drive Motor | ★★★★☆ | |

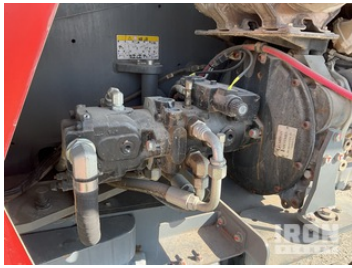
| Hydraulics | | |
|---|---|---|
| Pumps (Hydraulics) | ★★★★☆ | |

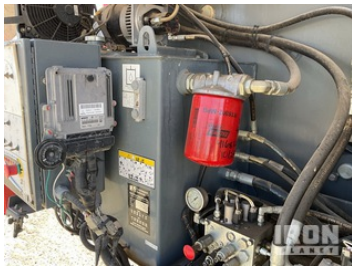
| Hydraulics | | |
|---|---|---|
| Hydraulic Tank | ★★★★☆ | |

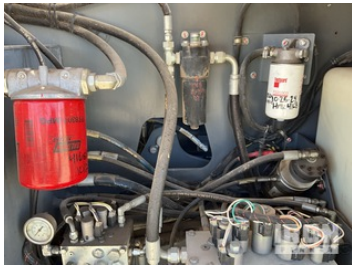
| Hydraulics | | |
|---|---|---|
| Hoses (Hydraulic) | ★★★★☆ | |

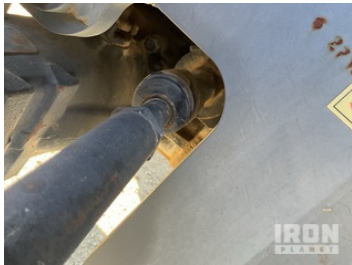
| Hydraulics | | |
|---|---|---|
| Steering Cylinders | ★★★★☆ | |

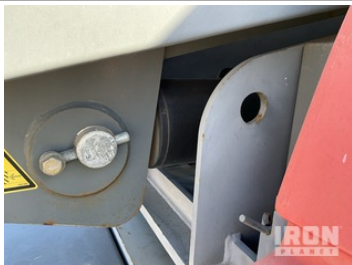
| Hydraulics | | |
|---|---|---|
| Boom Lift Cylinder | ★★★★☆ | |

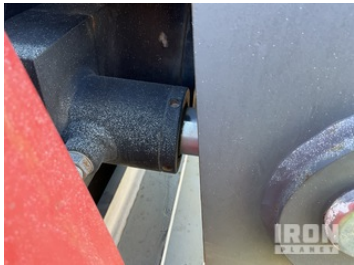
| Secondary Boom Cylinder | ★★★★☆ | |

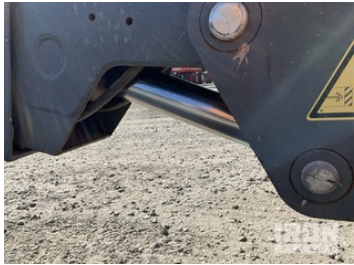
| Basket Tilt Cylinder | ★★★★☆ | |

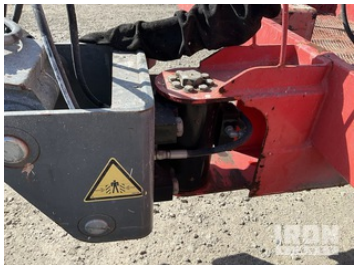
| Basket Rotator Motor | ★★★★☆ | |

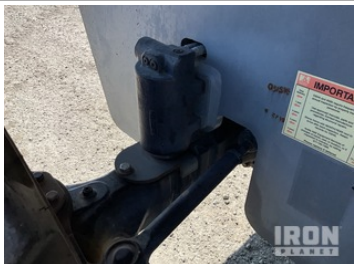
| Frame Leveling Cylinders | ★★★★☆ | |

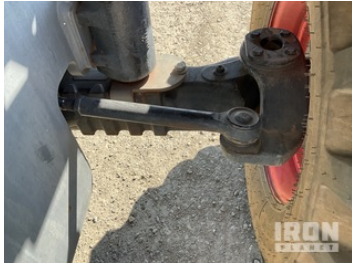
| Chassis | | |
|---|---|---|
| Steering Linkage | ★★★★☆ | |

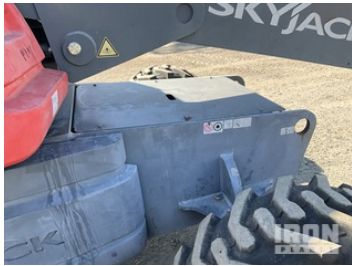
| Chassis | | |
|---|---|---|
| Frame Condition | ★★★★☆ | |

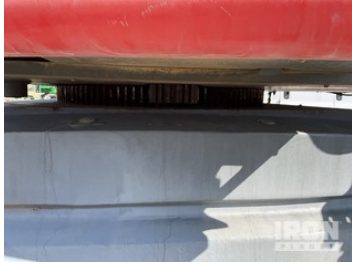
| Turntable Bearing | ★★★★☆ | |

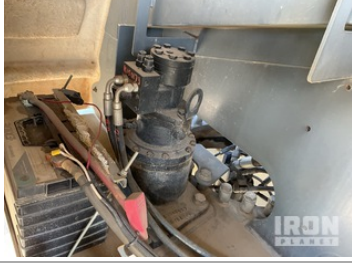
| Swing Motor | ★★★★☆ | |

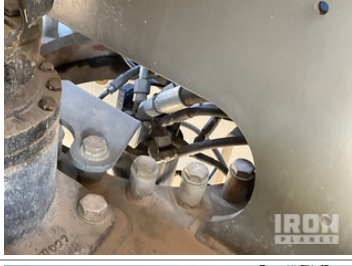
| Hydraulic Center Swivel | ★★★★☆ | |

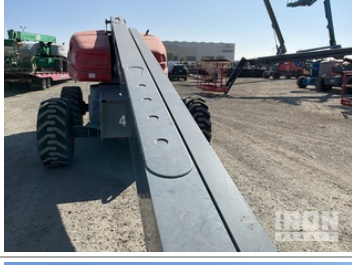
| Boom Condition | ★★★★☆ | |

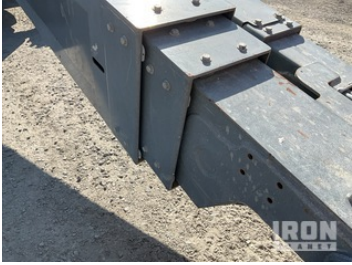
| Boom Wear Guides | ★★★☆☆ | A close-up photograph of the boom wear guides, showing the metal components and the wear guides themselves. |
