## Item #14251149 - 2007 Genie S-65 4WD Diesel Telescopic Boom Lift

# Inspection Report

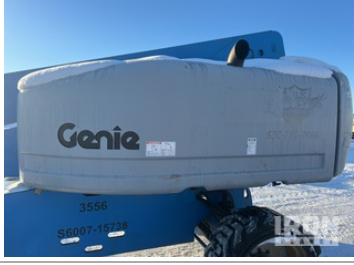
| Body Panels | Engine compartment door damaged, Hydraulic compartment door heavy rust / corrosion | |

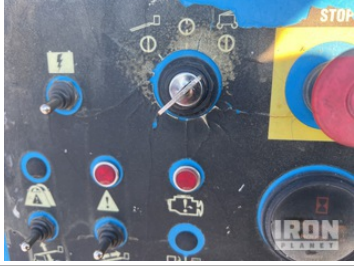
| Control Station Ground | | |
|---|---|---|
| Oil Pressure | Warning light inoperable | |

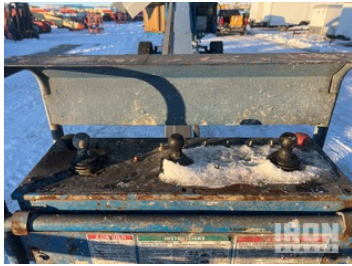
| Item | Assessment | Photo |
|---|---|---|
| Control Console | Material buildup | |

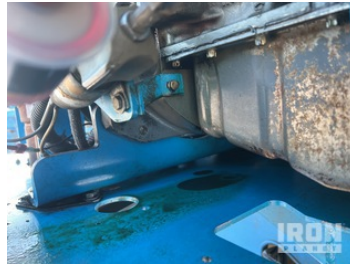
| Engine | | |
|---|---|---|
| Oil Leaks | Rear of engine | |

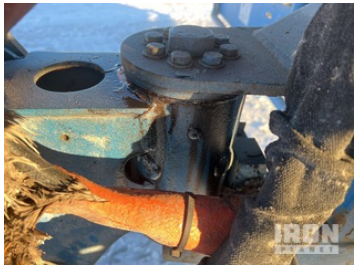
| Basket Rotator Motor | ★★★☆☆<br>Dripping leak | |

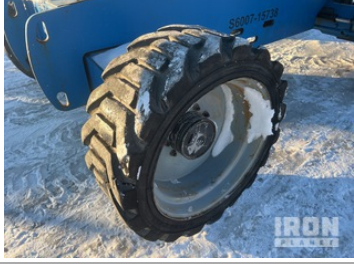
| Chassis | | |
|---|---|---|
| Left Front Tire | Cracks, Chunks missing, Tears | |

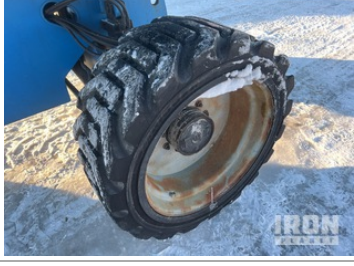
| Chassis | | |
|---|---|---|
| Left Rear Tire | Cracks, Chunks missing, Tears | |

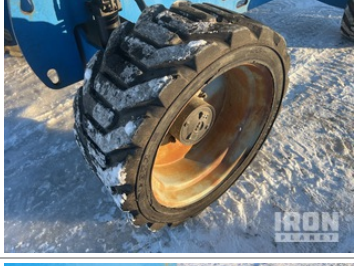
| Chassis | | |
|---|---|---|
| Right Rear Tire | Cracks, Chunks missing, Tears | |

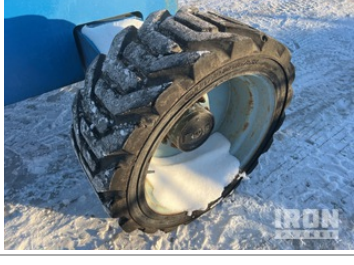
| Chassis | | |
|---|---|---|
| Right Front Tire | Cracks, Chunks missing, Tears | |
