## Item #13810725 - 2016 JLG 600S 4WD Diesel Telescopic Boom Lift

# Inspection Report

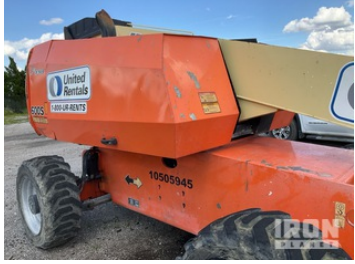
| Paint | No visible damage, some concrete residue present | |

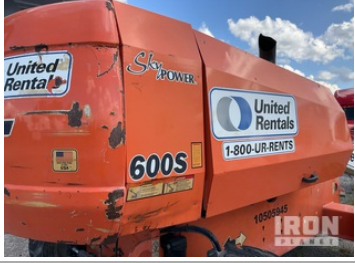
| Body Panels | Engine compartment door damaged, Hydraulic compartment door damaged | |

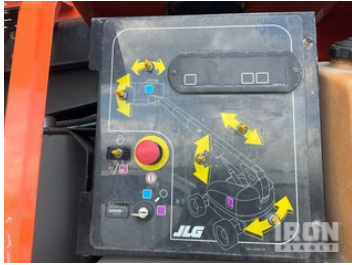
| Control Station Ground | | |
|---|---|---|
| Function Controls | ★★★★☆ | |

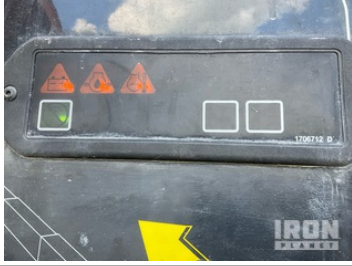
| Control Station Ground | | |
|---|---|---|
| Oil Pressure | The fault indicator shuts off after the engine oil pressure rises. | |

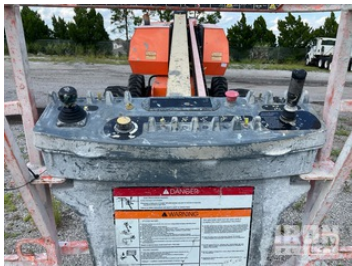
| Item | Assessment | Photo |
|---|---|---|
| Control Console | No visible damage or missing components | |

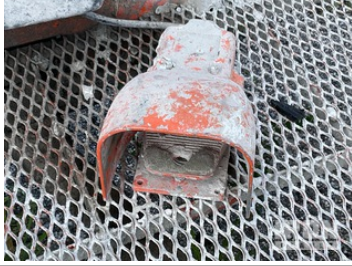
| Item | Assessment | Photo |
|---|---|---|
| Safety Control Hand/Foot Switch | ★★★★☆<br>Operational | |

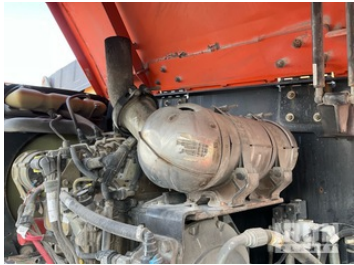
| Engine | | |
|---|---|---|
| Exhaust System | No visible damage or missing components | |

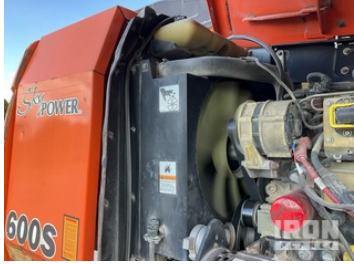
| Engine | | |
|---|---|---|
| Radiator | ★★★★☆ | |

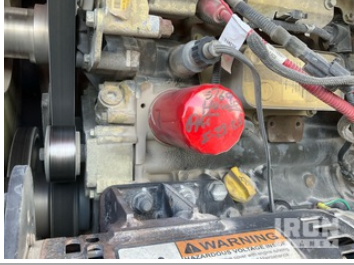
| Engine | | |
|---|---|---|
| Oil Leaks | No dripping leaks | |

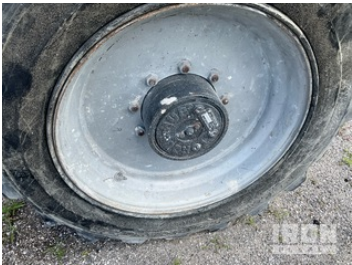
| Right Front Final Drive | ☆☆☆☆ | |

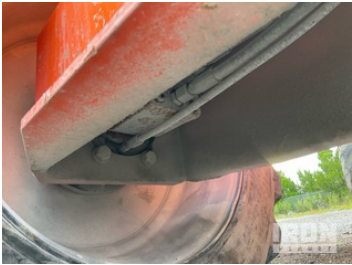
| Right Front Drive Motor | ☆☆☆☆ | |

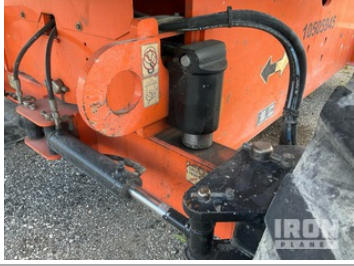
| Frame Leveling Cylinders | Dripping leak | |

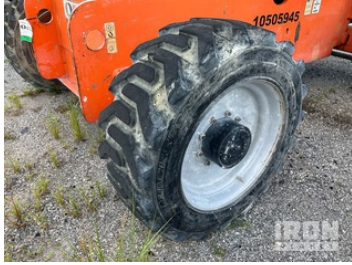
| Chassis | | |
|---|---|---|
| Left Front Tire | Cracks, Chunks missing | |

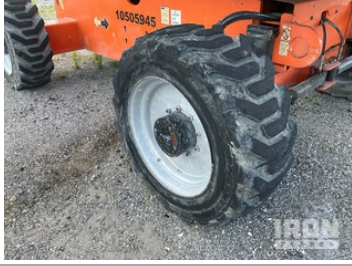
| Chassis | | |
|---|---|---|
| Left Rear Tire | Cracks, Chunks missing | |

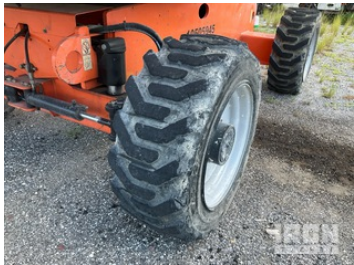
| Right Rear Tire | Cracks, Chunks missing | |

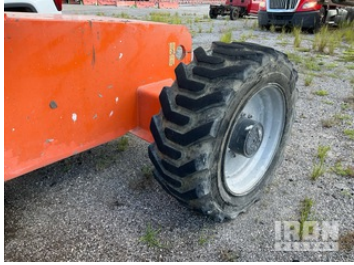
| Right Front Tire | Cracks, Chunks missing | |

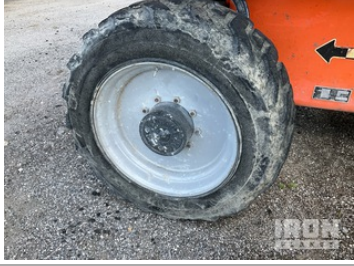
| Wheel Condition | No visible damage or missing components | |

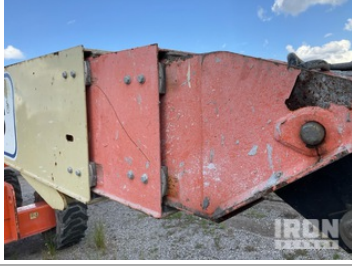
| Boom Wear Guides | ☆☆☆☆ | |
