## Item #14340450 - 2018 Skyjack SJ1044TH Telehandler

# Inspection Report

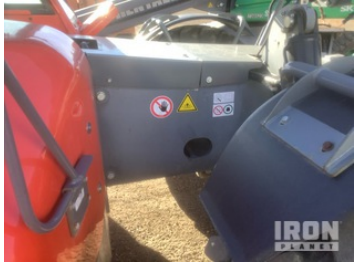
| Paint | No visible damage | |

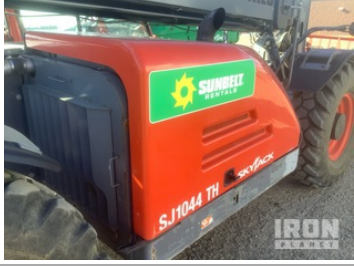
| Body Panels | No visible damage or missing components | |

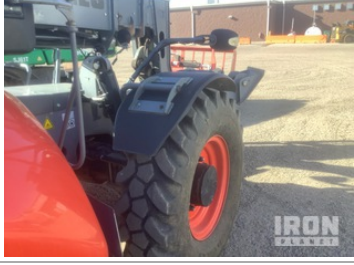
| Fenders | No visible damage or missing components. | |

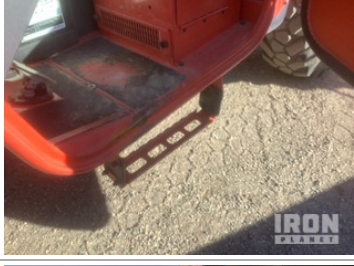
| Steps | No visible damage or missing components | |

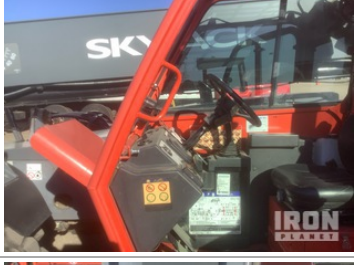
| Hand Rails | No visible damage or missing components | |

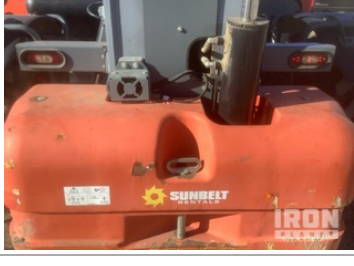
| Exterior Lights | All lights operational | |

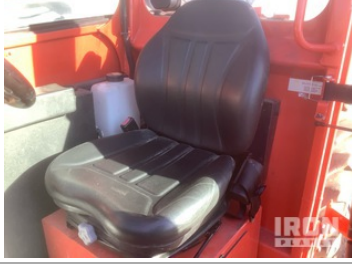
| Control Station | | |
|---|---|---|
| Seat/Armrests | No visible damage or missing components | |

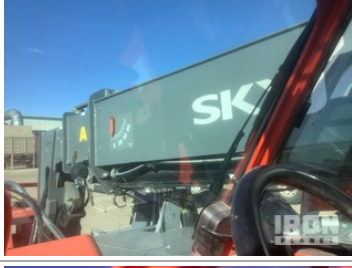
| Control Station | | |
|---|---|---|
| Glass | No visible damage or missing components | |

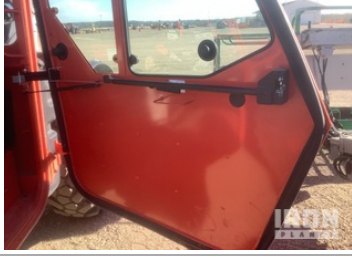
| Control Station | | |
|---|---|---|
| Cab Door | No visible damage or missing components | |

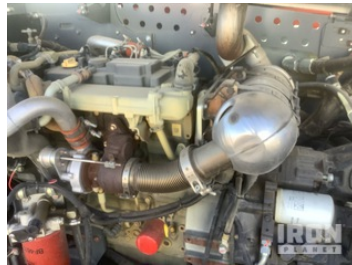
| Engine | | |
|---|---|---|
| Exhaust System | No visible damage or missing components | |

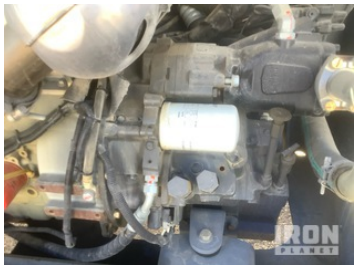
| Item | Assessment | Photo |
|---|---|---|
| Transmission | ★★☆☆<br>Operational | |

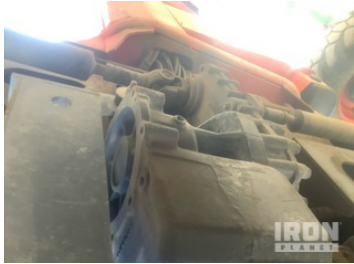
| Item | Assessment | Photo |
|---|---|---|
| Transfer Case / Drop Box | ★★☆☆ | |

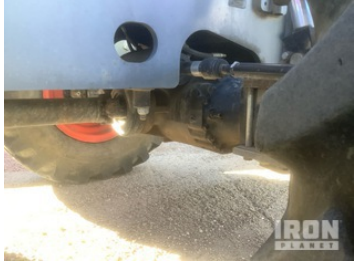
| Item | Assessment | Photo |
|---|---|---|
| Front Drive Axle | ★★☆☆ | |

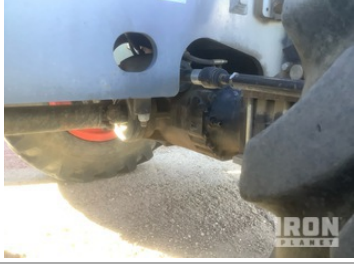
| Item | Assessment | Photo |
|---|---|---|
| Front Axle Oscillating Pin | ★★☆☆ | |

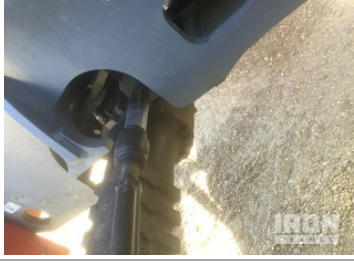
| Item | Assessment | Photo |
|---|---|---|
| Rear Drive Axle | ★★☆☆ | |

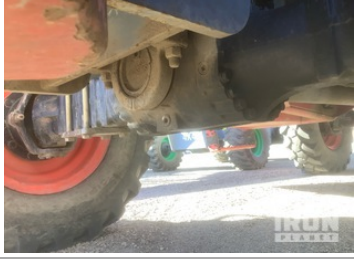
| Item | Assessment | Photo |
|---|---|---|
| Rear Axle Oscillating Pin | ★★☆☆ | |

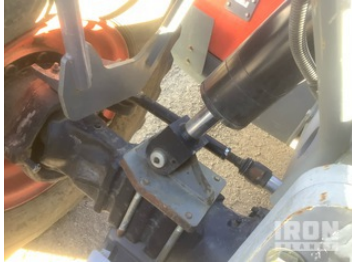
| Frame Leveling Cylinders | ★★★★☆<br>Dripping leak | |

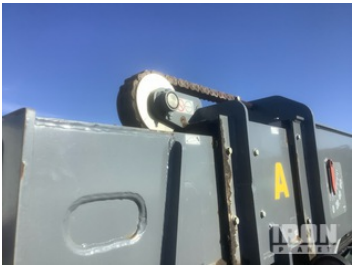
| Rollers and Guides | ☆☆☆☆ | |

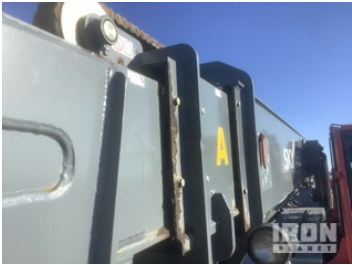
| Boom Wear Guides | ☆☆☆☆ | |

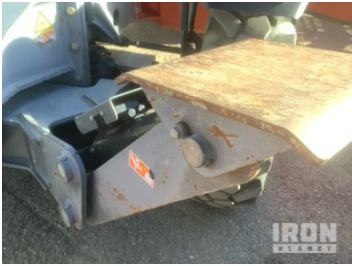
| Outriggers | ☆☆☆☆ | |

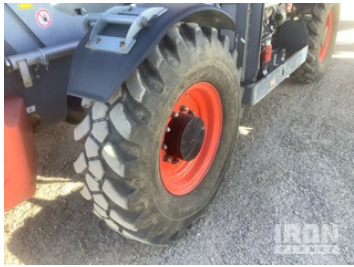
| Right Rear Tire | Size: 14.00-24 Brand: Galaxy Model: Giraffe Tread Depth: 20/32 | |

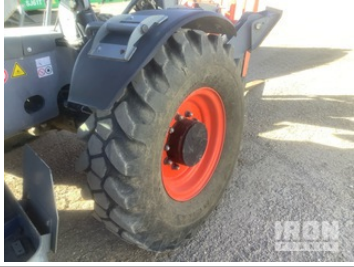
| Right Front Tire | Size: 14.00-24 Brand: Galaxy Model: Giraffe Tread Depth: 19/32 | |
