## Item #14096209 - 2018 Skyjack SJ843TH Telehandler

# Inspection Report

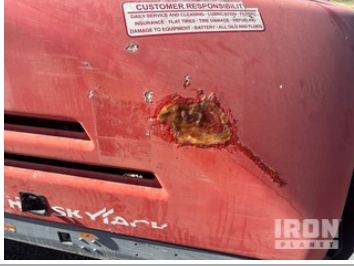
| Body Panels | Engine cover damaged | |

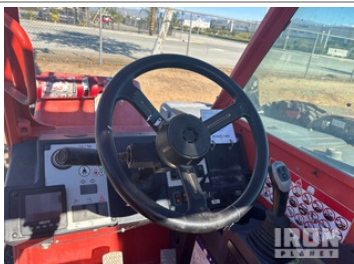
| Control Station | | |
|---|---|---|
| Steering Control | ★★★★☆ | |

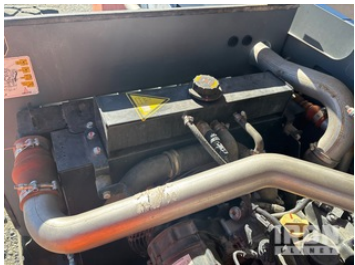
| Engine | | |
|---|---|---|
| Radiator | ★★★★☆ | |

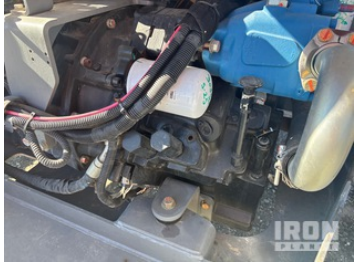
| Item | Assessment | Photo |
|---|---|---|
| Transmission | ★★☆☆<br>Operational | |

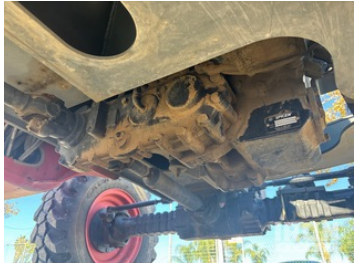
| Item | Assessment | Photo |
|---|---|---|
| Transfer Case / Drop Box | ★★☆☆<br>Operational | |

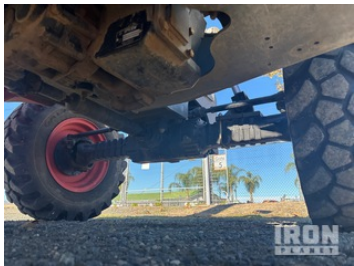
| Item | Assessment | Photo |
|---|---|---|
| Front Drive Axle | ★★☆☆ | |

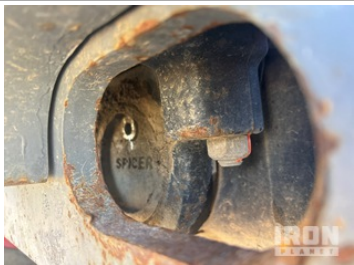
| Item | Assessment | Photo |
|---|---|---|
| Front Axle Oscillating Pin | ★★☆☆ | |

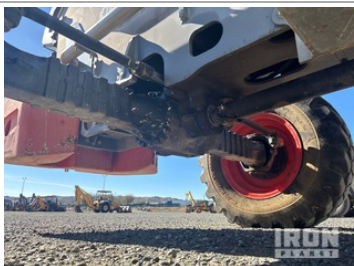
| Item | Assessment | Photo |
|---|---|---|
| Rear Drive Axle | ★★☆☆ | |

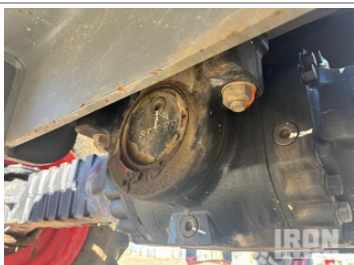
| Item | Assessment | Photo |
|---|---|---|
| Rear Axle Oscillating Pin | ★★☆☆ | |

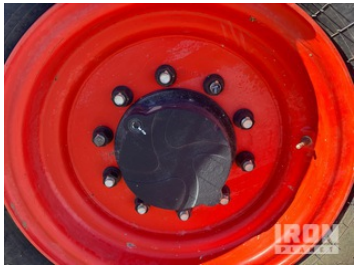
| Final Drives | ☆☆☆☆ | |

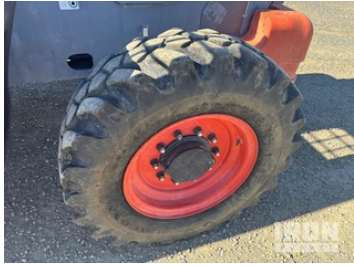
| Item | Assessment | Photo |
|---|---|---|
| Left Rear Tire | Size: 13.00-24 Brand: Galaxy Model: Giraffe xlw Tread Depth: 13/32 | |
