## Item #14005021 - 2016 JLG 1255 Telehandler

# Inspection Report

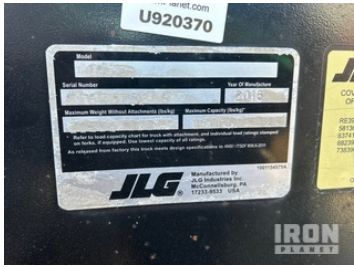
| Serial Number / VIN | 0160073668 | A close-up photograph of a JLG serial number plate. The plate is white with black text and features the JLG logo. It includes fields for Model, Serial Number, and Year of Manufacture. The serial number U920370 is clearly visible. The plate is mounted on a dark surface, and an 'IRON PLANET' logo is visible in the bottom right corner. |

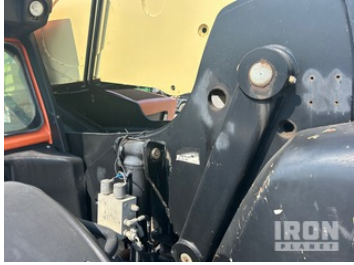
| Paint | Damage | A close-up photograph showing significant paint damage on the side of the telehandler. The paint is chipped and peeling, revealing the underlying metal. The 'IRON PLANET' logo is visible on the side panel. |

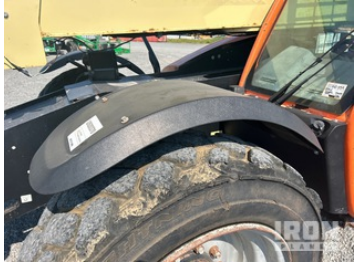
| Fenders | No visible damage or missing components. | A close-up photograph of the front fender and tire of the telehandler. The fender is black and shows some wear. The tire is large and appears to be in good condition. The 'IRON PLANET' logo is visible on the fender. |

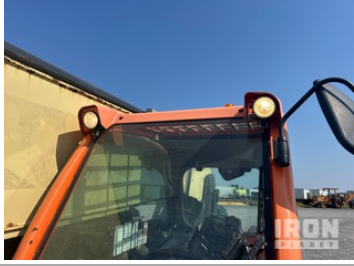
| Exterior Lights | All lights operational | A close-up photograph of the front exterior lights of the telehandler. The lights are orange and appear to be in good condition. The 'IRON PLANET' logo is visible on the side panel. |

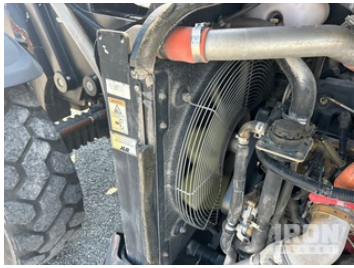
| Engine | | |
|---|---|---|
| Radiator | ★★★★☆ | |

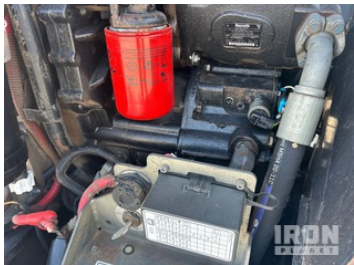
| Item | Assessment | Photo |
|---|---|---|
| Transmission | ★★☆☆<br>Operational | |

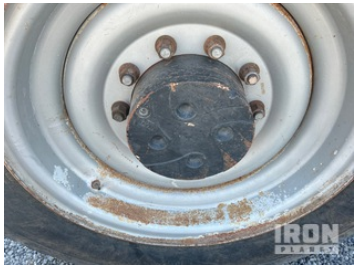
| Final Drives | ☆☆☆☆ | |

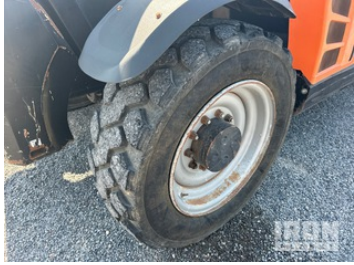
| Right Rear Tire | Size: 400/75-28 Brand: Firestone<br>Model: Duraforce Tread Depth: 26/32 | |

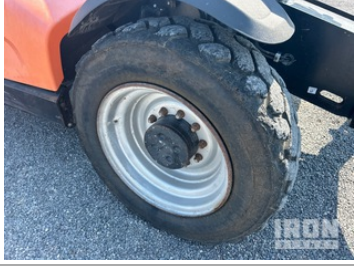
| Right Front Tire | Size: 400/75-28 Brand: Lightning Tread<br>Depth: 23/32 | |

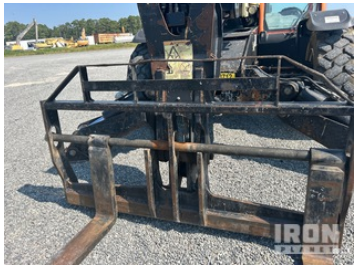
| Load Back Rest | ☆☆☆☆ | |
