## Item #14097039 - 2018 JCB 509.42 Telehandler

# Inspection Report

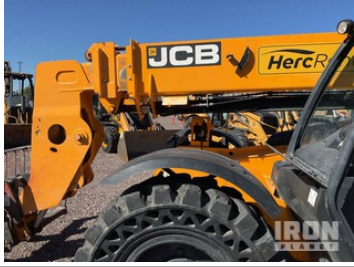
| Paint | No visible damage | |

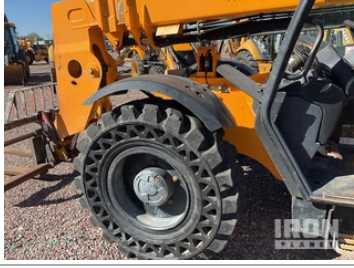
| Fenders | No visible damage or missing components. | |

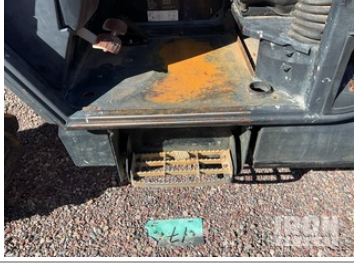
| Steps | No visible damage or missing components | |

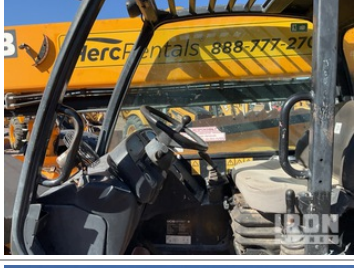
| Hand Rails | No visible damage or missing components | |

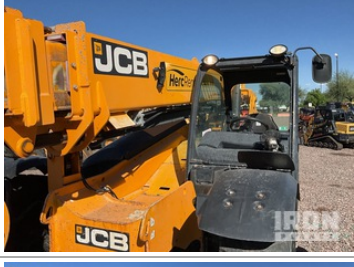
| Exterior Lights | All lights operational | |

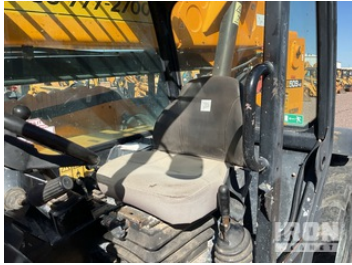
| Control Station | | |
|---|---|---|
| Seat/Armrests | No visible damage or missing components | |

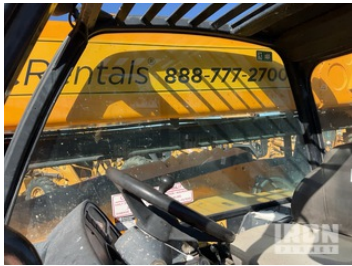
| Control Station | | |
|---|---|---|
| Glass | No visible damage or missing components | |

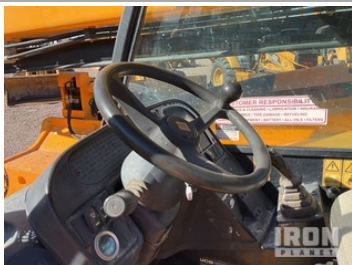
| Control Station | | |
|---|---|---|
| Steering Control | ★★★★☆ | |

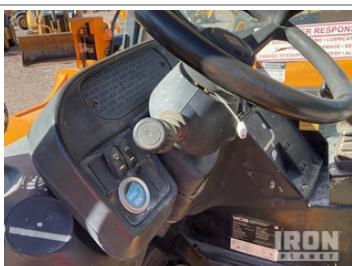
| Control Station | | |
|---|---|---|
| Drivetrain Controls | ★★★★☆ | |

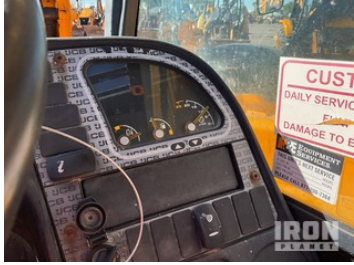
| Engine Oil Pressure | The fault indicator shuts off after the engine oil pressure rises. | |

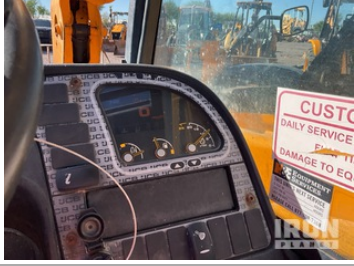
| Warning Lights | Operational | |

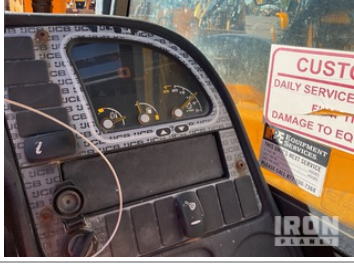
| Gauges | Operational | |

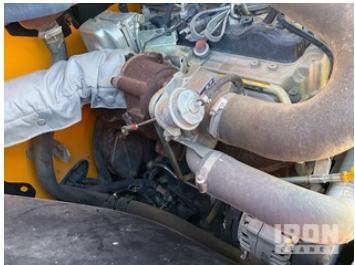
| Engine | | |
|---|---|---|
| Exhaust System | No visible damage or missing components | |

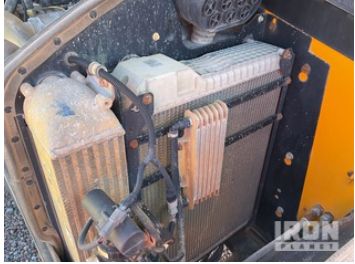
| Engine | | |
|---|---|---|
| Radiator | ★★★★☆ | |

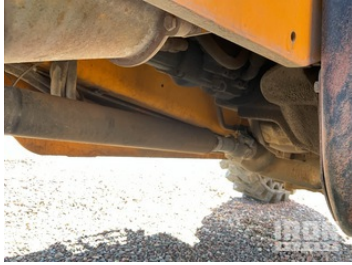
| Item | Assessment | Photo |
|---|---|---|
| Transmission | ★★★★☆ | |

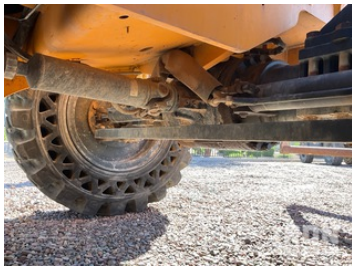
| Item | Assessment | Photo |
|---|---|---|
| Front Drive Axle | ★★★★☆ | |

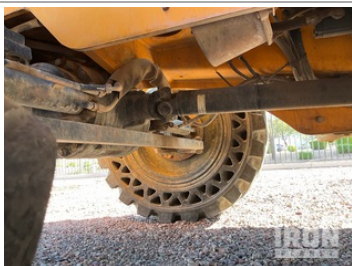
| Item | Assessment | Photo |
|---|---|---|
| Rear Drive Axle | ★★★★☆ | |

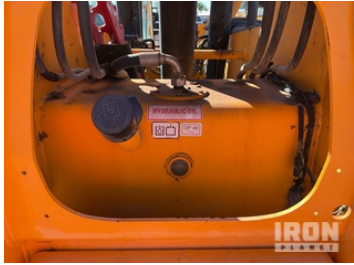
| Hydraulics | | |
|---|---|---|
| Hydraulic Tank | ★★★★☆ | |

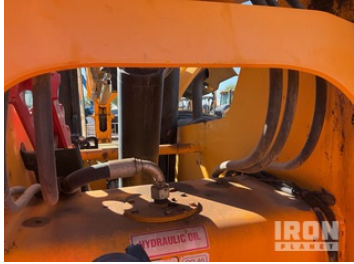
| Hydraulics | | |
|---|---|---|
| Hoses (Hydraulics) | ★★★★☆ | |

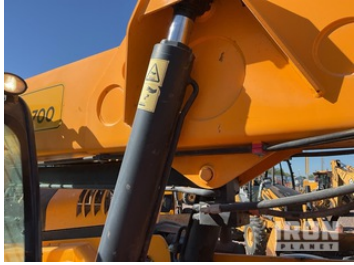
| Hydraulics | | |
|---|---|---|
| Boom Lift Cylinder(s) | ★★★★☆ | |

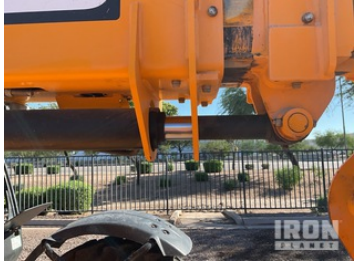
| Hydraulics | | |
|---|---|---|
| Telescopic Boom Cylinders | ★★★★☆ | |

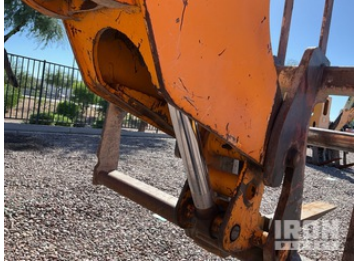
| Hydraulics | | |
|---|---|---|
| Carriage Tilt Cylinder | ★★★★☆ | |

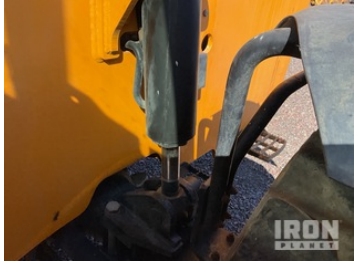
| Hydraulics | | |
|---|---|---|
| Frame Leveling Cylinders | ★★★★☆ | |

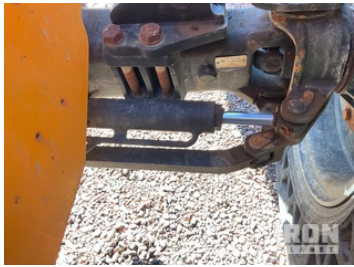
| Steering Cylinders | ★★★★☆ | |

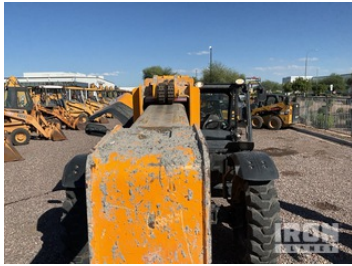
| Item | Assessment | Photo |
|---|---|---|
| Boom Condition | ★★★★☆ | |

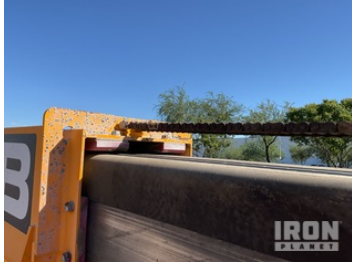
| Item | Assessment | Photo |
|---|---|---|
| Chain / Tensioners | ★★★★☆ | |

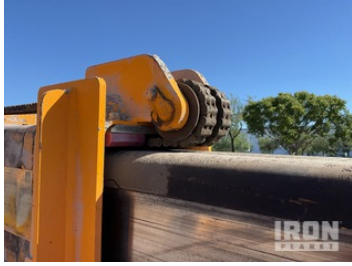
| Item | Assessment | Photo |
|---|---|---|
| Rollers and Guides | ★★★★☆ | |

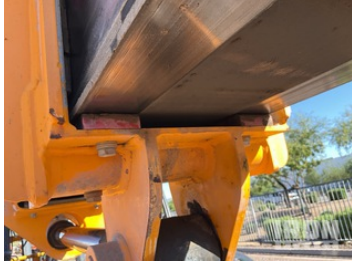
| Item | Assessment | Photo |
|---|---|---|
| Boom Wear Guides | ★★★★☆ | |

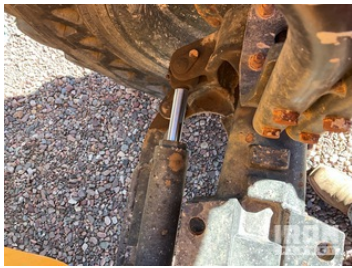
| Item | Assessment | Photo |
|---|---|---|
| Steering Linkage | ★★★★☆ | |

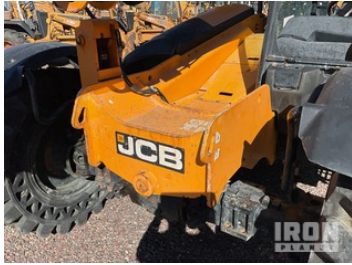
| Item | Assessment | Photo |
|---|---|---|
| Frame Condition | ★★★★☆ | |

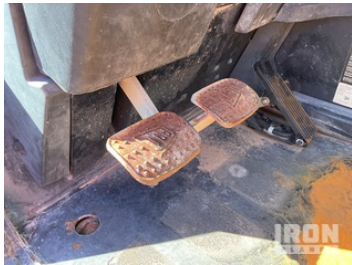
| Item | Assessment | Photo |
|---|---|---|
| Master Cylinder | ★★★★☆ | |

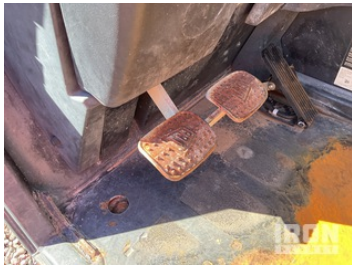
| Item | Assessment | Photo |
|---|---|---|
| Brake Control | ★★★★☆ | |

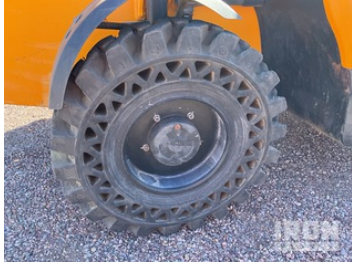
| Right Rear Tire | Size: 14.00R24 Brand: Solid air Tread Depth: 86/32 | |

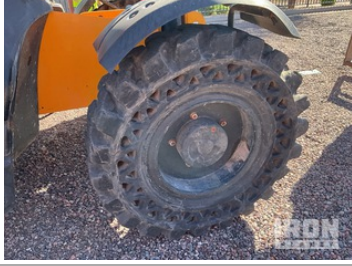
| Right Front Tire | Size: 14.00R24 Brand: solid air Tread Depth: 64/32 | |

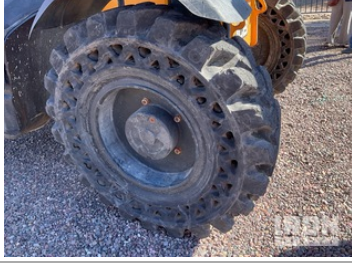
| Wheel Condition | No visible damage or missing components | |

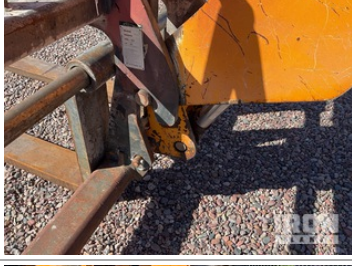
| Loader Quick Coupler | ★★★★☆ | |

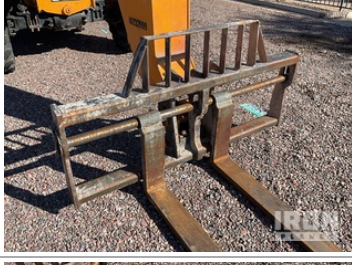
| Load Back Rest | ★★★★☆ | |

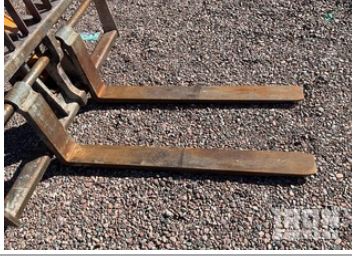
| Forks | ★★★★☆ | |
