## Item #13869133 - 2017 Genie GTH-844 Telehandler

- Features: Open Operator Station, 6000 lb Max Lift Capacity, 2017 US EPA Label, 48 in Forks, Frame Leveling, Auxiliary Hydraulic Plumbing
- Meter Reading: 1,762 Hours
- Serial # : GTH08E-11226
- Inspection Completed: 8/23/25

# Inspection Report

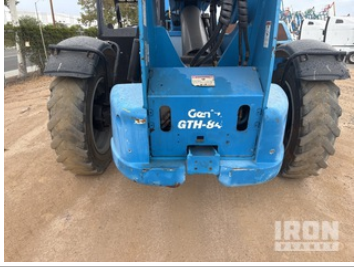
| Paint | Damage/Rust | |

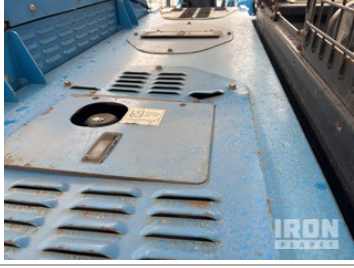
| Body Panels | Damage | |

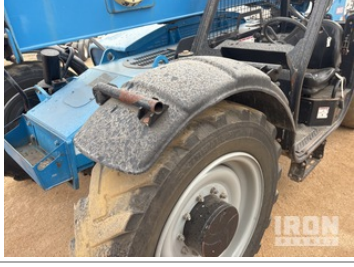
| Fenders | All fenders damaged | |

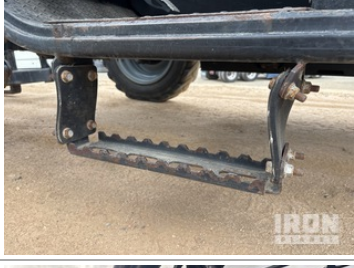
| Steps | Cab step bent, Bent bracket | |

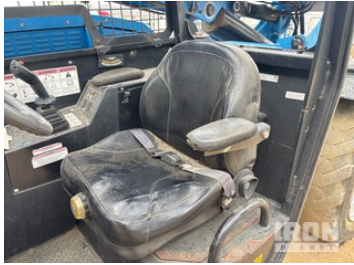
| Control Station | | |
|---|---|---|
| Seat/Armrests | Operator seat cushion damaged, Entire seat damage | |

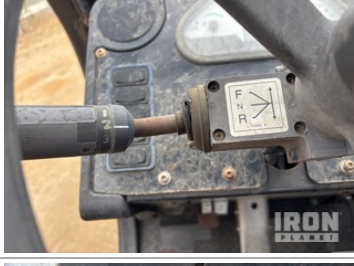
| Control Station | | |
|---|---|---|
| Drivetrain Controls | ★★★★☆<br>Boot damage and handle damage | |

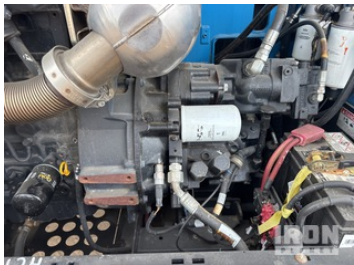
| Item | Assessment | Photo |
|---|---|---|
| Transmission | ★★☆☆<br>Operational | |

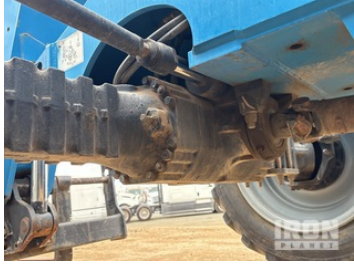
| Item | Assessment | Photo |
|---|---|---|
| Front Drive Axle | ★★☆☆ | |

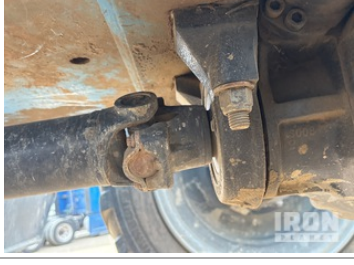
| Item | Assessment | Photo |
|---|---|---|
| Rear Axle Oscillating Pin | ★★☆☆ | |

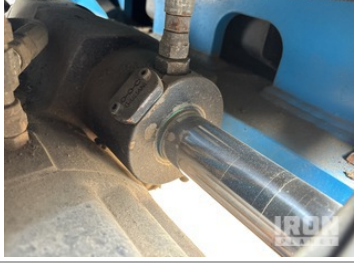
| Steering Cylinders | ★★★☆☆<br>Boots cracked | |

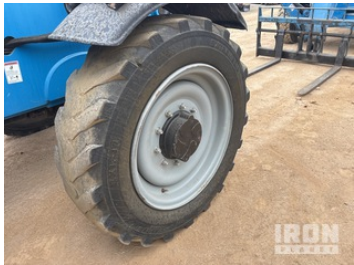
| Left Rear Tire | Tread Depth: 3/32 | |

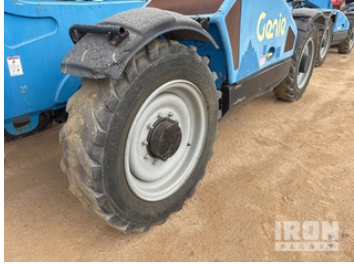
| Right Rear Tire | Tread Depth: 4/32 | |

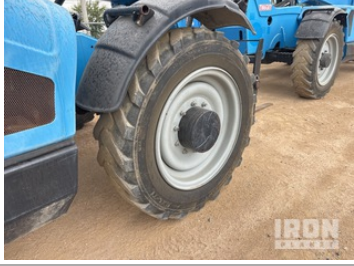
| Right Front Tire | Tread Depth: 5/32 | |
