## Item #13811325 - 2016 JLG 1055 Telehandler

# Inspection Report

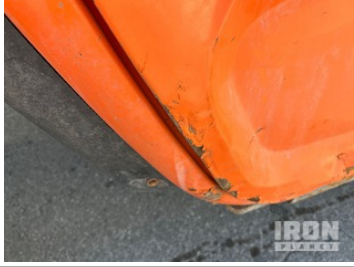
| Paint | Damage | |

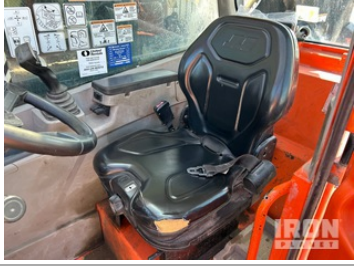
| Seat/Armrests | Operator seat cushion damaged | |

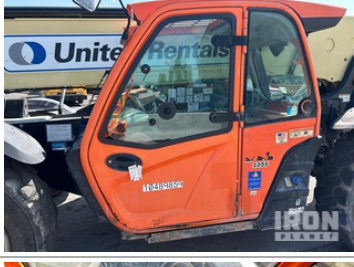
| Cab Door | Door seal damaged | |

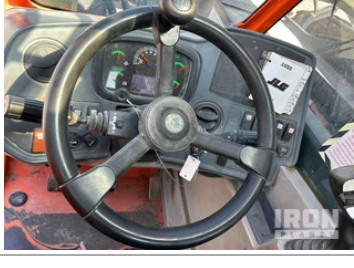
| Steering Control | ★★☆☆<br>Signs of use and minor damages | |

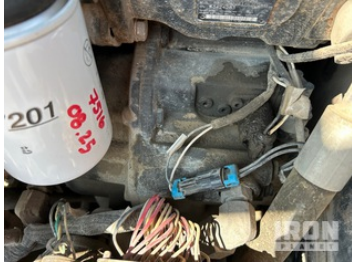
| Item | Assessment | Photo |
|---|---|---|
| Transmission | ★★☆☆<br>Operational, Dripping leak, Leaking from the sensor seal | |

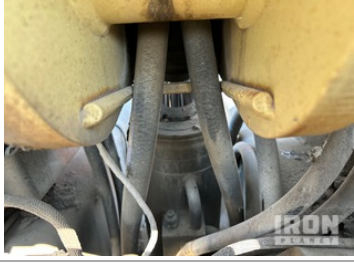
| Hydraulics | | |
|---|---|---|
| Hoses (Hydraulics) | ★★★☆☆<br>Some are dry and cracked | |

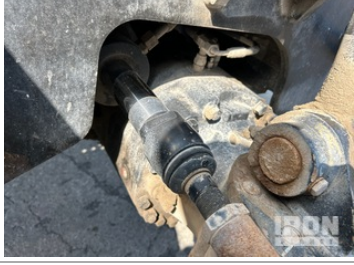
| Steering Cylinders | ★★★☆☆<br>Dripping leak on the left cylinder, Front left cylinder seems to be leaking | |
