## Item #13869134 - 2017 Genie GTH-844 Telehandler

# Inspection Report

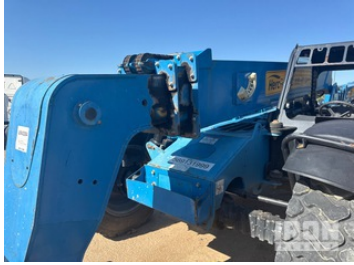
| Paint | Damage | |

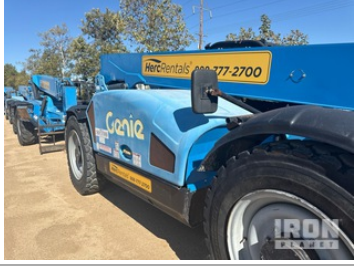
| Body Panels | No visible damage or missing components | |

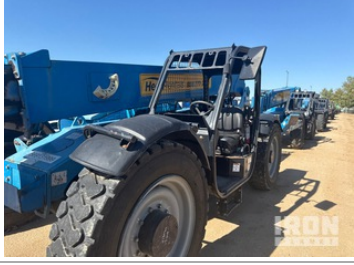
| Fenders | No visible damage or missing components. | |

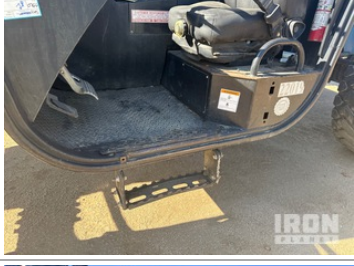
| Steps | No visible damage or missing components | |

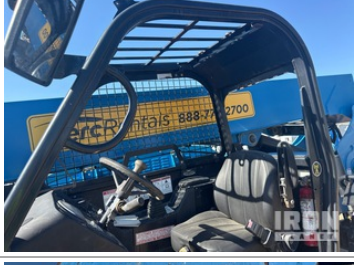
| Hand Rails | No visible damage or missing components | |

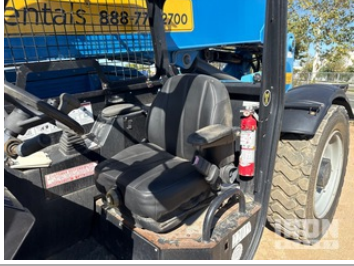
| Seat/Armrests | No visible damage or missing components | |

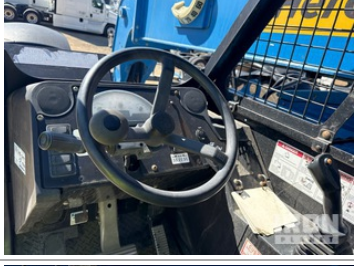
| Steering Control | ★★★★☆<br>Heavy steering wheel play | |

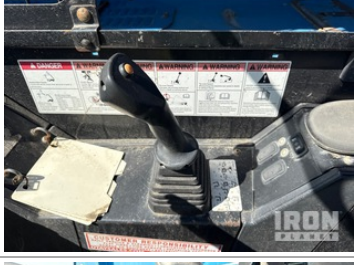
| Hydraulic Controls | ★★★★☆ | |

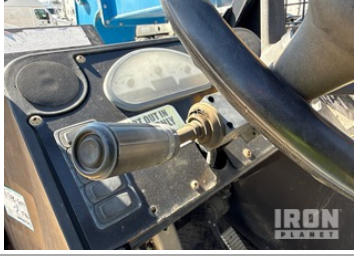
| Drivetrain Controls | ★★★★☆ | |

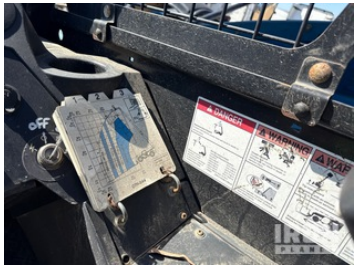
| Load Charts | Posted on cab wall | |

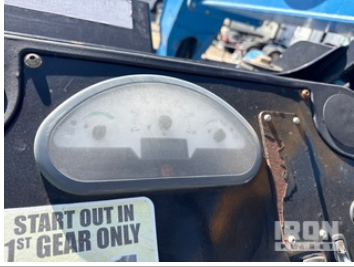
| Warning Lights | Operational | |

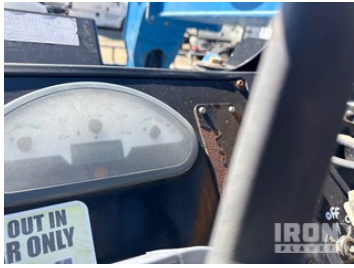
| Gauges | Operational | |

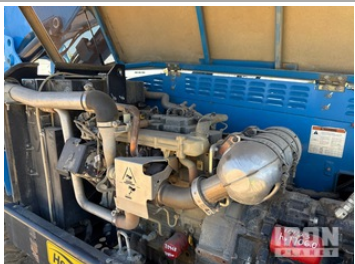
| Engine | | |
|---|---|---|
| Exhaust System | No visible damage or missing components | |

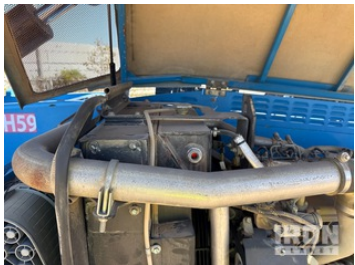
| Engine | | |
|---|---|---|
| Radiator | ★★★★☆ | |

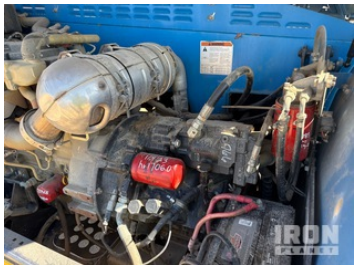
| Item | Assessment | Photo |
|---|---|---|
| Transmission | ★★☆☆<br>Operational | |

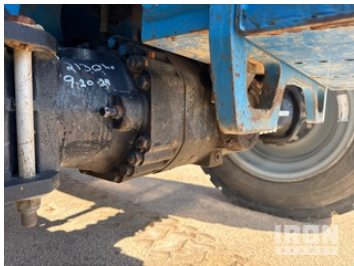
| Item | Assessment | Photo |
|---|---|---|
| Front Drive Axle | ★★☆☆ | |

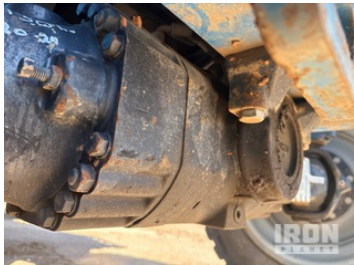
| Item | Assessment | Photo |
|---|---|---|
| Front Axle Oscillating Pin | ★★☆☆ | |

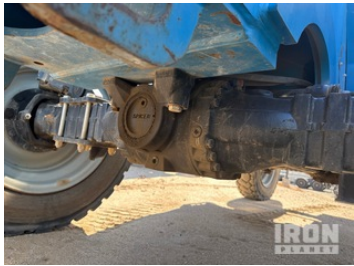
| Item | Assessment | Photo |
|---|---|---|
| Rear Drive Axle | ★★☆☆ | |

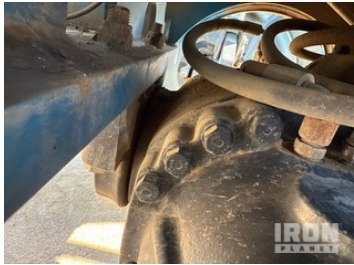
| Item | Assessment | Photo |
|---|---|---|
| Rear Axle Oscillating Pin | ★★☆☆ | |

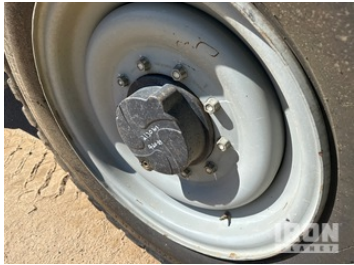
| Item | Assessment | Photo |
|---|---|---|
| Final Drives | ★★☆☆ | |

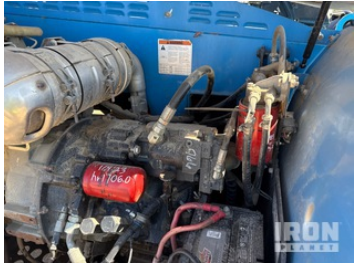
| Hydraulics | | |
|---|---|---|
| Pumps (Hydraulics) | ★★★★☆ | |

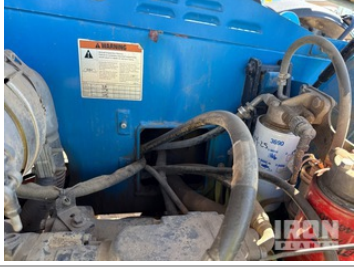
| Hydraulics | | |
|---|---|---|
| Valves | ★★★★☆ | |

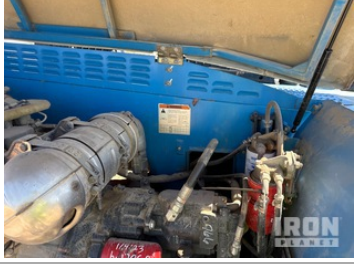
| Hydraulics | | |
|---|---|---|
| Hydraulic Tank | ★★★★☆ | |

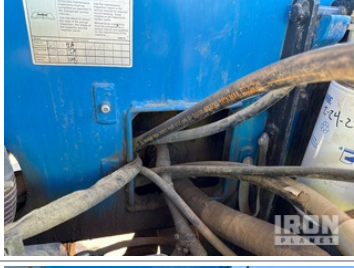
| Hydraulics | | |
|---|---|---|
| Hoses (Hydraulics) | ★★★★☆ | |

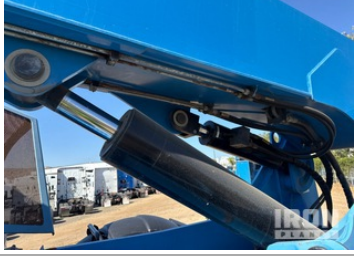
| Hydraulics | | |
|---|---|---|
| Boom Lift Cylinder(s) | ★★★★☆ | |

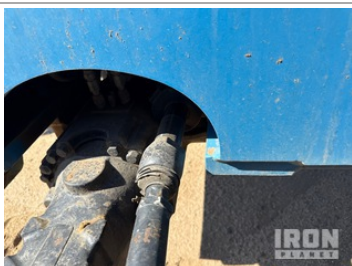
| Steering Cylinders | ★★★★☆ | |

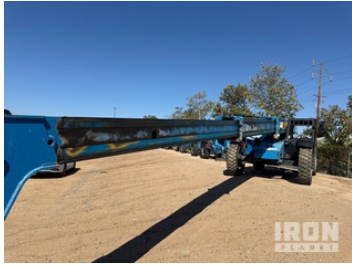
| Item | Assessment | Photo |
|---|---|---|
| Boom Condition | ☆☆☆☆ | |

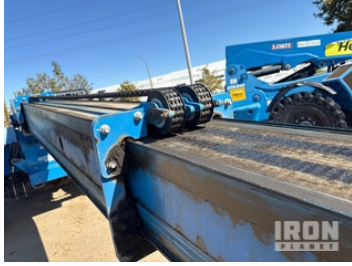
| Item | Assessment | Photo |
|---|---|---|
| Chain / Tensioners | ☆☆☆☆ | |

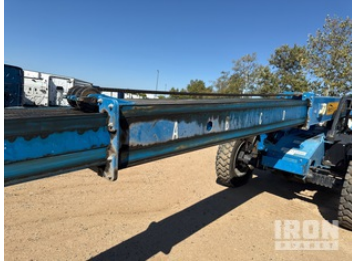
| Item | Assessment | Photo |
|---|---|---|
| Rollers and Guides | ☆☆☆☆ | |

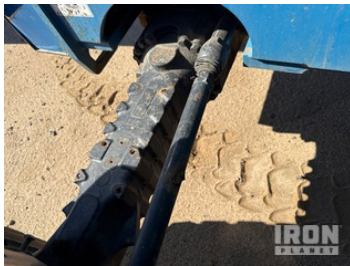
| Item | Assessment | Photo |
|---|---|---|
| Steering Linkage | ★★★★☆ | |

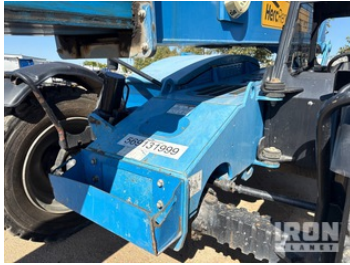
| Item | Assessment | Photo |
|---|---|---|
| Frame Condition | ★★★★☆ | |

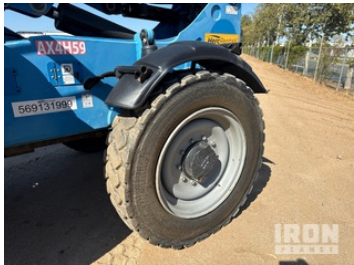
| Left Rear Tire | Size: 330/85-28 Brand: Extremelift<br>Model: ETH-1 Tread Depth: 31/32 | |

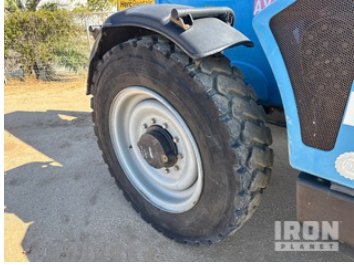
| Right Rear Tire | Size: 330/85-28 Brand: Extremelift<br>Model: EXL-T1 Tread Depth: 31/32 | |

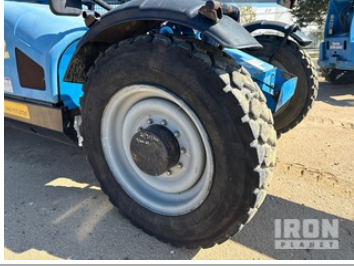
| Right Front Tire | Size: 330/85-28 Brand: Extreme lift<br>Model: EXL-T1 Tread Depth: 31/32 | |

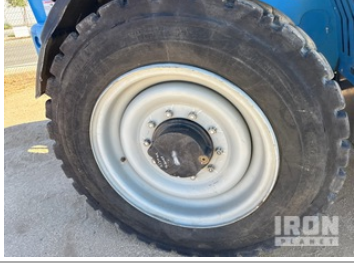
| Wheel Condition | No visible damage or missing components | |

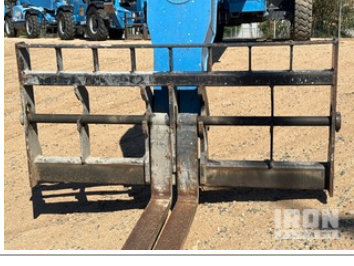
| Load Back Rest | ★★★★☆ | |
