## Item #13869098 - 2019 Skyjack SJ1256THS Telehandler

# Inspection Report

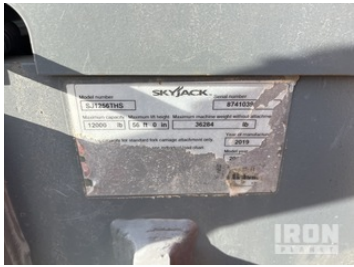
| Serial Number / VIN | 87410396, The serial number is not legible. This unit may be difficult to export. Tag damaged | |

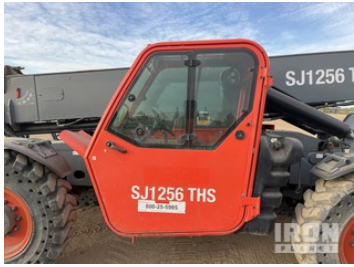
| Paint | Damage | |

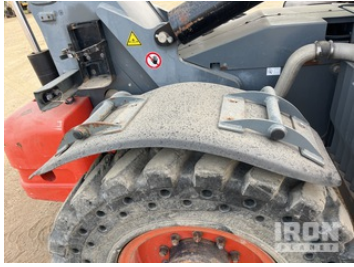
| Fenders | Right rear damaged, Right rear fender bent | |

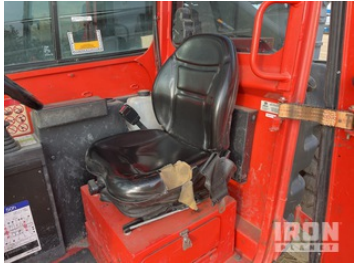
| Control Station | | |
|---|---|---|
| Seat/Armrests | Operator seat cushion damaged | |

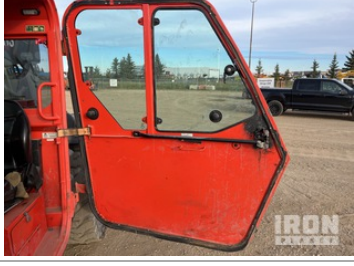
| Control Station | | |
|---|---|---|
| Cab Door | Door frame damaged Door seal damaged | |

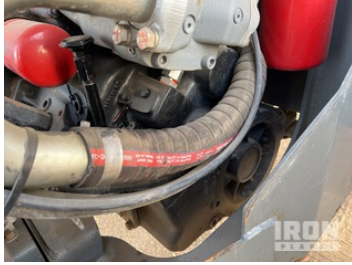
| Item | Assessment | Photo |
|---|---|---|
| Transmission | ★★☆☆<br>Operational | |

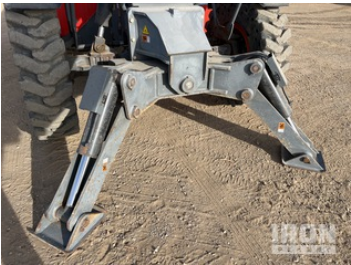
| Outriggers | ★★★☆☆<br>Dirt pads | |

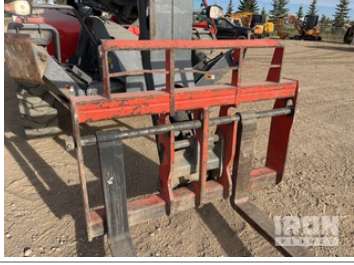
| Load Back Rest | ★★★★☆<br>Top bars bent | |
