## Item #13869136 - 2017 Genie GTH-844 Telehandler

- Features: Open Operator Station, 8000 lb Max Lift Capacity, 2017 US EPA Label, CARB Compliant, 60 in Forks, Frame Leveling, Auxiliary Hydraulic Plumbing
- Meter Reading: 0 Miles
- Serial # : GTH08E-11291
- Inspection Completed: 8/21/25

## Inspection Report

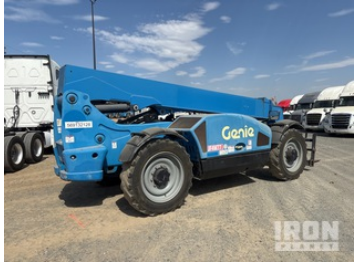
| Paint | Damage | |

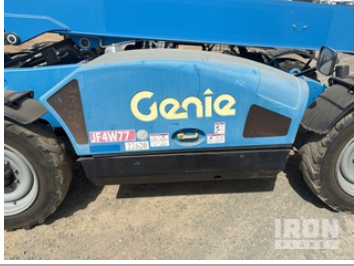
| Body Panels | Front tool box | |

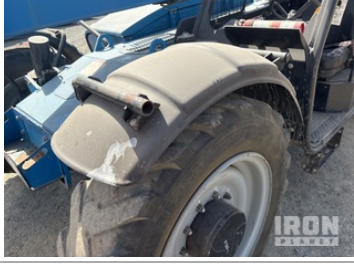
| Fenders | Left rear damaged | |

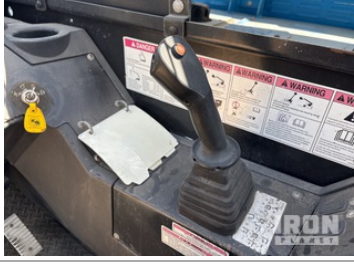
| Control Station | | |
|---|---|---|
| Hydraulic Controls | ★★★★☆<br>Minor play | |

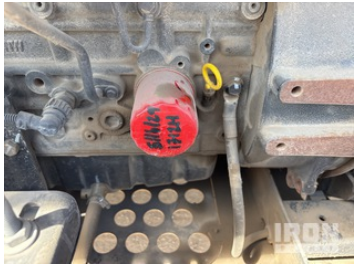
| Engine | | |
|---|---|---|
| Oil Leaks | Seep around filter | |

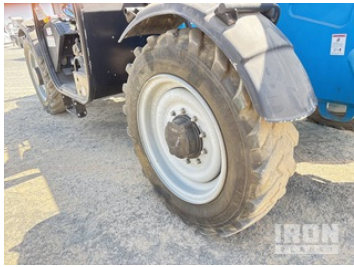
| Left Rear Tire | Tread Depth: 5/32 | |

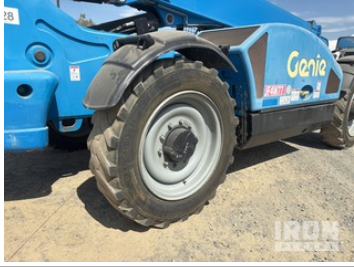
| Right Rear Tire | Tread Depth: 5/32 | |

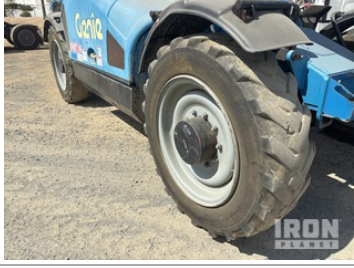
| Right Front Tire | Tread Depth: 7/32 | |
