## Item #13869145 - 2018 Genie GTH-844 Telehandler

# Inspection Report

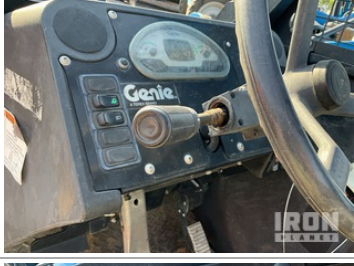
| Control Station | | |
|---|---|---|
| Drivetrain Controls | ★★★☆☆<br>Missing boot | |

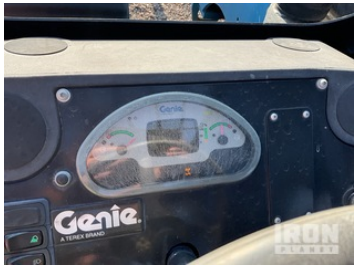
| Engine Oil Pressure | The fault indicator shuts off after the engine oil pressure rises. | |

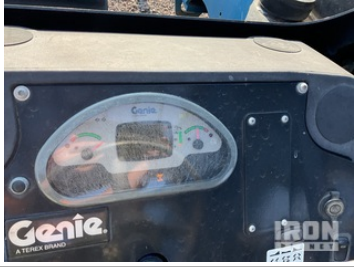
| Warning Lights | Operational, Digital screen, heat damaged, not working | |

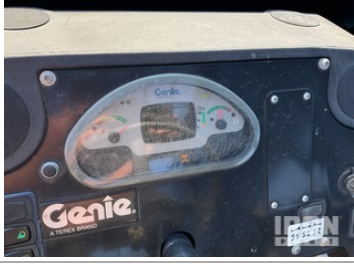
| Hour Meter / Odometer | 0 mi, Meter reading could not be obtained, Screen heat damage cannot make out hours | |

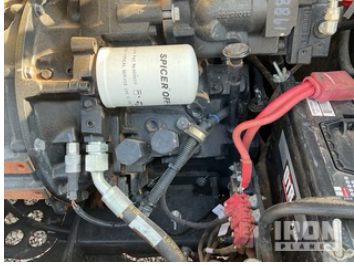
| Item | Assessment | Photo |
|---|---|---|
| Transmission | ★★☆☆<br>Operational | |

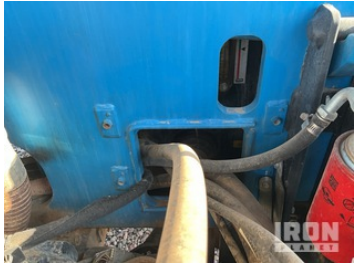
| Item | Assessment | Photo |
|---|---|---|
| Transfer Case / Drop Box | ★★☆☆ | |

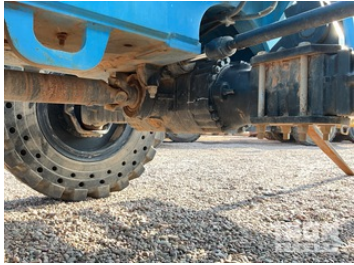
| Item | Assessment | Photo |
|---|---|---|
| Front Drive Axle | ★★☆☆ | |

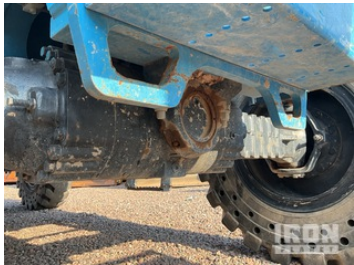
| Item | Assessment | Photo |
|---|---|---|
| Front Axle Oscillating Pin | ★★☆☆ | |

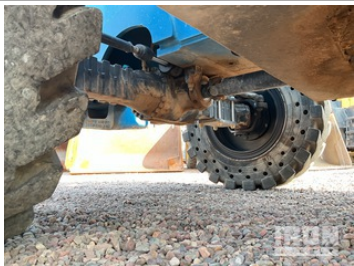
| Item | Assessment | Photo |
|---|---|---|
| Rear Drive Axle | ★★☆☆<br>Slot leak on left rear, outer seal or planetary | |

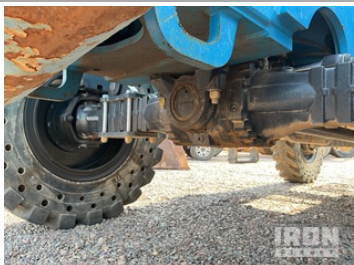
| Item | Assessment | Photo |
|---|---|---|
| Rear Axle Oscillating Pin | ★★☆☆ | |

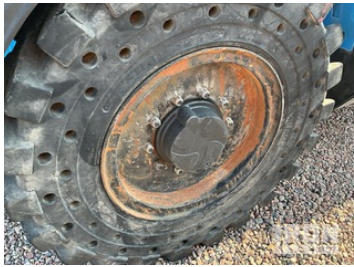
| Final Drives | ★★☆☆<br>Slight leak on left rear planetary | |

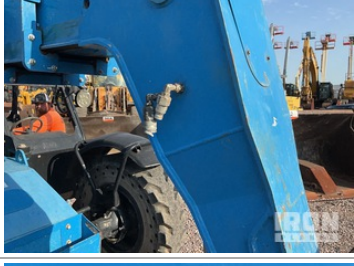
| Hydraulics | | |
|---|---|---|
| Auxiliary Hydraulic Plumbing | Capped off | |

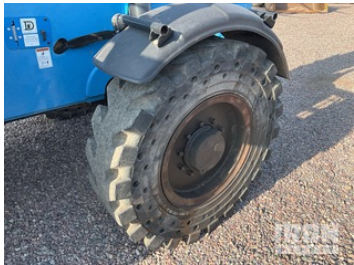
| Left Rear Tire | Size: 1300 x 24 Brand: Solid boss<br>Model: TH Tread Depth: 46/32 | |

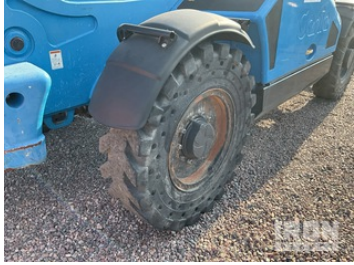
| Right Rear Tire | Size: 1300 x 24 Brand: Solid boss<br>Model: TH Tread Depth: 48/32 | |

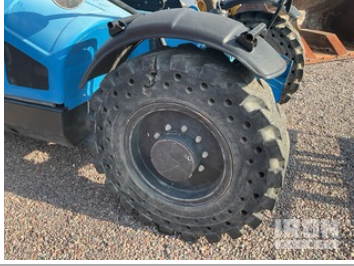
| Right Front Tire | Size: 1300 x 24 Brand: Solid boss<br>Model: TH Tread Depth: 48/32 | |

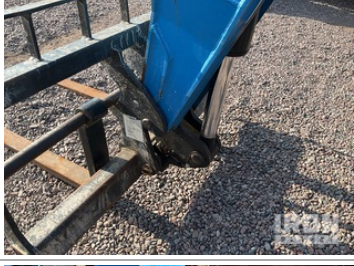
| Loader Quick Coupler | ★★★★☆<br>Not operationally checked | |
