## Item #13810734 - 2017 Skyjack SJ643 TH Telehandler

- Features: Enclosed Cab, Air Conditioner, 43 ft Max Lift Height, 6000 lb Max Lift Capacity, 2016 US EPA Label, CARB Compliant, 48 in Forks, Tilt Carriage, Manual Coupler, Auxiliary Hydraulic Plumbing
- Meter Reading: 2,683 Hours
- Serial # : 87110528
- Inspection Completed: 8/21/25

# Inspection Report

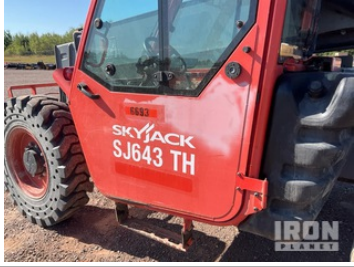
| Paint | No visible damage | |

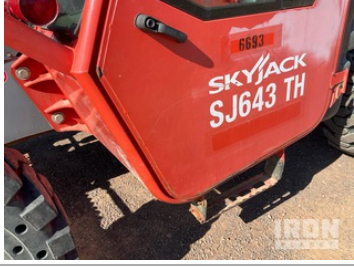
| Body Panels | No visible damage or missing components | |

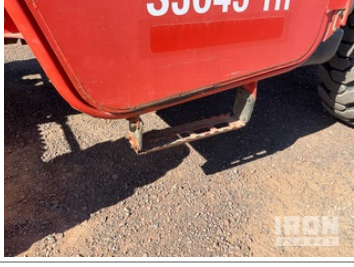
| Steps | No visible damage or missing components | |

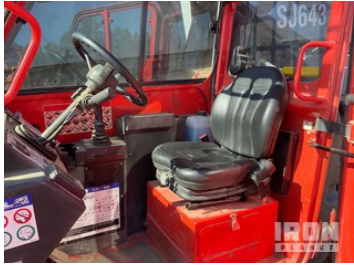
| Control Station | | |
|---|---|---|
| Seat/Armrests | No visible damage or missing components | |

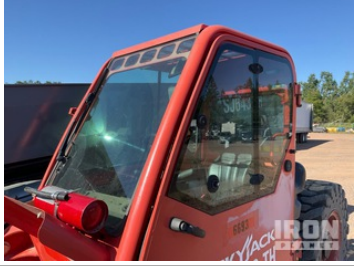
| Control Station | | |
|---|---|---|
| Glass | No visible damage or missing components | |

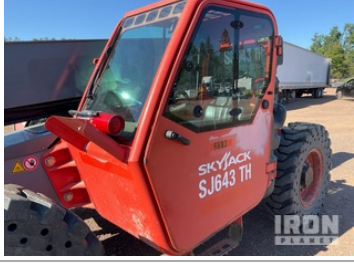
| Control Station | | |
|---|---|---|
| Cab Door | Door latch damaged | |

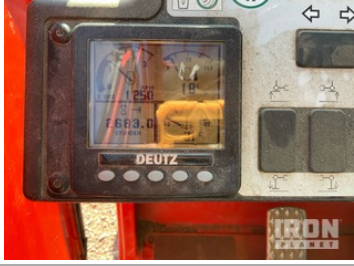
| Engine Oil Pressure | No oil pressure indicator | |

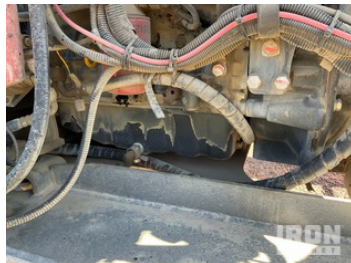
| Engine | | |
|---|---|---|
| Oil Leaks | No dripping leaks | |

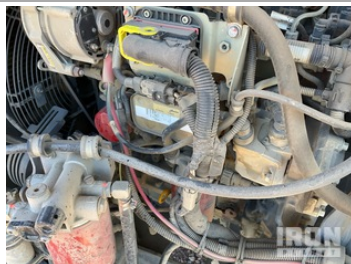
| Engine | | |
|---|---|---|
| Fuel Leaks | No dripping leaks | |

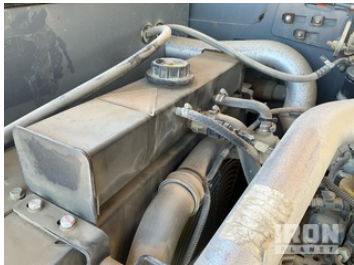
| Cooling System Leaks | No dripping leaks | |

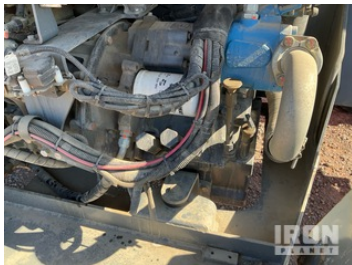
| Item | Assessment | Photo |
|---|---|---|
| Transmission | ★★☆☆<br>Operational | |

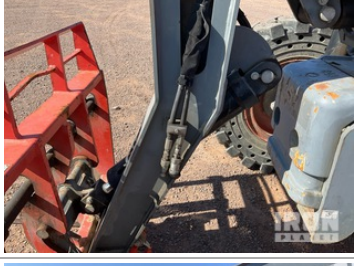
| Hydraulics | | |
|---|---|---|
| Auxiliary Hydraulic Plumbing | Capped off, Not operationally checked, Front | |

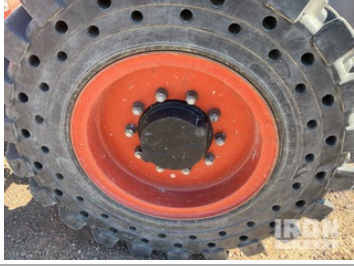
| Wheel Condition | No visible damage or missing components | |
