## Item #14094987 - 2018 Skyjack SJ1056TH Telehandler

# Inspection Report

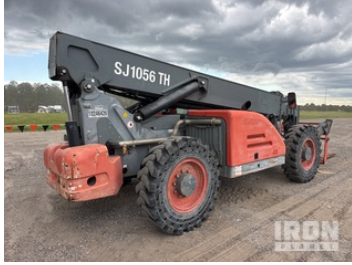
| Paint | Damage | |

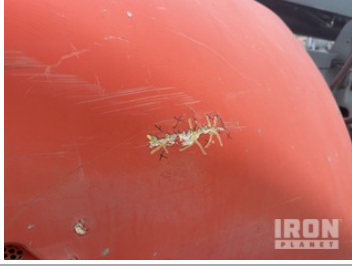
| Body Panels | Engine cover damaged | |

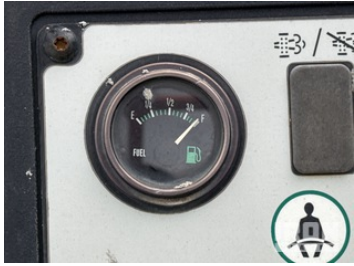
| Warning Lights | Inoperable Digital screen does not function. | |
| Gauges | Digital screen does not function. gauges are inoperable | |

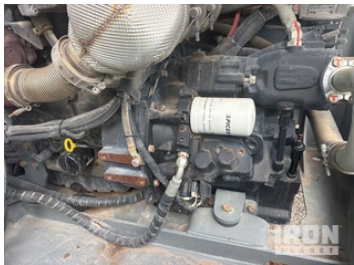
| Item | Assessment | Photo |
|---|---|---|
| Transmission | ★★☆☆<br>Operational | |

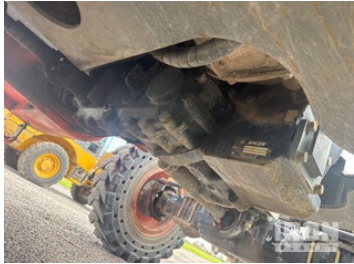
| Item | Assessment | Photo |
|---|---|---|
| Transfer Case / Drop Box | ★★☆☆<br>Operational | |

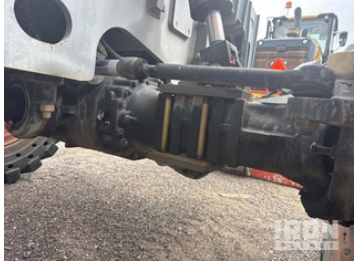
| Item | Assessment | Photo |
|---|---|---|
| Front Drive Axle | ★★☆☆ | |

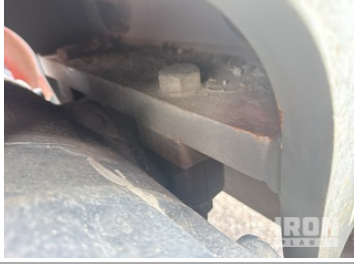
| Item | Assessment | Photo |
|---|---|---|
| Front Axle Oscillating Pin | ★★☆☆ | |

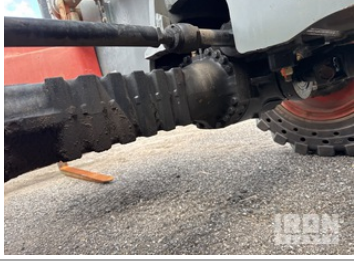
| Item | Assessment | Photo |
|---|---|---|
| Rear Drive Axle | ★★☆☆ | |

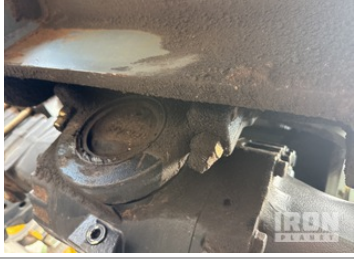
| Item | Assessment | Photo |
|---|---|---|
| Rear Axle Oscillating Pin | ★★☆☆ | |
