## Item #14096208 - 2017 Skyjack SJ843TH Telehandler

# Inspection Report

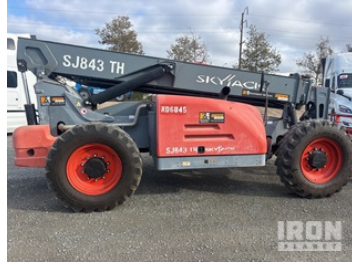
| Paint | No visible damage | |

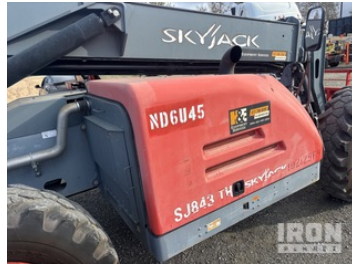
| Body Panels | No visible damage or missing components | |

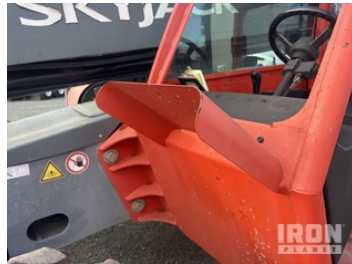
| Fenders | No visible damage or missing components. | |

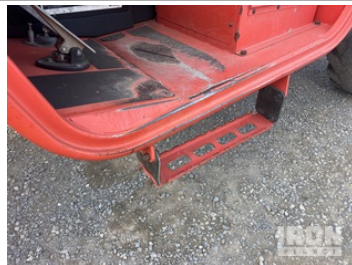
| Steps | No visible damage or missing components | |

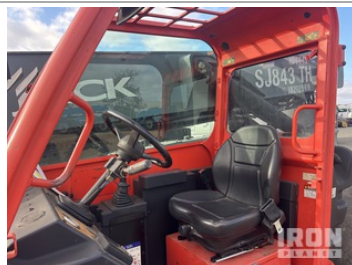
| Hand Rails | No visible damage or missing components | |

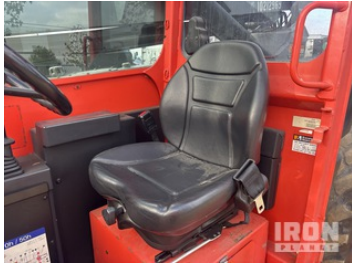
| Control Station | | |
|---|---|---|
| Seat/Armrests | No visible damage or missing components | |

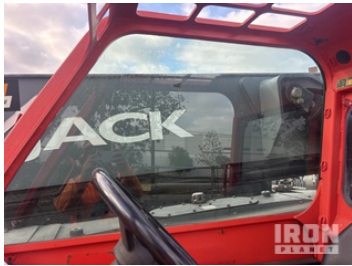
| Control Station | | |
|---|---|---|
| Glass | No visible damage or missing components | |

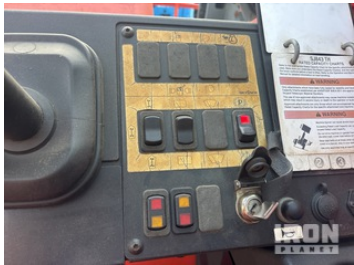
| Transmission Disconnect Control | ☆☆☆☆ | |

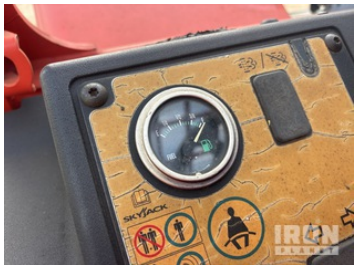
| Engine Oil Pressure Gauges | No oil pressure indicator<br>Operational | |

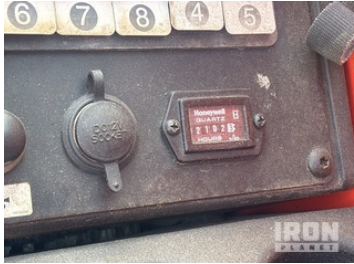
| Hour Meter / Odometer | 2102 hrs | |

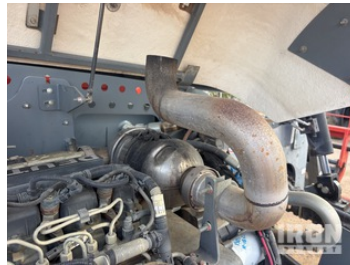
| Engine | | |
|---|---|---|
| Exhaust System | No visible damage or missing components | |

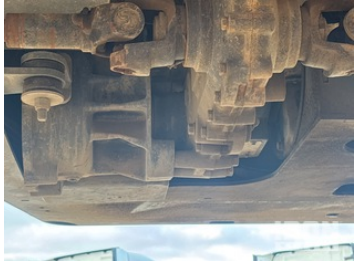
| Item | Assessment | Photo |
|---|---|---|
| Transmission | ★★☆☆<br>Operational | |

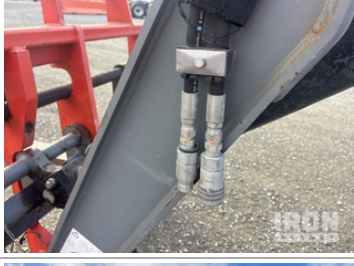
| Hydraulics | | |
|---|---|---|
| Auxiliary Hydraulic Plumbing | Not operationally checked | |

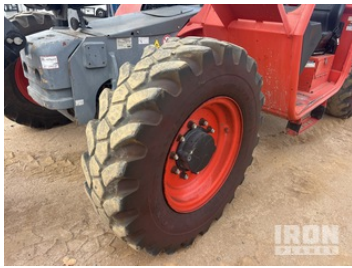
| Item | Assessment | Photo |
|---|---|---|
| Left Front Tire | Size: 300-24 Brand: Galaxy Model: Giraffe XLW Tread Depth: 8 /32 | |

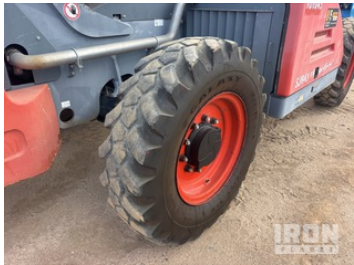
| Right Rear Tire | Size: 300-24 Brand: Galaxy Model: Giraffe XLW Tread Depth: 7 /32 | |

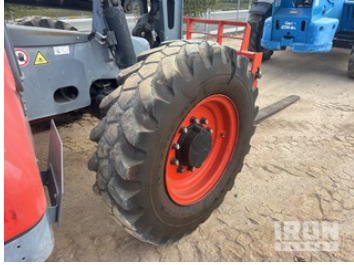
| Right Front Tire | Size: 300-24 Brand: Galaxy Model: Giraffe XLW Tread Depth: 9 /32 | |

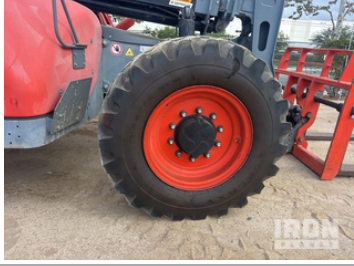
| Wheel Condition | No visible damage or missing components | |
