## Item #14095045 - 2016 Skyjack SJ63AJ 4WD Diesel Articulating Boom Lift

# Inspection Report

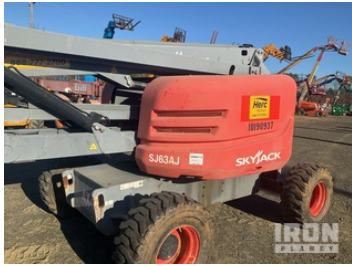
| Paint | No visible damage | |

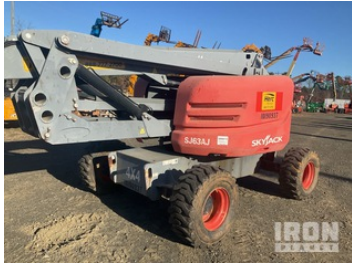
| Body Panels | No visible damage or missing components | |

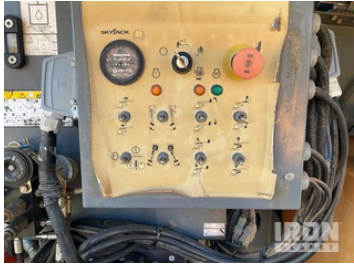
| Control Station Ground | | |
|---|---|---|
| Function Controls | ★★★★☆ | |

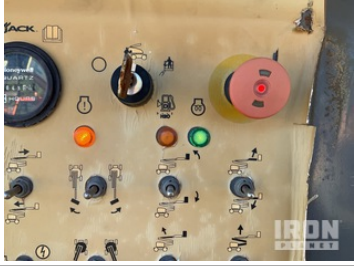
| Control Station Ground | | |
|---|---|---|
| Warning Lights | Operational | |

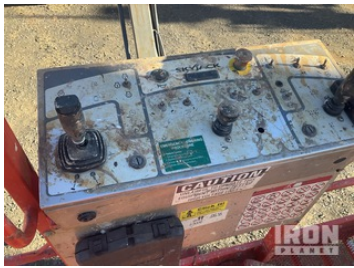
| Item | Assessment | Photo |
|---|---|---|
| Control Console | No visible damage or missing components | |

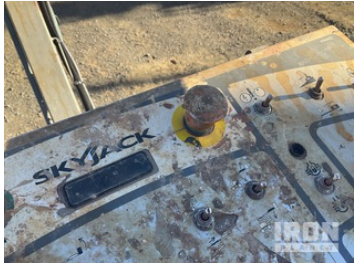
| Item | Assessment | Photo |
|---|---|---|
| Emergency Shut Off Switch | Operational | |

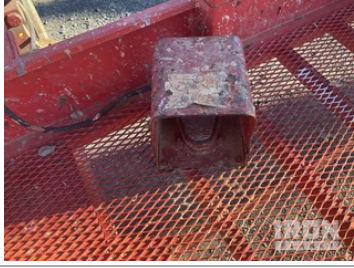
| Item | Assessment | Photo |
|---|---|---|
| Safety Control Hand/Foot Switch | ☆☆☆☆ | |

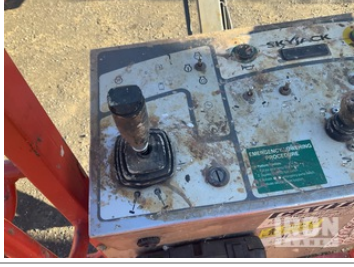
| Item | Assessment | Photo |
|---|---|---|
| Function Controls | ☆☆☆☆ | |

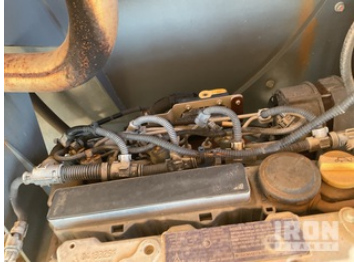
| Engine | | |
|---|---|---|
| Fuel System | Operational | |

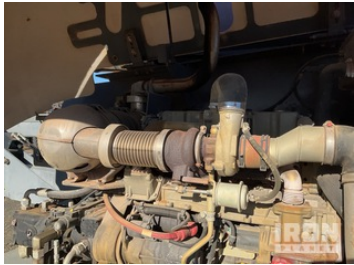
| Engine | | |
|---|---|---|
| Exhaust System | No visible damage or missing components | |

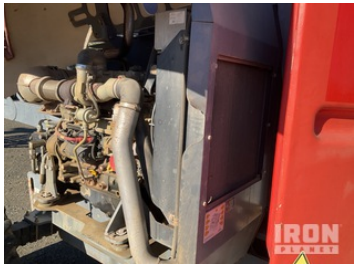
| Engine | | |
|---|---|---|
| Radiator | ★★★★☆ | |

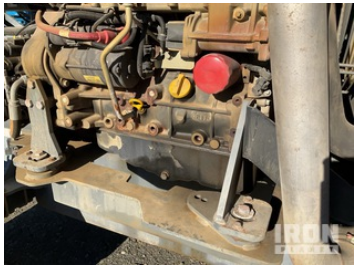
| Engine | | |
|---|---|---|
| Oil Leaks | No dripping leaks | |

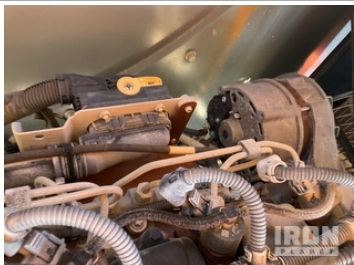
| Engine | | |
|---|---|---|
| Fuel Leaks | No dripping leaks | |

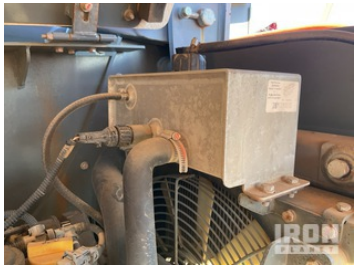
| Cooling System Leaks | No dripping leaks | |

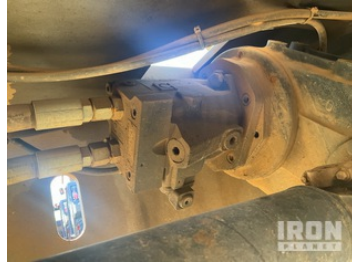
| Item | Assessment | Photo |
|---|---|---|
| Rear Center Drive Motor | ☆☆☆☆ | |

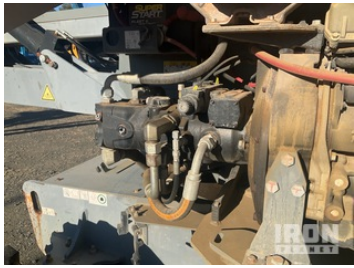
| Hydraulics | | |
|---|---|---|
| Pumps (Hydraulics) | ★★★★☆ | |

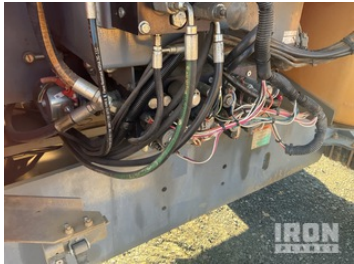
| Hydraulics | | |
|---|---|---|
| Valves | ★★★★☆ | |

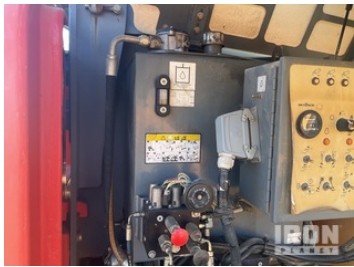
| Hydraulics | | |
|---|---|---|
| Hydraulic Tank | ★★★★☆ | |

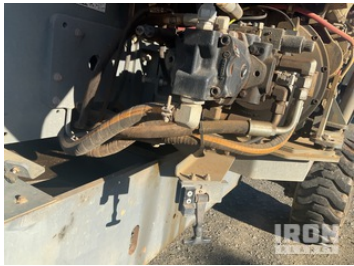
| Hydraulics | | |
|---|---|---|
| Hoses (Hydraulic) | ★★★★☆ | |

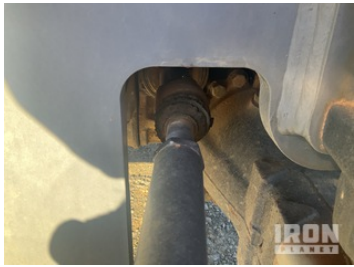
| Hydraulics | | |
|---|---|---|
| Steering Cylinders | ★★★★☆ | |

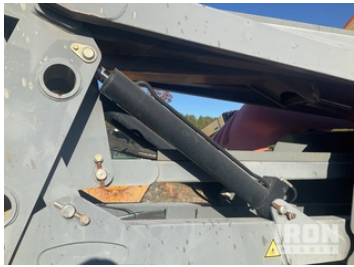
| Hydraulics | | |
|---|---|---|
| Boom Lift Cylinder | ★★★★☆ | |

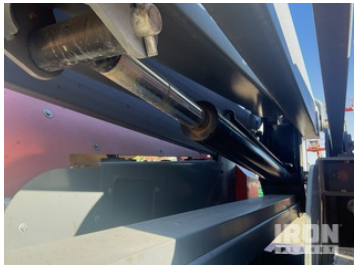
| Secondary Boom Cylinder | ★★★★☆ | |

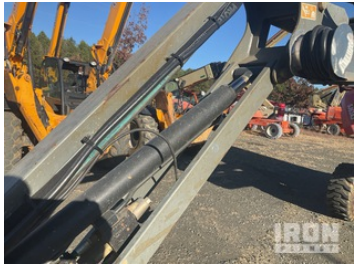
| Jib Cylinder | ★★★★☆ | |

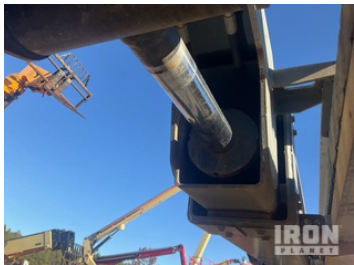
| Basket Tilt Cylinder | ★★★★☆ | |

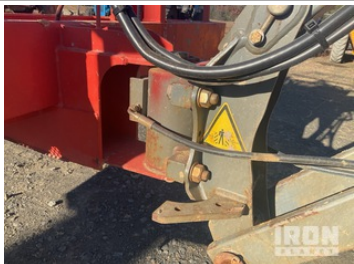
| Basket Rotator Motor | ★★★★☆ | |

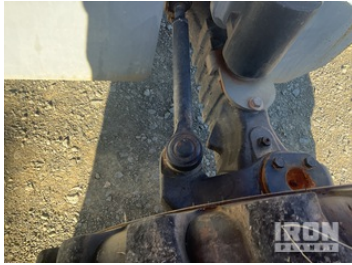
| Chassis | | |
|---|---|---|
| Steering Linkage | ★★★★☆ | |

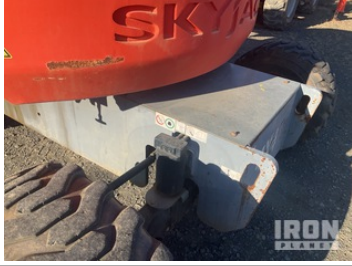
| Chassis | | |
|---|---|---|
| Frame Condition | ★★★★☆ | |

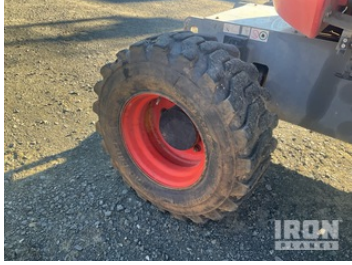
| Chassis | | |
|---|---|---|
| Left Front Tire | No visible defects | |

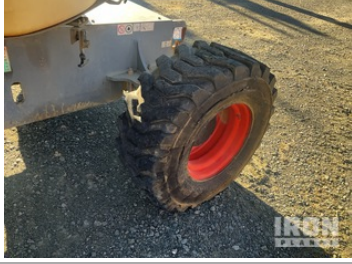
| Chassis | | |
|---|---|---|
| Left Rear Tire | No visible defects | |

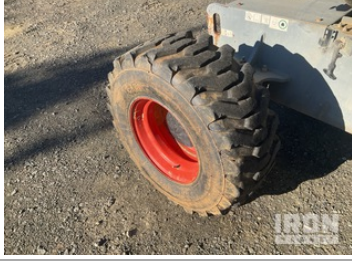
| Chassis | | |
|---|---|---|
| Right Rear Tire | No visible defects | |

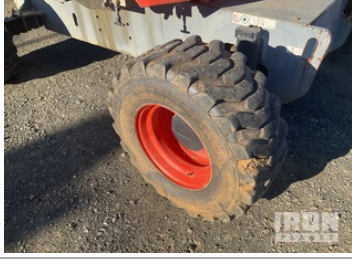
| Chassis | | |
|---|---|---|
| Right Front Tire | No visible defects | |

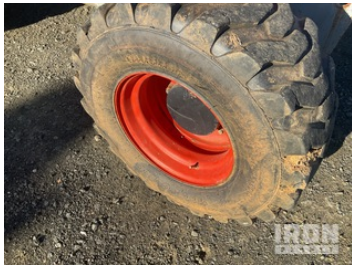
| Wheel Condition | No visible damage or missing components | |

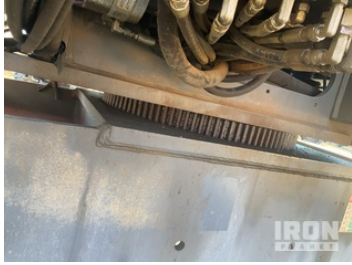
| Turntable Bearing | ★★★★☆ | |

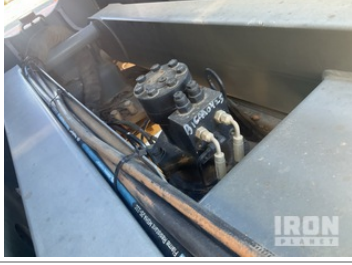
| Swing Motor | ★★★★☆ | |

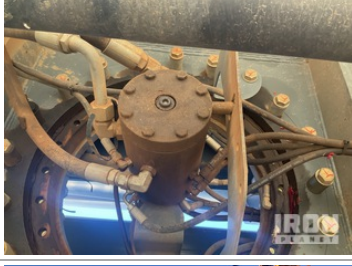
| Hydraulic Center Swivel | ★★★★☆ | |

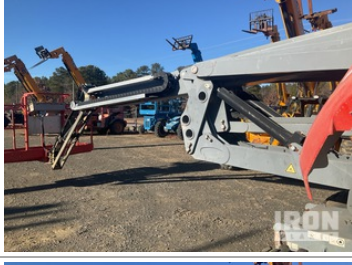
| Boom Condition | ★★★★☆ | |

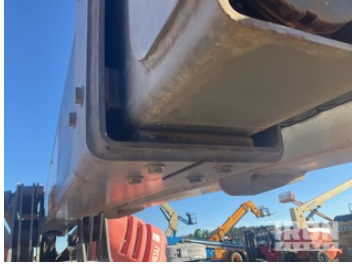
| Boom Wear Guides | ★★★★☆ | |

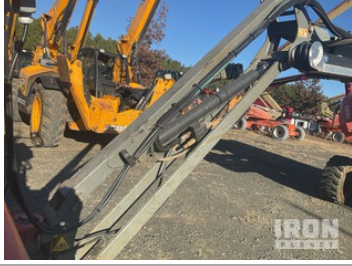
| Jib Condition | ★★★★☆ | |
