## Item #14577210 - 2015 Skyjack SJ6832 RT Dual Fuel 4x4 Scissor Lift

# Inspection Report

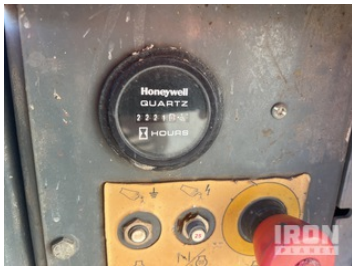
| Hour Meter / Odometer | 2221 hrs | |

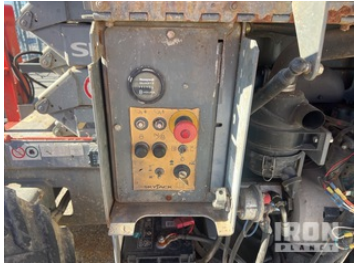
| <b>Control Station Ground</b> | | |
|---|--|--|
| Function Controls | ★ ★ ★ ☆ | |

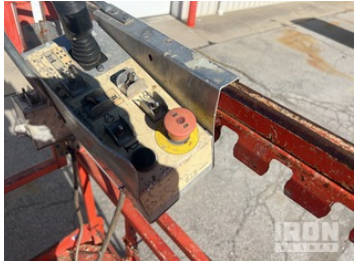
| <b>Control Station Upper</b> | | |
|---|--|--|
| Emergency Shut Off Switch | Operational | |

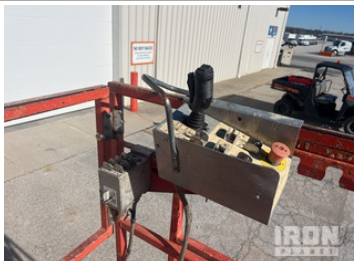
| <b>Control Station Upper</b> | | |
|---|--|--|
| Safety Control Hand/Foot Switch | ★★★★☆<br>Operational | |

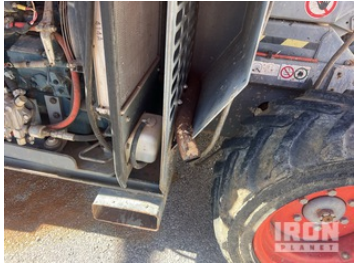
| <b>Engine</b> | | |
|---|---|--|
| Exhaust System | No visible damage or missing components | |

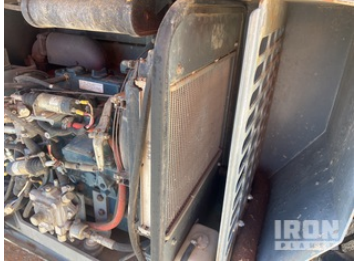
| <b>Engine</b> | | |
|---|---|--|
| Radiator | ★★★★☆ | |

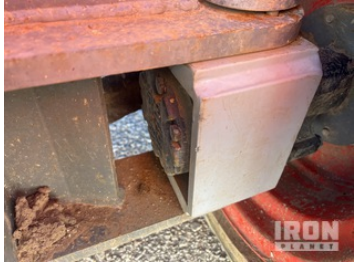
| <b>Drivetrain</b> | | |
|--|---|--|
| Drive Motors | ★★★☆☆ | |

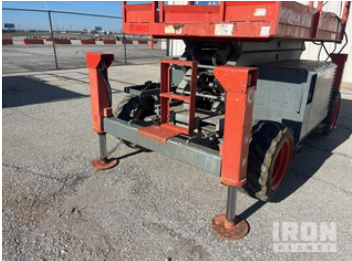
| Outrigger Cylinders | ☆☆☆☆ | |

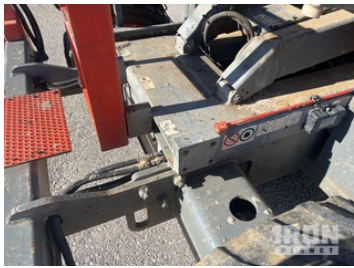
| Chassis | | |
|--|--|--|
| Brake System | ★★☆☆<br>The brake system functioned, stopping and holding the machine. | |

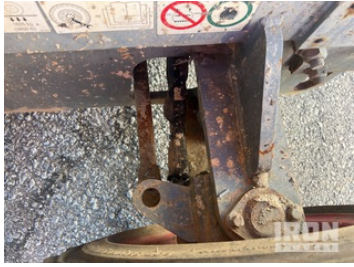
| Chassis | | |
|--|--|--|
| Steering Linkage | ★★☆☆ | |

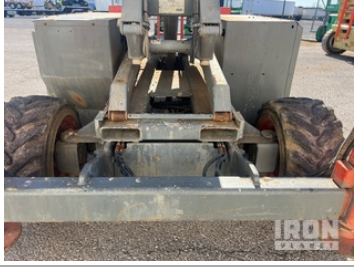
| Chassis | | |
|--|--|--|
| Frame Condition | ★★☆☆ | |

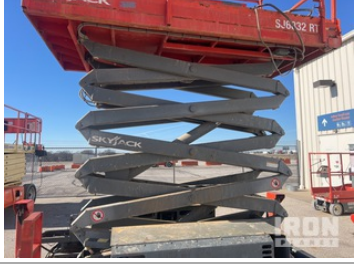
| Chassis | | |
|--|--|--|
| Scissor Linkage | ★★☆☆ | |

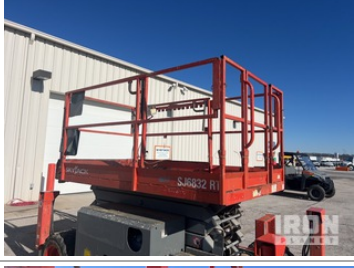
| Chassis | | |
|--|--|--|
| Platform Condition | ★★☆☆ | |

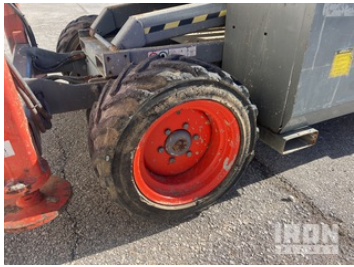
| Left Front Tire | Cracks, Chunks missing | |

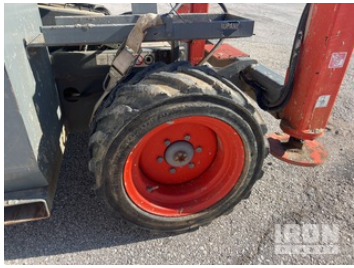
| Left Rear Tire | Cracks, Chunks missing | |

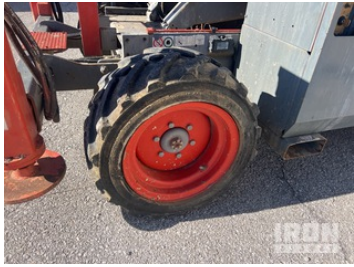
| Right Rear Tire | Cracks, Chunks missing | |

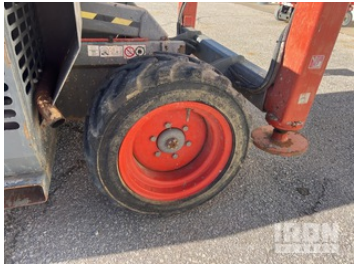
| Right Front Tire | Cracks, Chunks missing | |

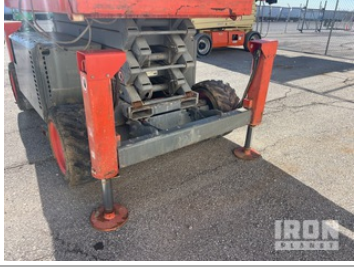
| Outriggers / Stabilizers | ★★★★☆ | |
