## Item #14577209 - 2016 Skyjack SJ6826 RT Dual Fuel 4x4 Scissor Lift

# Inspection Report

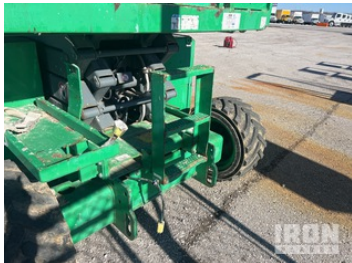
Serial Number / VIN	37007970	 
CE Mark	No CE mark found	
Hour Meter / Odometer	2160 hrs	 
Paint	Concrete residue	 
Body Panels	Engine compartment door damaged	 
Steps/Ladders

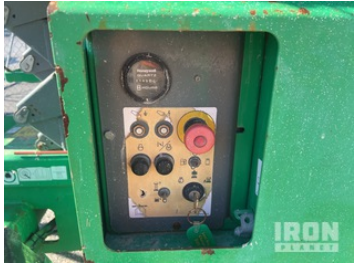
<b>Control Station Ground</b>		
<b>Item</b>	<b>Assessment</b>	<b>Photo</b>
Function Controls	★ ★ ★ ☆

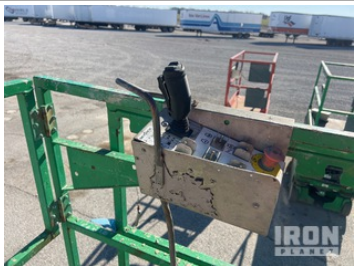
Safety Control Hand/Foot Switch	★★★★☆ Operational

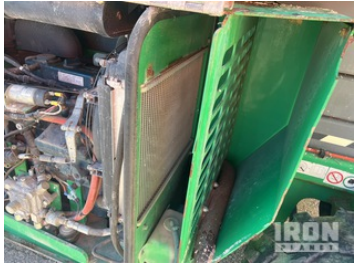
Radiator	★★★★☆

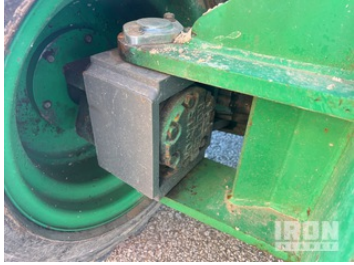
<b>Drivetrain</b>		
Operational test is limited to low speed in a confined flat area without load. Differential interlocks, full transmission shifting and functionality of all drive axles cannot be fully verified. Inspector listens for abnormal noises, observes leaks and notes physical damage.		
<b>Item</b>	<b>Assessment</b>	<b>Photo</b>
Drive Motors	★★★☆☆

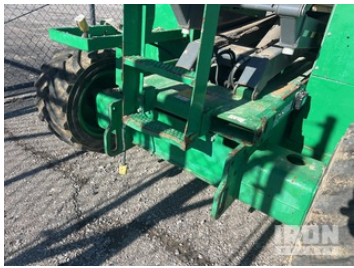
Chassis		
IronPlanet pin connection pivot point wear inspections are limited to sound, sight and feel observations. Dial indicator testing is not performed.		
Item	Assessment	Photo
Brake System	★★☆☆ The brake system functioned, stopping and holding the machine.

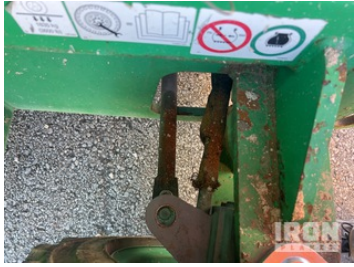
Steering Linkage	★★☆☆

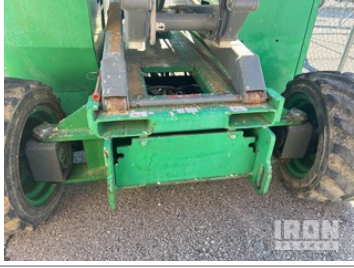
Frame Condition	★★☆☆

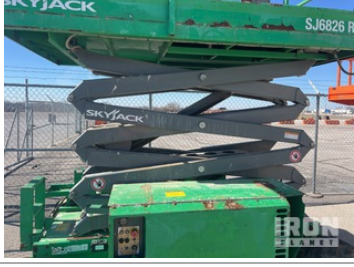
Scissor Linkage	★★☆☆

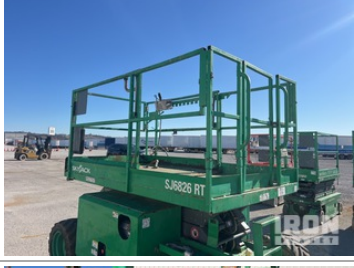
Platform Condition	★★☆☆

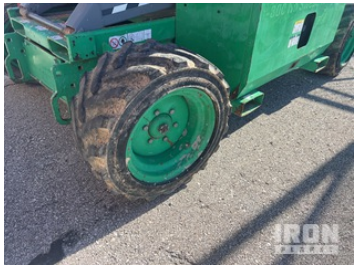
Left Front Tire	Cracks, Chunks missing

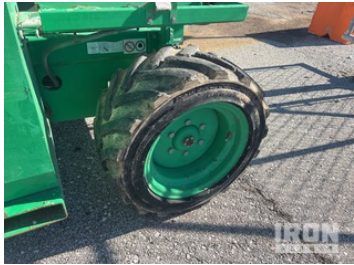
Left Rear Tire	Cracks, Chunks missing

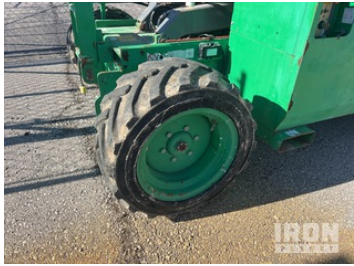
Right Rear Tire	Cracks, Chunks missing

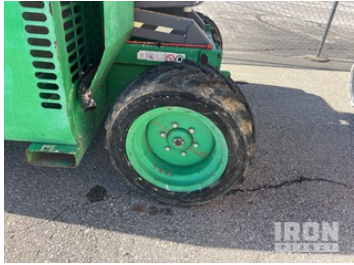
Right Front Tire	Cracks, Chunks missing
