Item #14251157 - 2006 JLG E400AJPN 2WD Electric Articulating Boom Lift

Inspection Report

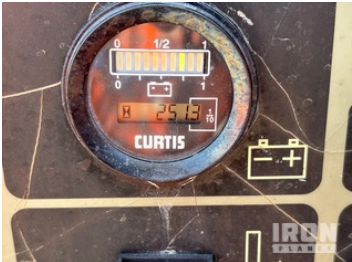
CE Mark	No CE mark found	
Hour Meter / Odometer	251 hrs

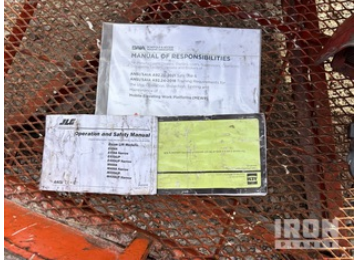
Safety		
Item	Assessment	Photo
Travel Alarm	Inoperable	
Horn	Operational	
Current Safety Manual	Yes	
Current Operator/Maintenance Manual	Yes	
ANSI Guidelines	Yes

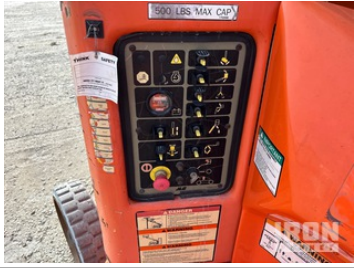
Control Station Ground		
Item	Assessment	Photo
Function Controls	★ ★ ★ ☆

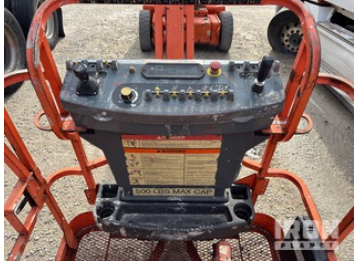
Control Station		
Pin connection pivot point wear inspections are limited to sound, sight and feel observations. Dial indicator testing is not performed.		
Item	Assessment	Photo
Control Console	No visible damage or missing components

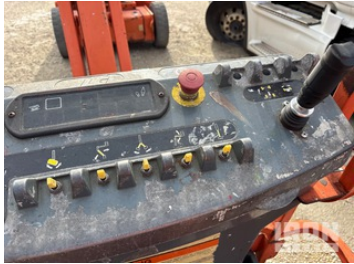
Emergency Shut Off Switch	Operational

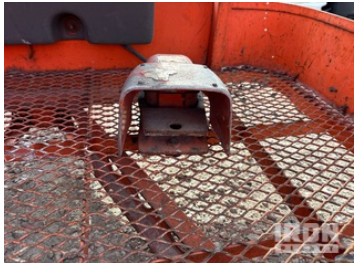
Safety Control Hand/Foot Switch	★★★★☆ Operational

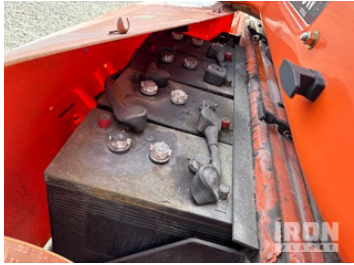
Electrical Operating System		
Item	Assessment	Photo
Operating Voltage	48 Volts	
Battery Condition	Functioned during the inspection	
Cables and Connections	No visible damage or missing components

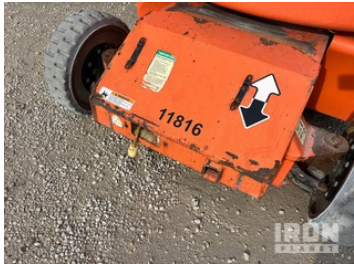
Battery Charger	Included Appears normal - Not operationally checked, Single Phase

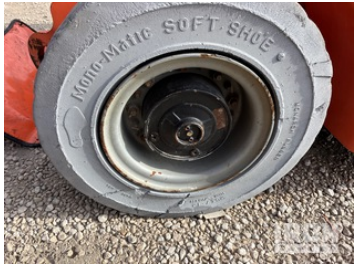
Drivetrain		
Operational test is limited to low speed in a confined flat area without load. Differential interlocks, full transmission shifting and functionality of all drive axles cannot be fully verified. Inspector listens for abnormal noises, observes leaks and notes physical damage.		
Item	Assessment	Photo
Left Front Final Drive	★ ★ ★ ☆

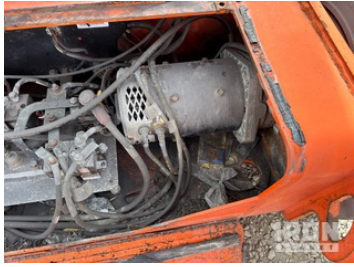
Left Front Drive Motor	★ ★ ★ ☆

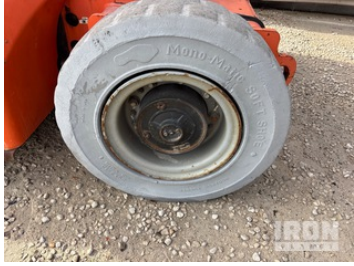
Right Front Final Drive	★ ★ ★ ☆

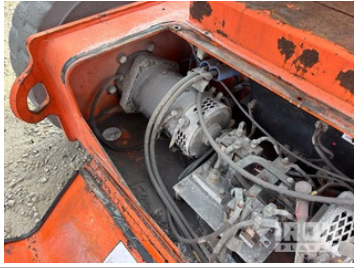
Right Front Drive Motor	★ ★ ★ ☆

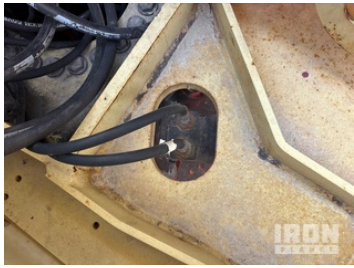
Hydraulics		
See photos for condition		
Item	Assessment	Photo
Pumps (Hydraulics)	★★★☆☆

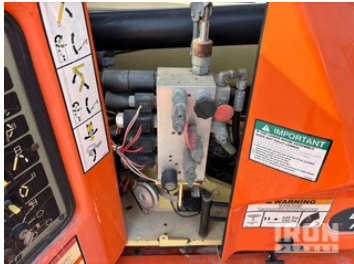
Valves	★★★☆☆

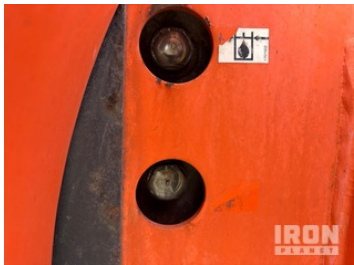
Hydraulic Tank	★★★☆☆

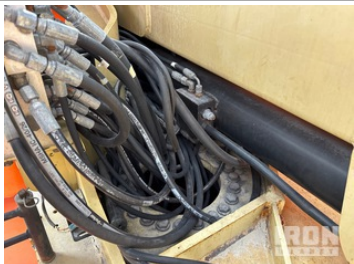
Hoses (Hydraulic)	★★★☆☆

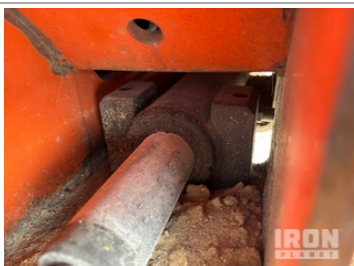
Steering Cylinders	★★★☆☆

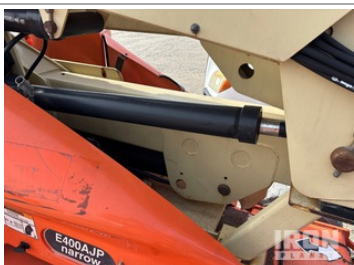
Boom Lift Cylinder	★★★☆☆

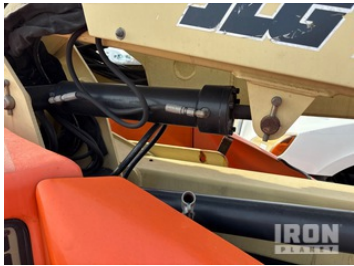
<p>Secondary Boom Cylinder</p>	<p>★★★★☆</p>

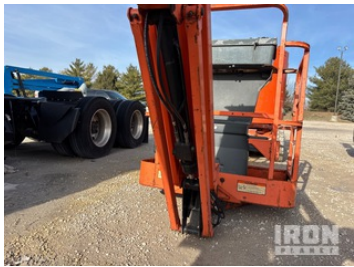
<p>Boom Extension Cylinder</p>	<p>★★★★★</p>	
<p>Jib Cylinder</p>	<p>★★★★☆</p>

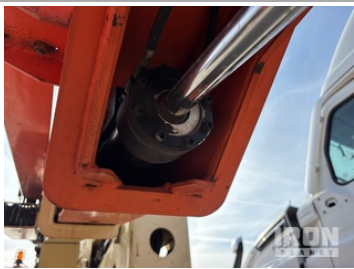
<p>Basket Tilt Cylinder</p>	<p>★★★★☆</p>

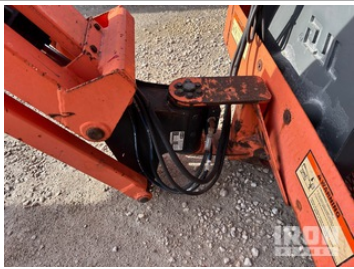
<p>Basket Rotator Motor</p>	<p>★★★★☆</p>

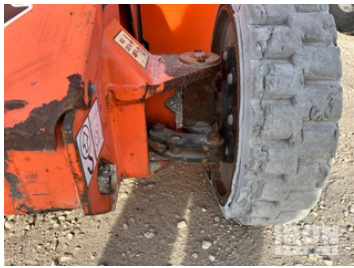
Chassis		
IronPlanet pin connection pivot point wear inspections are limited to sound, sight and feel observations. Dial indicator testing is not performed.		
Item	Assessment	Photo
Steering Linkage	★★★☆☆

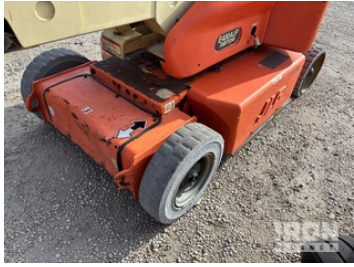
Frame Condition	★★★☆☆

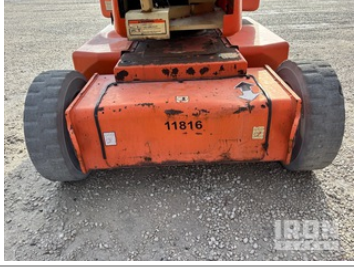
Brake System	★★★☆☆ The brake system functioned, stopping and holding the machine.

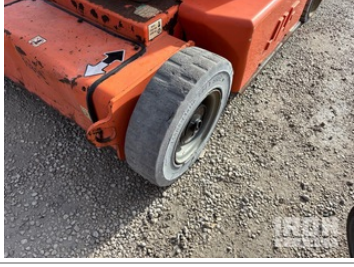
Left Front Tire	Cracks, Chunks missing, Tears

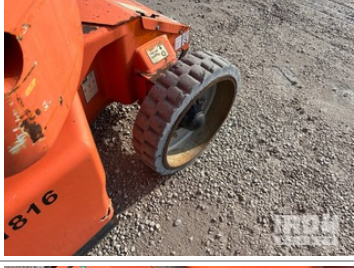
Left Rear Tire	Cracks, Chunks missing, Tears

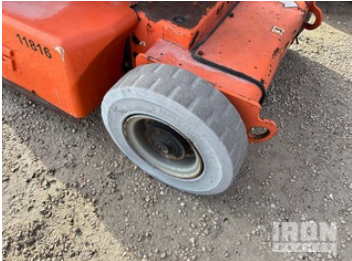
Right Front Tire	Cracks, Chunks missing, Tears

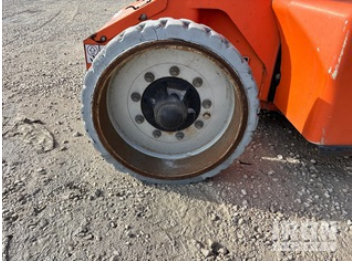
Wheel Condition	No visible damage or missing components

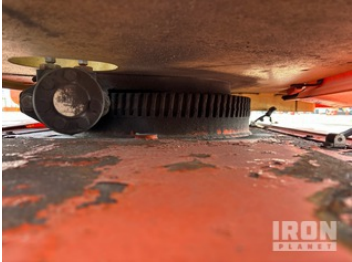
Turntable Bearing	★★★★☆

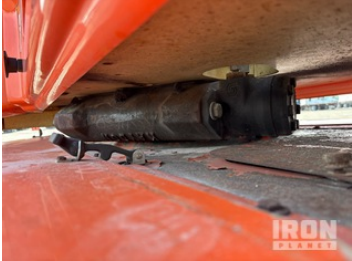
Swing Motor	★★★★☆

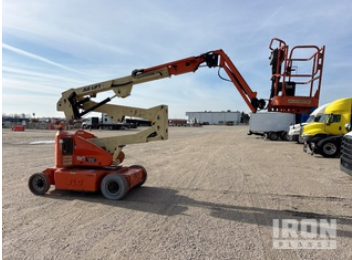
Boom Condition	★★★★☆

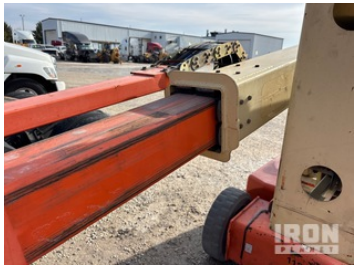
A photograph showing the right side of the boom lift, including the articulating boom and the rear of the truck chassis. The lift is orange and white.
Boom Wear Guides	★★★★☆

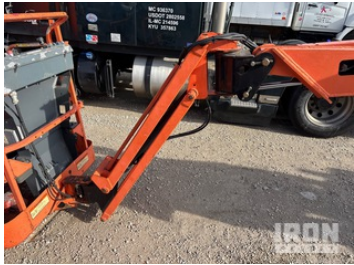
A close-up photograph of the boom wear guides, showing the orange boom and the white wear guides.
Jib Condition	★★★★☆
