Item #14577181 - 2015 Skyjack SJ6826 RT Diesel 4x4 Scissor Lift

Inspection Report

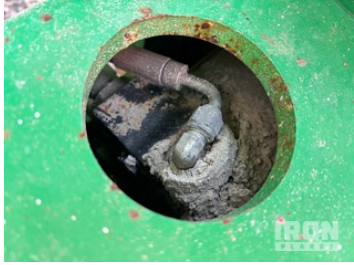
Drivetrain		
Operational test is limited to low speed in a confined flat area without load. Differential interlocks, full transmission shifting and functionality of all drive axles cannot be fully verified. Inspector listens for abnormal noises, observes leaks and notes physical damage.		
Item	Assessment	Photo
Drive Motors	☆☆☆☆

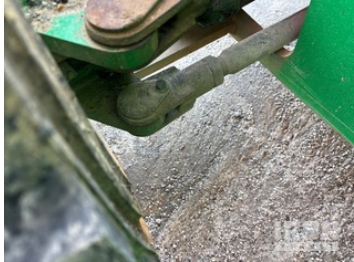
Chassis		
IronPlanet pin connection pivot point wear inspections are limited to sound, sight and feel observations. Dial indicator testing is not performed.		
Item	Assessment	Photo
Brake System	★★☆☆ The brake system functioned, stopping and holding the machine.	
Steering Linkage	★★☆☆

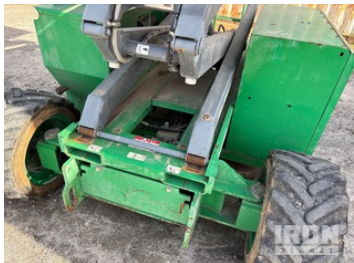
Frame Condition	★★☆☆

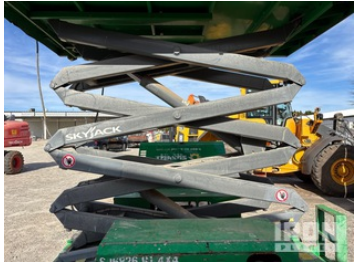
Scissor Linkage	★★☆☆

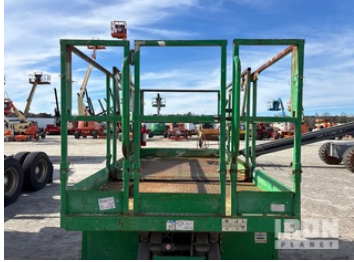
Platform Condition	★★☆☆ Damaged front

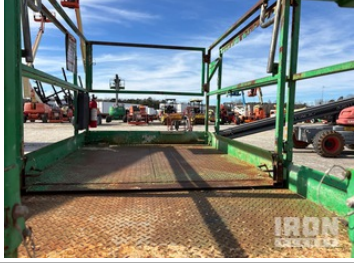
Platform Extension	★★☆☆

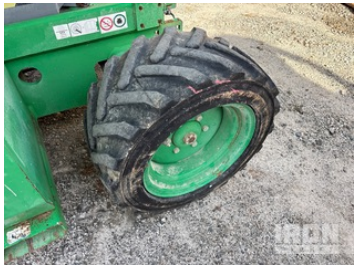
Left Rear Tire	Cracks, Chunks missing, Tears

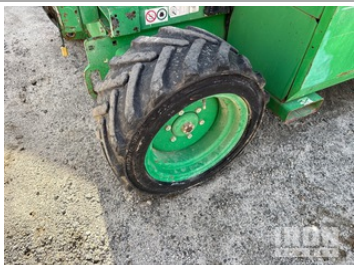
Right Rear Tire	Cracks, Chunks missing, Tears

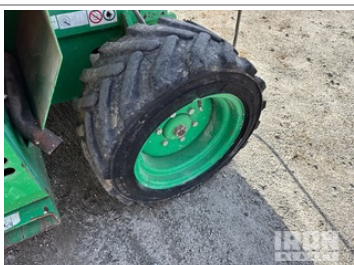
Right Front Tire	Cracks, Chunks missing, Tears
