## Item #14787247 - 2017 JLG 4069LE Electric Scissor Lift

# Inspection Report

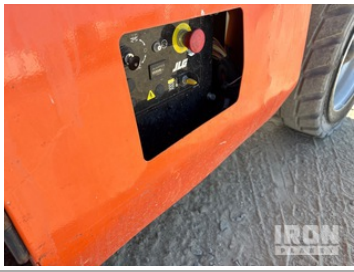
Body Panels	No visible damage or missing components

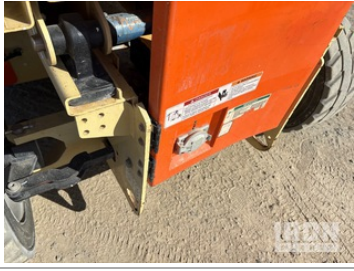
Basket / Safety Railing	No visible damage or missing components	
General Appearance #1

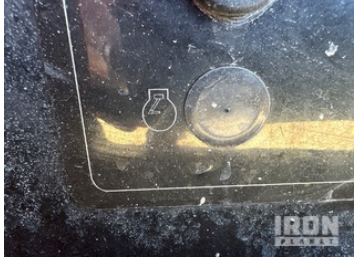
Engine Oil Pressure	No oil pressure indicator Warning light not installed

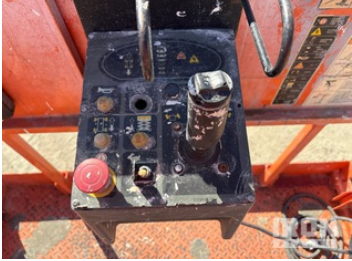
Item	Assessment	Photo
Control Console	No visible damage or missing components

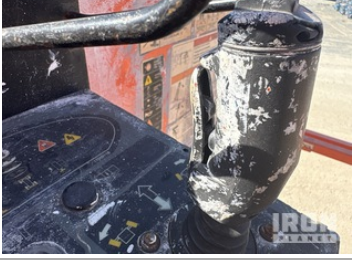
Safety Control Hand/Foot Switch	★★☆☆ Operational

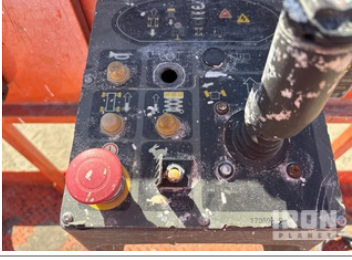
Upper Function Controls	★★☆☆

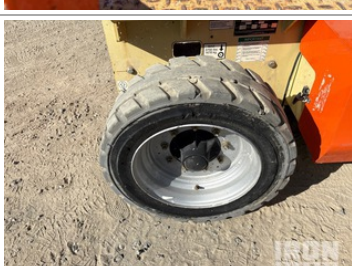
Left Front Tire	Chunks missing

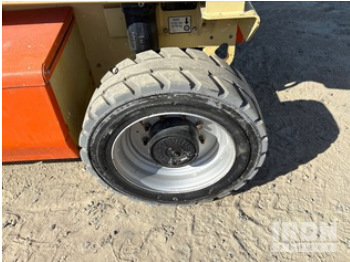
Left Rear Tire	Chunks missing

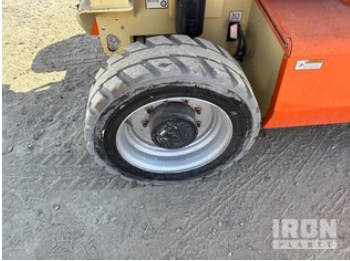
Right Rear Tire	Cracks

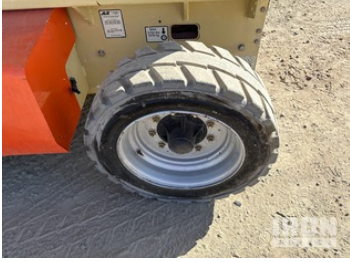
Right Front Tire	No visible defects

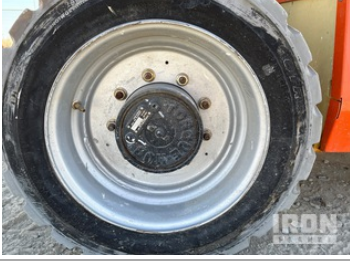
Wheel Condition	No visible damage or missing components
