Item #14097093 - 2018 Skyjack SJ85AJ 4WD Diesel Articulating Boom Lift

- Features: 85 ft Max Platform Height, 500 lb Max Weight Capacity, Jib, Power to Platform, 2018 US EPA Label, Deutz TD29LA 4 Cylinder 74 hp 2.9 L Engine, Positive Air Shutoff, 18-625 Foam-Filled Tires
- Meter Reading: 1,773 Hours
- Serial # : 95400337
- Inspection Completed: 1/29/26

Inspection Report

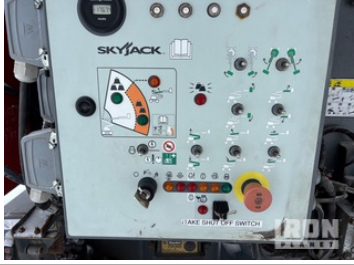
Oil Pressure	No oil pressure indicator

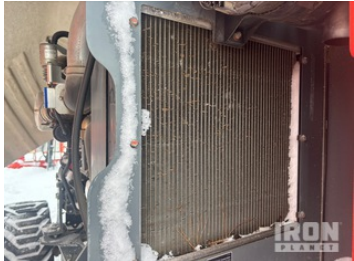
Radiator	★★★★☆

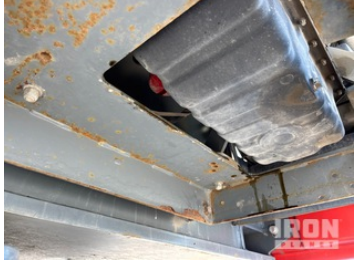
Oil Leaks	Can't determine origin of leak

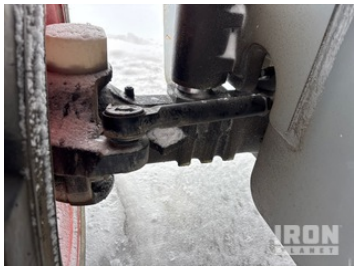
Chassis		
IronPlanet pin connection pivot point wear inspections are limited to sound, sight and feel observations. Dial indicator testing is not performed.		
Item	Assessment	Photo
Steering Linkage	★★★☆☆

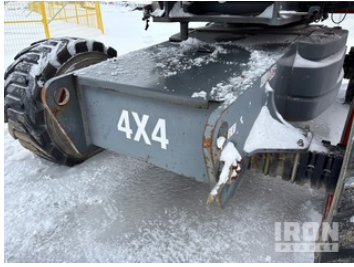
Frame Condition	★★★☆☆

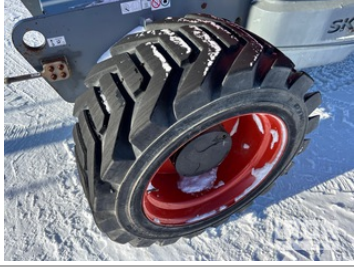
Left Front Tire	Cracks

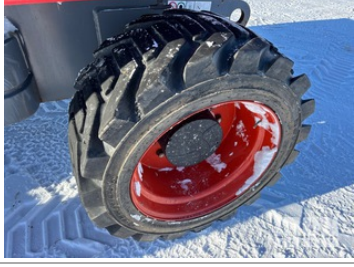
Left Rear Tire	Cracks, Chunks missing

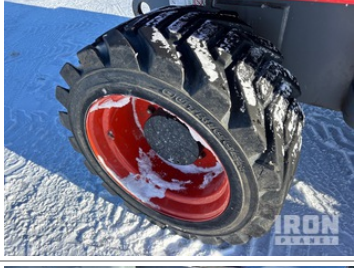
Right Rear Tire	Cracks, Tears
