Item #14577193 - 2016 Skyjack SJ6832 RTE Electric 4x4 Scissor Lift

Inspection Report

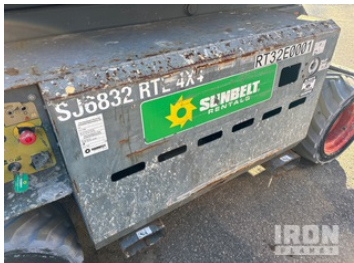
Paint	Concrete residue

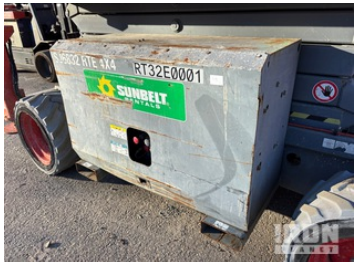
Body Panels	Battery compartment door damaged, Hydraulic compartment door damaged

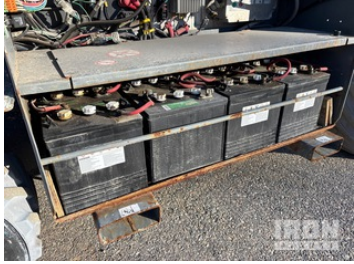
Electrical Operating System		
Item	Assessment	Photo
Operating Voltage	48 Volts	
Battery Condition	Functioned during the inspection, Weak or under-charged, Unit was charged at one point to finish inspection	
Cables and Connections	No visible damage or missing components

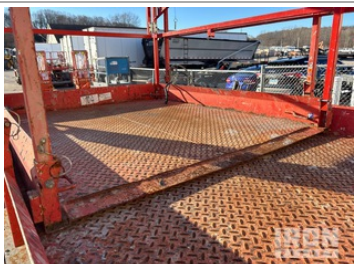
Platform Extension	★☆☆☆☆ Would not slide

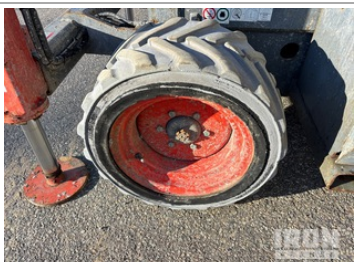
Left Front Tire	Chunks missing, Tears

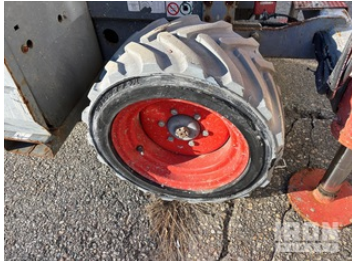
Left Rear Tire	Chunks missing, Tears

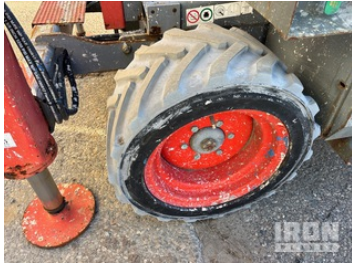
Right Rear Tire	Chunks missing, Tears

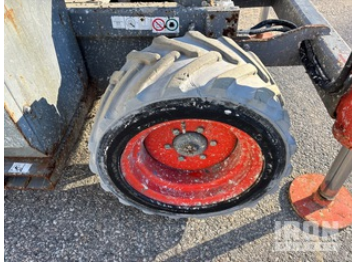
Right Front Tire	Chunks missing, Tears
