Item #14787259 - 2020 JLG 430LRT Diesel Scissor Lift

Inspection Report

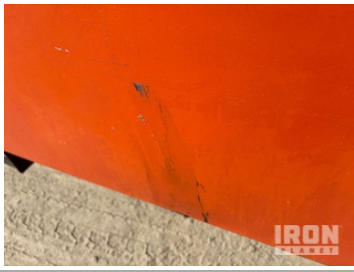
<p>IRON</p>
Body Panels	Engine compartment door damaged

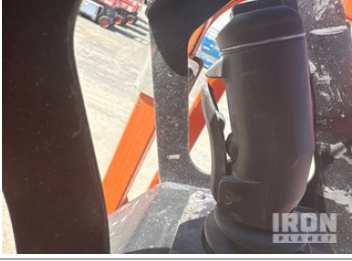
Safety Control Hand/Foot Switch	★★☆☆ Operational

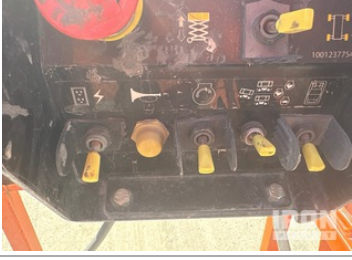
Upper Function Controls	★★☆☆

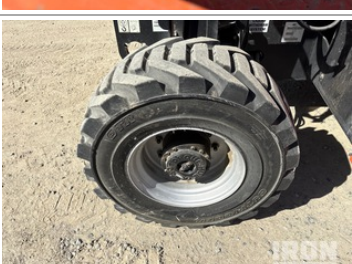
Left Front Tire	Chunks missing

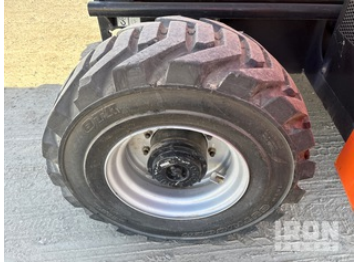
Right Rear Tire	Chunks missing

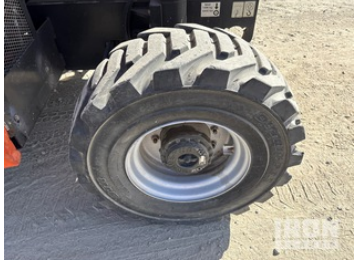
Right Front Tire	Chunks missing
