Item #14339878 - 2017 Genie Z-45/25 4WD Dual Fuel Articulating Boom Lift

Inspection Report

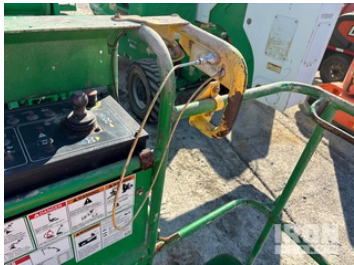
Emergency Shut Off Switch	Operational	 
Safety Control Hand/Foot Switch	★★★★☆ Operational	 
Function Controls	★★★★☆	 
Limited Function Check	The main components are in place and operational as noted. Safety shut down cable does not function	
Control Station #1

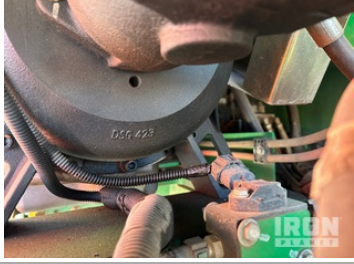
Oil Leaks	No dripping leaks Buildup rear of engine

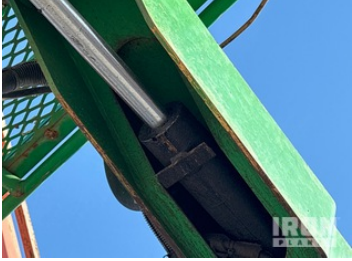
Boom Extension Cylinder	★★★★☆	
Basket Tilt Cylinder	★★★☆☆ Dripping leak

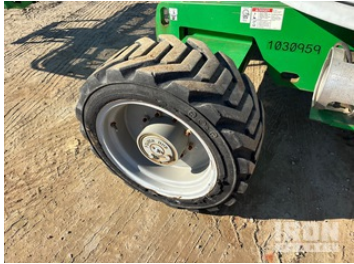
Brake System	★★★☆☆ The brake system functioned, stopping and holding the machine.	
Left Front Tire	Cracks, Chunks missing, Tears

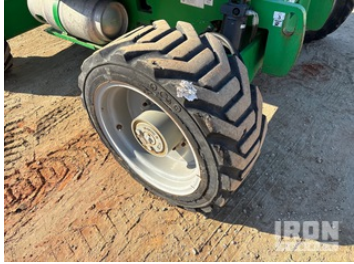
Left Rear Tire	Cracks, Chunks missing, Tears

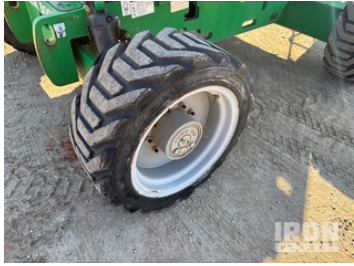
Right Rear Tire	Cracks, Chunks missing, Tears

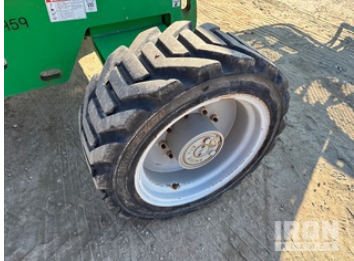
Right Front Tire	Cracks, Chunks missing, Tears

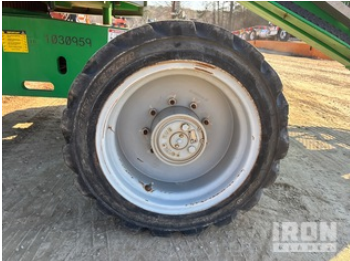
Wheel Condition	Left front damaged, Right front damaged, Right rear damaged, Left rear damaged

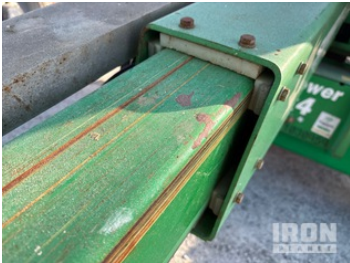
Boom Wear Guides	★★★☆☆ Cracked guides
