Item #14615296 - 2016 Skyjack SJ63AJ 4WD Diesel Articulating Boom Lift

- Features: 63 ft Max Platform Height, 500 lb Max Weight Capacity, Jib, Power to Platform, Tier 4, 2016 US EPA Label, Deutz TD2.9L4 4 Cylinder 74 hp 2.9 L Diesel Engine, 14-17.5 Foam-Filled Tires
- Meter Reading: 3,344 Hours
- Serial # : 95300914
- Inspection Completed: 1/28/26

Inspection Report

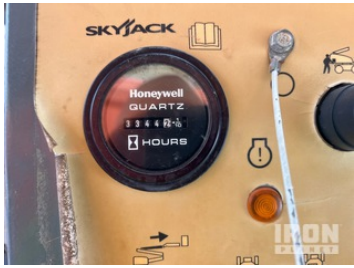
Hour Meter / Odometer	3344 hrs

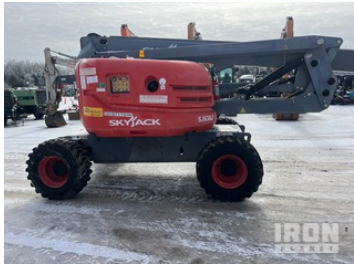
Paint	No visible damage

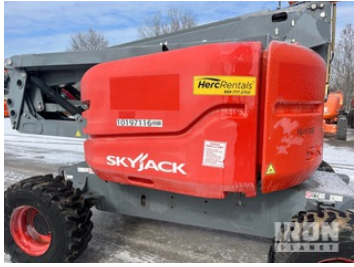
Body Panels	No visible damage or missing components

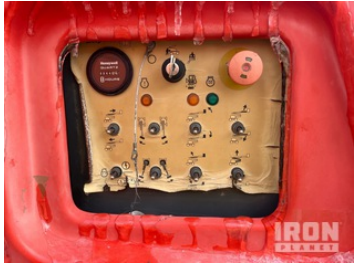
Control Station Ground		
Item	Assessment	Photo
Function Controls	★★★☆☆

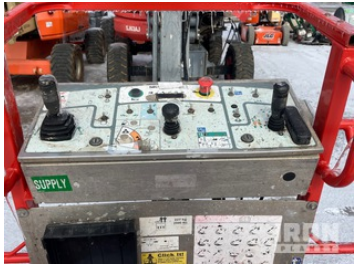
Function Controls	★★★★☆

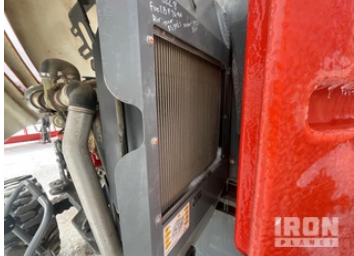
Radiator	★★★★☆

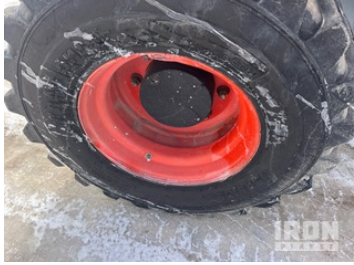
Drivetrain		
Operational test is limited to low speed in a confined flat area without load. Differential interlocks, full transmission shifting and functionality of all drive axles cannot be fully verified. Inspector listens for abnormal noises, observes leaks and notes physical damage.		
Item	Assessment	Photo
Left Front Final Drive	★ ★ ★ ☆

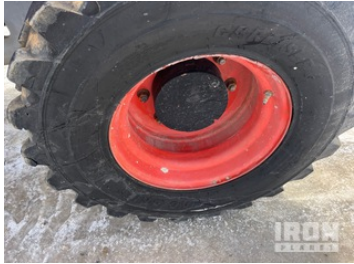
Left Rear Final Drive	★ ★ ★ ☆

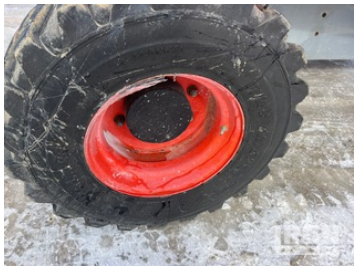
Right Rear Final Drive	★ ★ ★ ☆

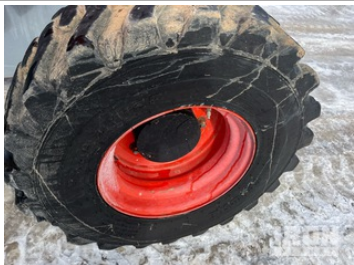
Right Front Final Drive	★ ★ ★ ☆

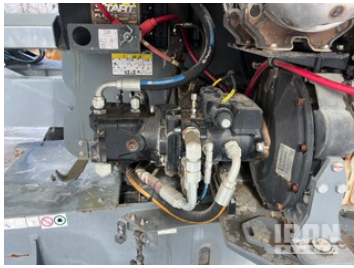
Hydraulics		
See photos for condition		
Item	Assessment	Photo
Pumps (Hydraulics)	★★★☆☆

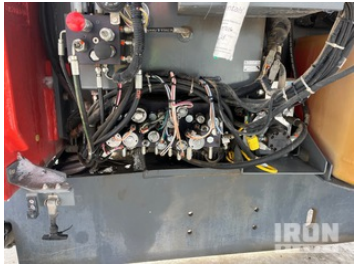
Valves	★★★☆☆

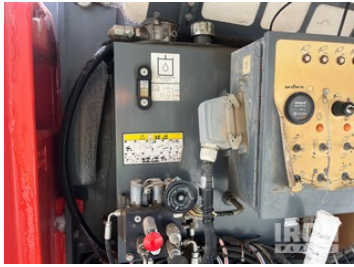
Hydraulic Tank	★★★☆☆

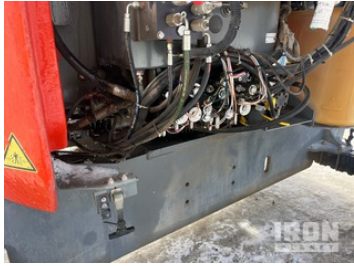
Hoses (Hydraulic)	★★★☆☆

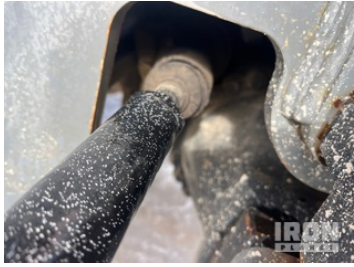
Steering Cylinders	★★★☆☆

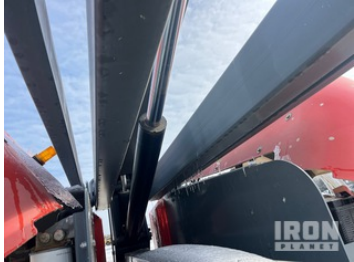
Boom Lift Cylinder	★★★☆☆

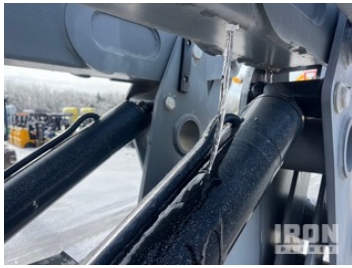
Secondary Boom Cylinder	★★☆☆

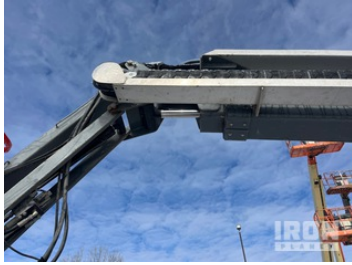
Boom Extension Cylinder	★★☆☆	
Jib Cylinder	★★☆☆

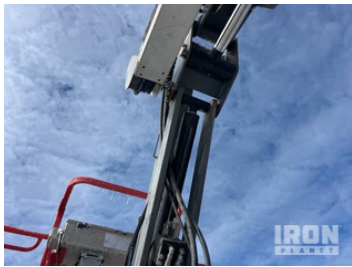
Basket Tilt Cylinder	★★☆☆

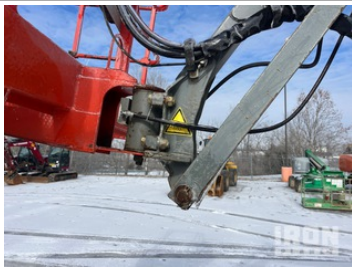
Basket Rotator Motor	★★☆☆

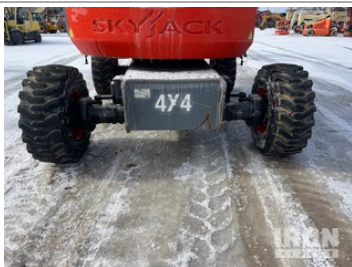
Frame Leveling Cylinders	★★☆☆

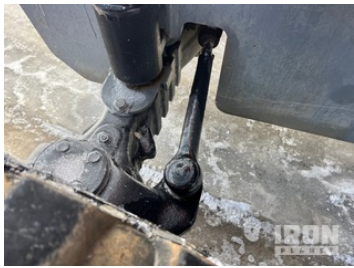
Chassis		
IronPlanet pin connection pivot point wear inspections are limited to sound, sight and feel observations. Dial indicator testing is not performed.		
Item	Assessment	Photo
Steering Linkage	★★★☆☆

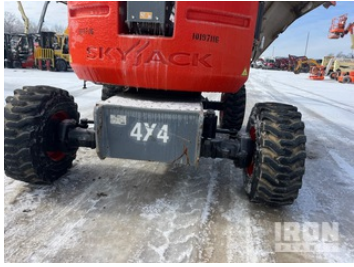
Frame Condition	★★★☆☆

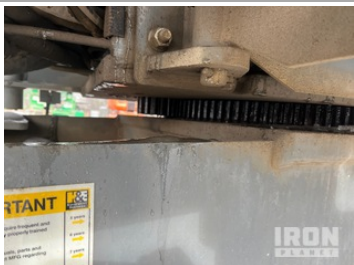
Turntable Bearing	★★★★☆

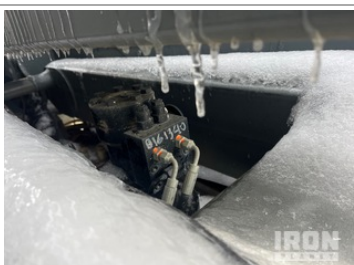
Swing Motor	★★★★☆

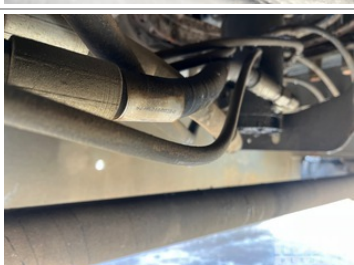
Hydraulic Center Swivel	★★★★☆

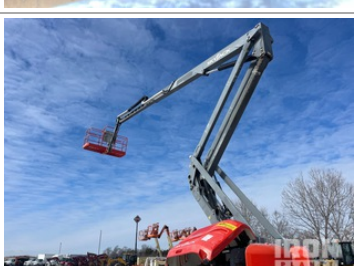
Boom Condition	★★★★☆

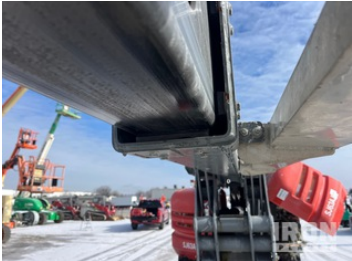
Boom Wear Guides	★★★★☆

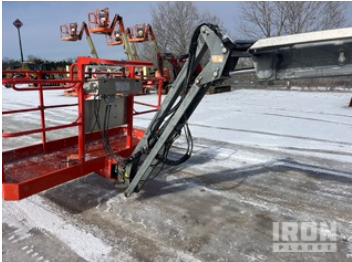
Jib Condition	★★★★☆
