## Item #14522849 - 2016 JLG 800 AJ 4WD Diesel Articulating Boom Lift

# Inspection Report

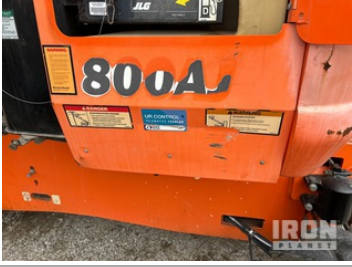
Body Panels	Hydraulic compartment door damaged

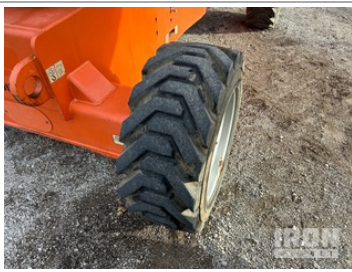
Brake System	★★★★☆ The brake system functioned, stopping and holding the machine.	
Left Front Tire	Cracks, Chunks missing

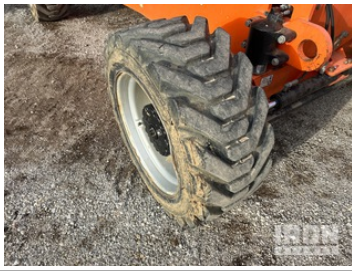
Left Rear Tire	Chunks missing

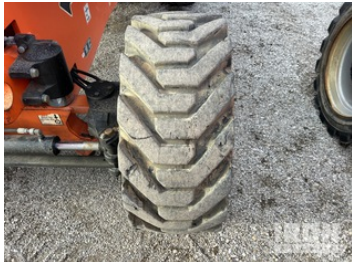
Right Rear Tire	Cracks, Chunks missing

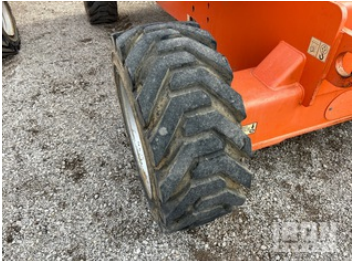
Right Front Tire	Cracks

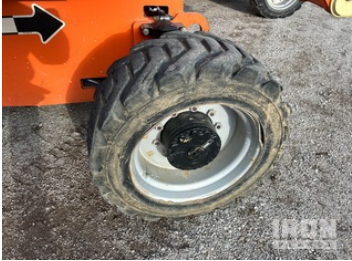
Wheel Condition	Right rear bent
