## Item #14480420 - 2014 Skyjack SJ6826 RT Dual Fuel 4x4 Scissor Lift

# Inspection Report

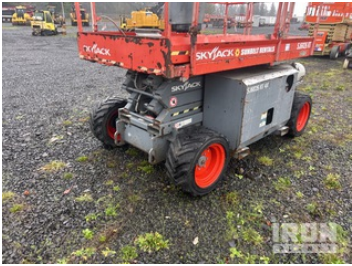
<p>Paint</p>	<p>No visible damage</p>

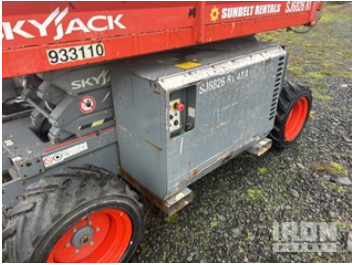
<p>Body Panels</p>	<p>No visible damage or missing components</p>

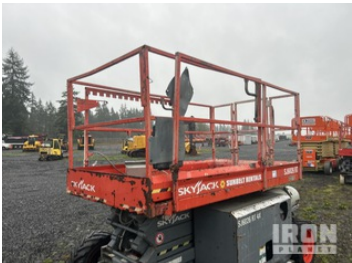
<p>Basket / Safety Railing</p>	<p>No visible damage or missing components</p>	
<p>General Appearance #1</p>

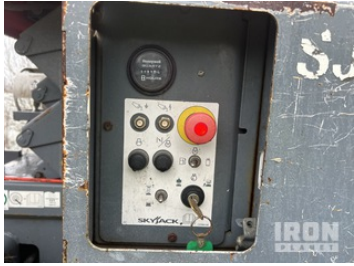
Control Station Ground		
Item	Assessment	Photo
Function Controls	★ ★ ★ ☆

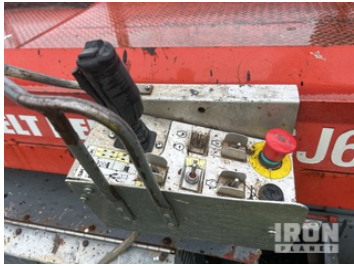
<b>Control Station Upper</b>		
Pin connection pivot point wear inspections are limited to sound, sight and feel observations. Dial indicator testing is not performed.		
<b>Item</b>	<b>Assessment</b>	<b>Photo</b>
Control Console	No visible damage or missing components

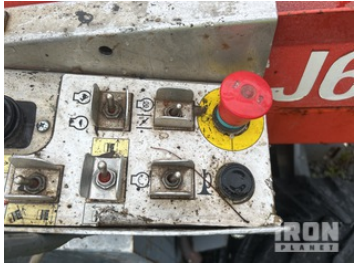
Emergency Shut Off Switch	Operational

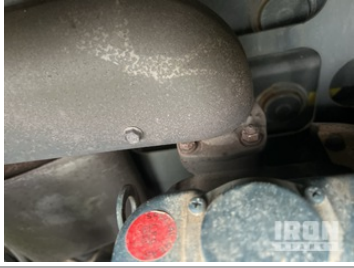
Exhaust System	No visible damage or missing components

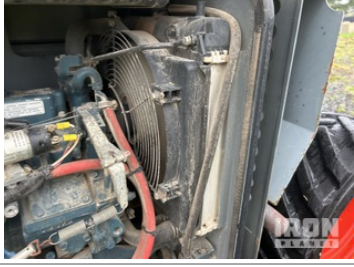
Radiator	★★★☆☆

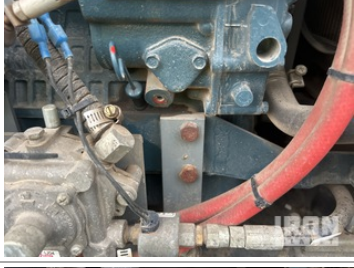
Oil Leaks	No dripping leaks

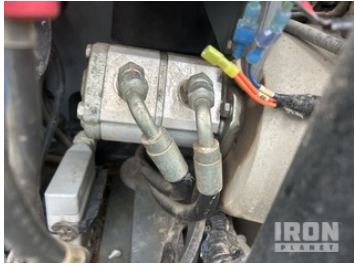
Hydraulics		
Item	Assessment	Photo
Pumps (Hydraulics)	★★★★☆

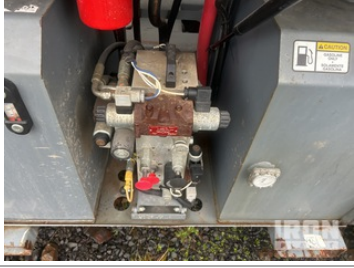
Valves	★★★★☆

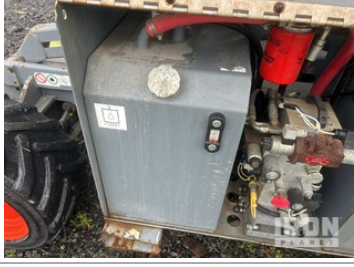
Hydraulic Tank	★★★★☆

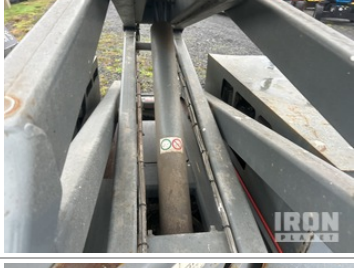
Lift Cylinders	★★★★☆

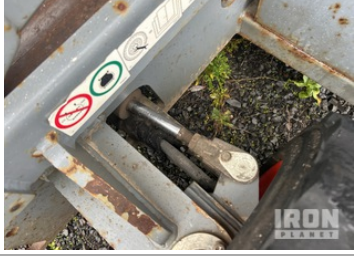
Steering Cylinder	★★★★☆

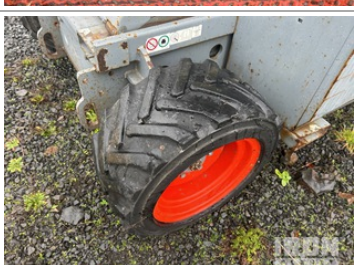
Left Front Tire	No visible defects

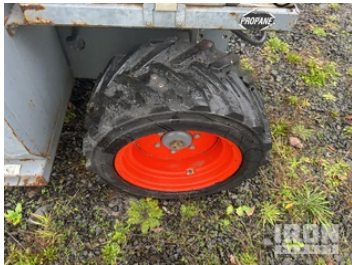
Left Rear Tire	No visible defects

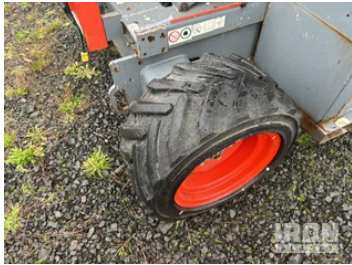
Right Rear Tire	No visible defects

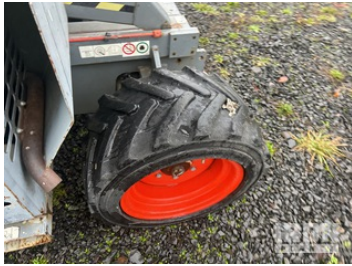
Right Front Tire	No visible defects

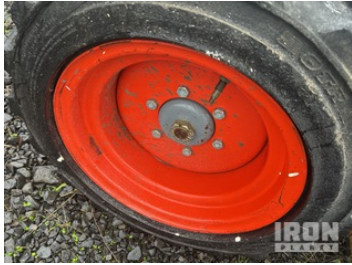
Wheel Condition	No visible damage or missing components

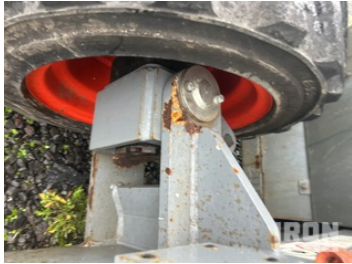
Wheel Studs	★★★★☆	
Limited Function Check (Scissor-lift)	The main components appear to be in place and operational.	
Chassis #1
