Item #14339904 - 2016 Skyjack SJ6832 RT Dual Fuel 4x4 Scissor Lift

Inspection Report

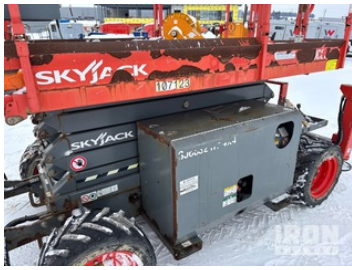
Paint	No visible damage

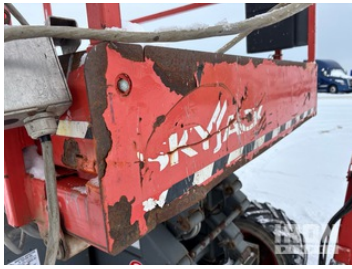
Body Panels	Front panel

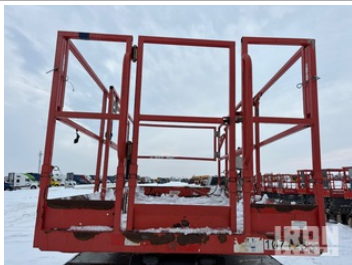
Basket / Safety Railing	No visible damage or missing components	
General Appearance #1

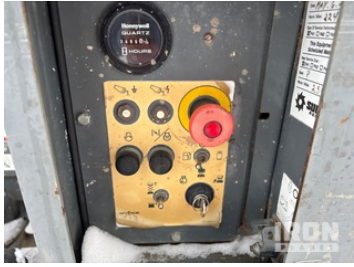
Control Station Ground		
Item	Assessment	Photo
Function Controls	★★★☆☆

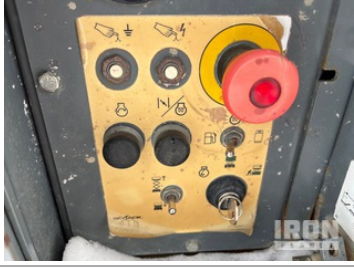
Engine Oil Pressure	No oil pressure indicator

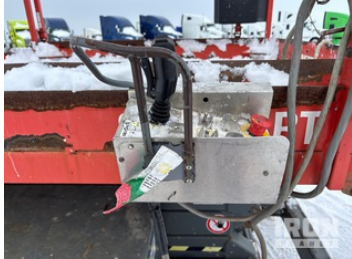
Item	Assessment	Photo
Control Console	No visible damage or missing components

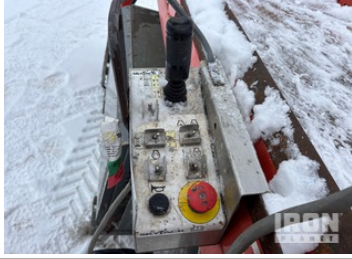
Upper Function Controls	★★★★☆

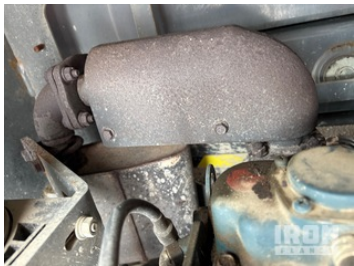
Exhaust System	No visible damage or missing components

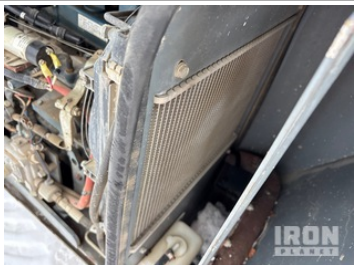
Radiator	★★★★☆

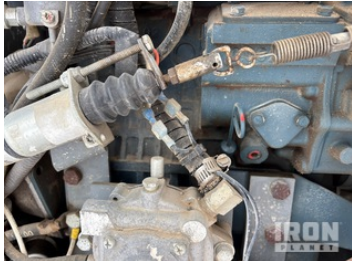
Oil Leaks	No dripping leaks

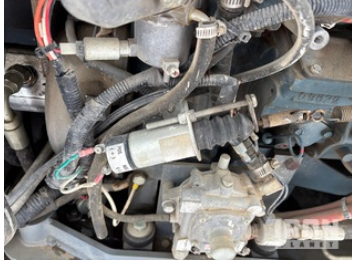
Fuel Leaks	No dripping leaks

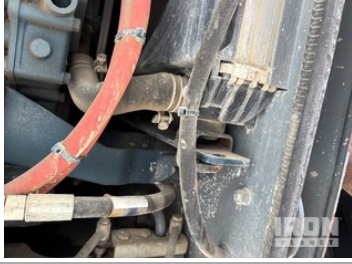
Cooling System Leaks	No dripping leaks

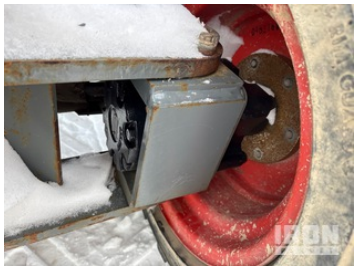
Drivetrain		
Operational test is limited to low speed in a confined flat area without load. Differential interlocks, full transmission shifting and functionality of all drive axles cannot be fully verified. Inspector listens for abnormal noises, observes leaks and notes physical damage.		
Item	Assessment	Photo
Drive Motors	★★★☆☆

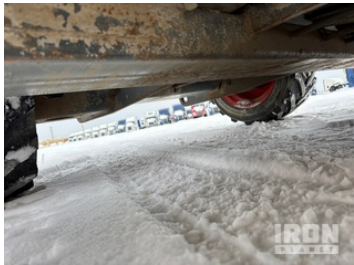
Front Drive Axle	★★★☆☆	 
Rear Drive Axle	★★★☆☆

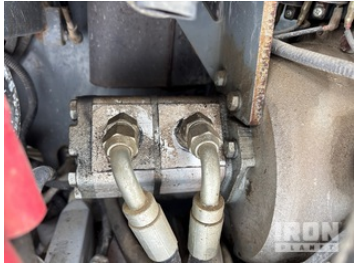
Hydraulics		
Item	Assessment	Photo
Pumps (Hydraulics)	★★☆☆☆ Seepage

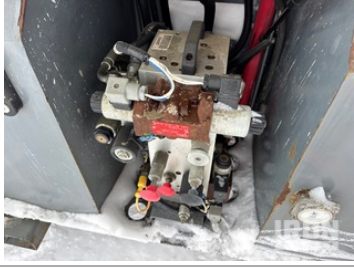
Valves	★★★☆☆

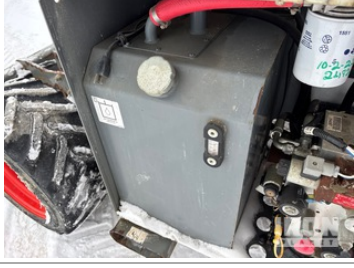
Hydraulic Tank	★★★☆☆

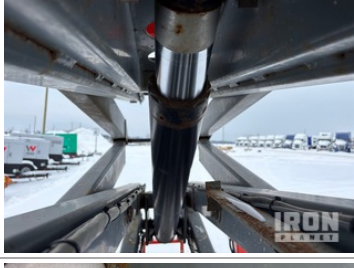
Lift Cylinders	★★★☆☆

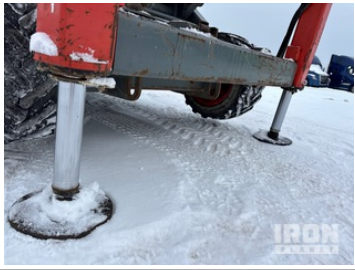
Outrigger Cylinders	☆☆☆☆

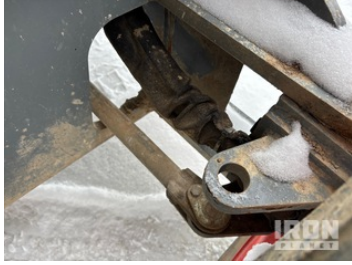
Item	Assessment	Photo
Steering Linkage	★★★★☆

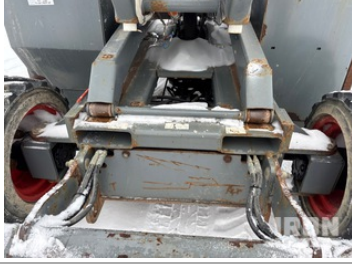
Frame Condition	★★★★☆

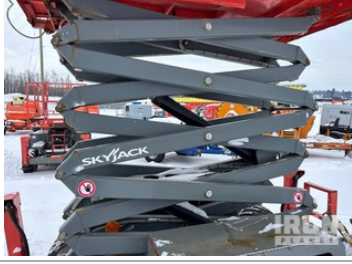
Scissor Linkage	★★★★☆

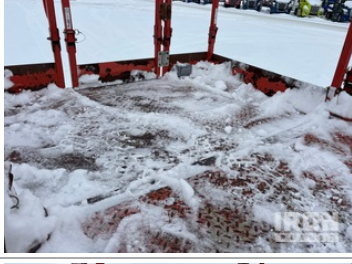
Platform Condition	★★★★☆

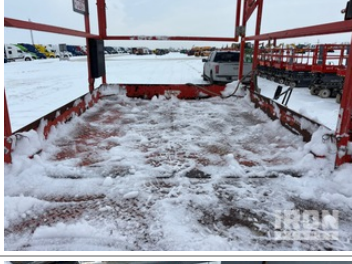
Platform Extension	★★★★☆

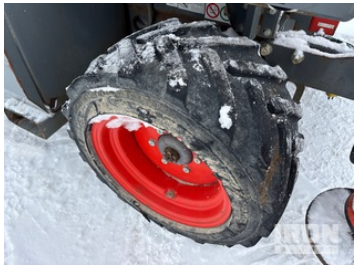
Left Rear Tire	Tears

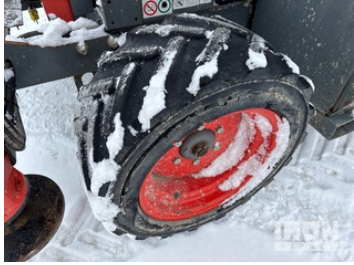
Right Rear Tire	Cracks, Chunks missing

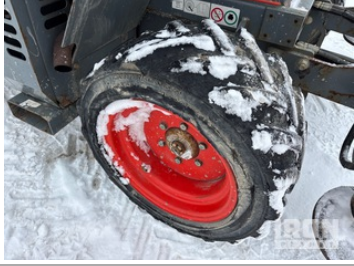
Right Front Tire	Cracks, Tears

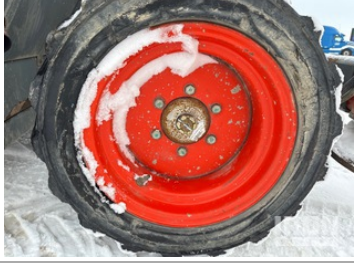
Wheel Condition	No visible damage or missing components

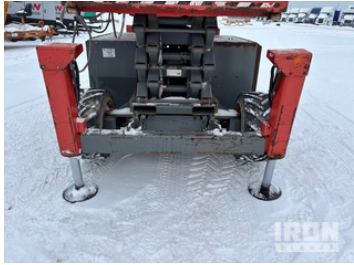
Wheel Studs	★★★★☆	
Outriggers / Stabilizers	★★★★☆
