Item #14786953 - 2016 Skyjack SJ40T 4WD Diesel Telescopic Boom Lift

Inspection Report

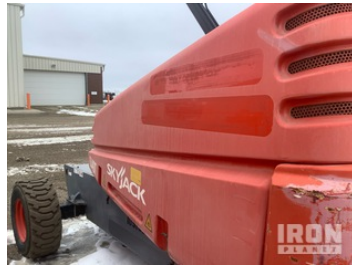
General Appearance #3

Serial Number / VIN	98001977	 
Hour Meter / Odometer	3183 hrs	 
Paint	No visible damage	 
Body Panels	Hydraulic compartment door damaged, Rear panel is damaged	 
Basket / Safety Railing	No visible damage or missing components	
General Appearance #1		 
General Appearance #2

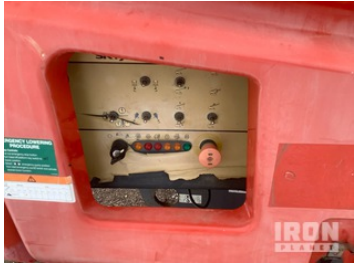
Control Station Ground		
Item	Assessment	Photo
Function Controls	★ ★ ★ ☆

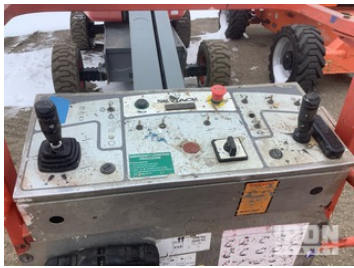
Control Station		
Pin connection pivot point wear inspections are limited to sound, sight and feel observations. Dial indicator testing is not performed.		
Item	Assessment	Photo
Control Console	No visible damage or missing components

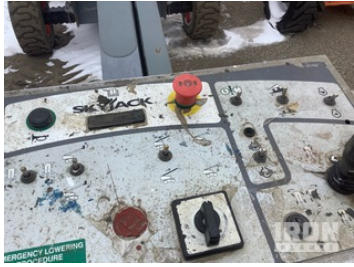
Emergency Shut Off Switch	Operational

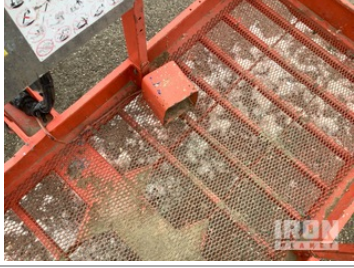
Safety Control Hand/Foot Switch	★★★★☆ Operational

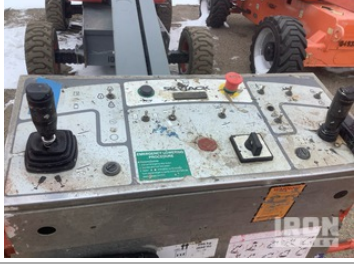
Function Controls	★★★★☆

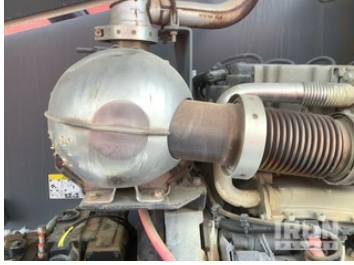
Engine		
Item	Assessment	Photo
Blow-by (subjective visual observation)	No noticeable vapor or pressure	
Starter	Operational	
Fuel System	Operational	
Exhaust System	No visible damage or missing components

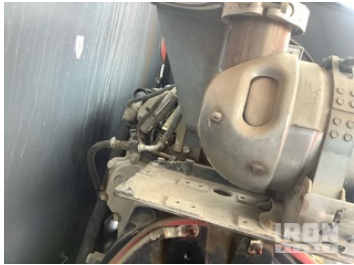
Oil Leaks	No dripping leaks	
Fuel Leaks	No dripping leaks	
Cooling System Leaks	No dripping leaks	
Engine - Left Side

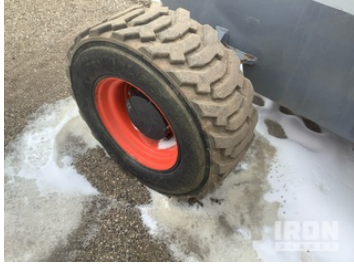
Drivetrain		
Operational test is limited to low speed in a confined flat area without load. Differential interlocks, full transmission shifting and functionality of all drive axles cannot be fully verified. Inspector listens for abnormal noises, observes leaks and notes physical damage.		
Item	Assessment	Photo
Left Front Final Drive	★ ★ ★ ☆

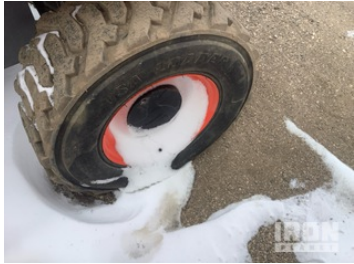
Left Rear Final Drive	★ ★ ★ ☆

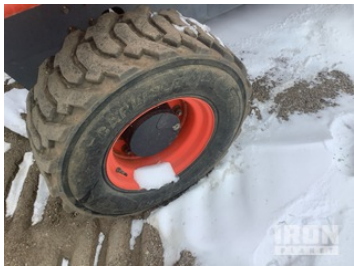
Right Rear Final Drive	★ ★ ★ ☆

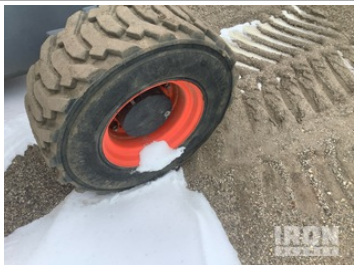
Right Front Final Drive	★ ★ ★ ☆

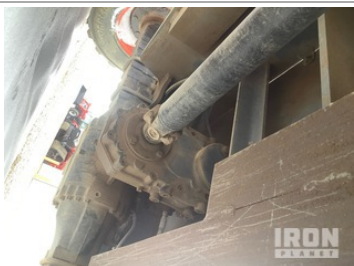
Front Center Drive Motor	★ ★ ★ ☆

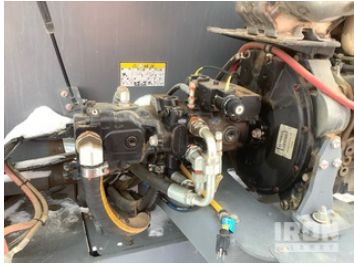
Hydraulics		
See photos for condition		
Item	Assessment	Photo
Pumps (Hydraulics)	★★★★☆

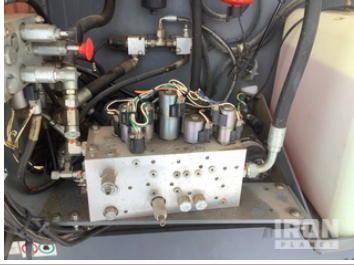
Valves	★★★★☆

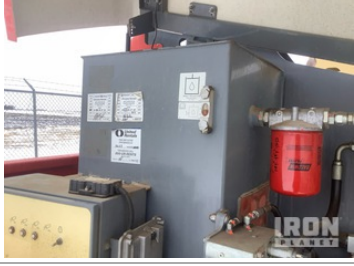
Hydraulic Tank	★★★★☆

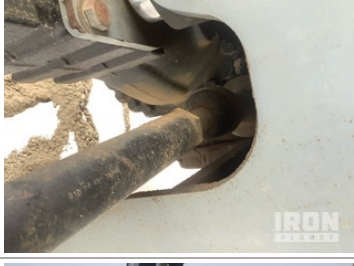
Hoses (Hydraulic)	★★★★☆	 
Steering Cylinders	★★★★☆

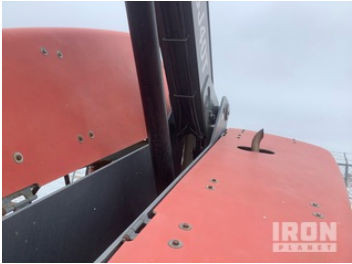
Secondary Boom Cylinder	★★★★☆

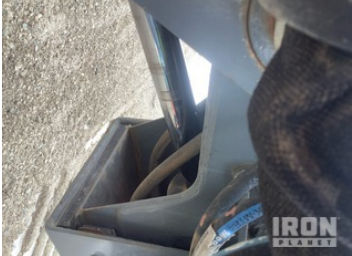
Boom Extension Cylinder	★★★★☆	
Basket Tilt Cylinder	★★★★☆

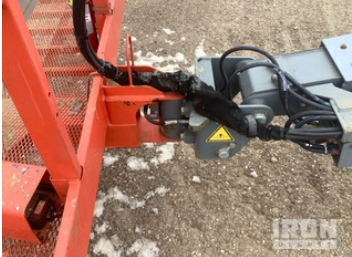
Basket Rotator Motor	★★★★☆

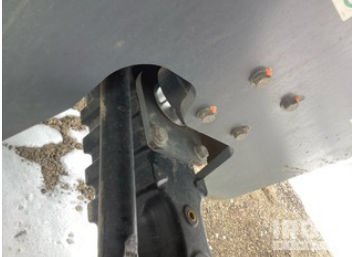
Frame Leveling Cylinders	★★★★☆

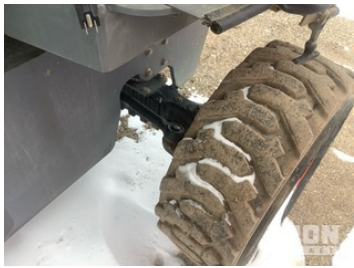
Chassis		
IronPlanet pin connection pivot point wear inspections are limited to sound, sight and feel observations. Dial indicator testing is not performed.		
Item	Assessment	Photo
Steering Linkage	★★★★☆

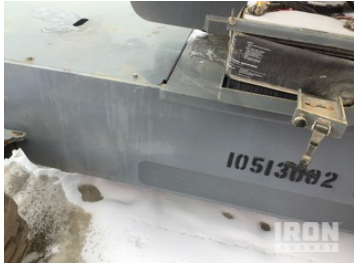
Frame Condition	★★★★☆

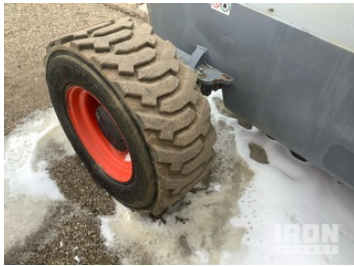
Brake System	★★★★☆ The brake system functioned, stopping and holding the machine.	
Left Front Tire	No visible defects

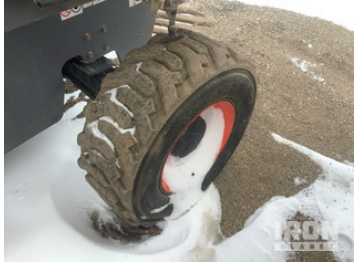
Left Rear Tire	No visible defects

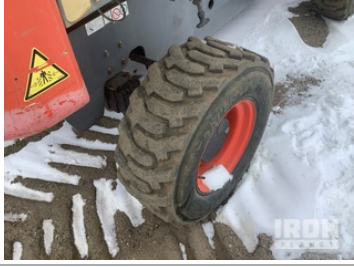
Right Rear Tire	No visible defects

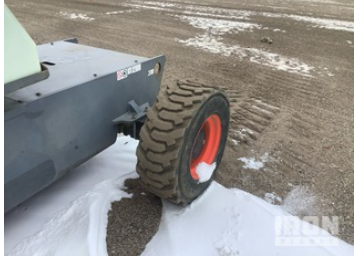
Right Front Tire	No visible defects

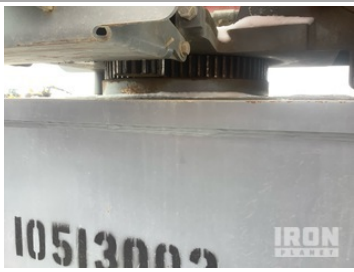
Wheel Condition	No visible damage or missing components	
Turntable Bearing	★★★★☆

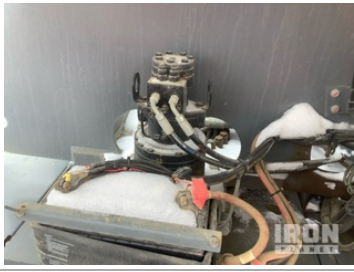
Swing Motor	★★★★☆

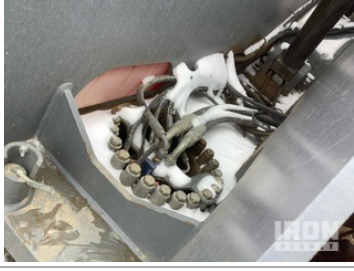
Hydraulic Center Swivel	★★★★☆

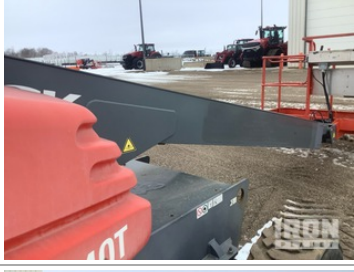
Boom Condition	★★★★☆

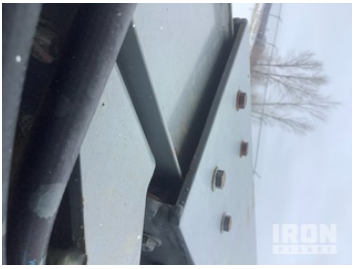
Boom Wear Guides	☆☆☆☆
