## Item #14786952 - 2016 Skyjack SJ40T 4WD Diesel Telescopic Boom Lift

# Inspection Report

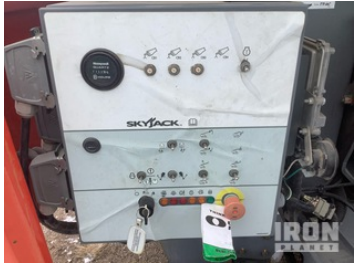
<b>Control Station Ground</b>		
<b>Item</b>	<b>Assessment</b>	<b>Photo</b>
Function Controls	★ ★ ★ ☆

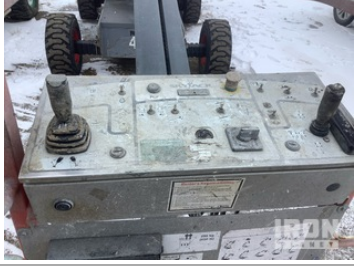
<b>Control Station</b>		
Pin connection pivot point wear inspections are limited to sound, sight and feel observations. Dial indicator testing is not performed.		
<b>Item</b>	<b>Assessment</b>	<b>Photo</b>
Control Console	No visible damage or missing components	 
Emergency Shut Off Switch	Operational	 
Safety Control Hand/Foot Switch	★★★★☆ Operational	 
Function Controls	★★★★☆

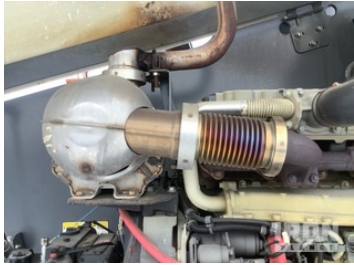
Blow-by (subjective visual observation)	Minor	
Starter	Operational	
Fuel System	Operational	
Exhaust System	Exhaust pipe damaged

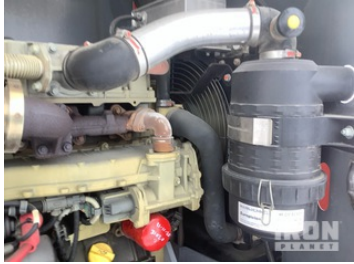
Radiator	★★★★☆

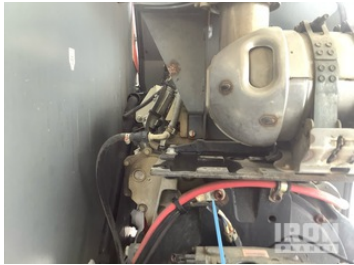
Oil Leaks	No dripping leaks	
Fuel Leaks	No dripping leaks	
Cooling System Leaks	No dripping leaks	
Engine - Left Side

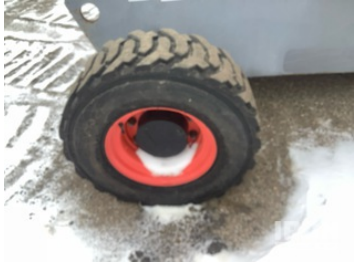
<b>Drivetrain</b>		
Operational test is limited to low speed in a confined flat area without load. Differential interlocks, full transmission shifting and functionality of all drive axles cannot be fully verified. Inspector listens for abnormal noises, observes leaks and notes physical damage.		
<b>Item</b>	<b>Assessment</b>	<b>Photo</b>
Left Front Final Drive	★★★★☆

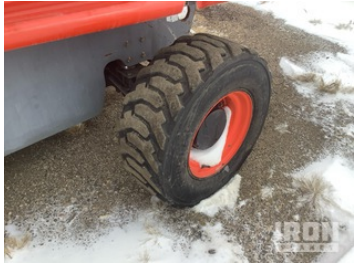
Left Rear Final Drive	★★★★☆

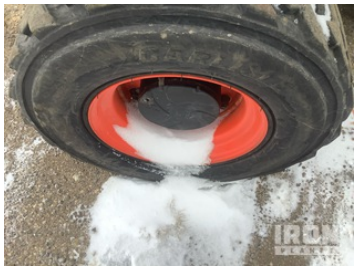
Right Rear Final Drive	★★★★☆

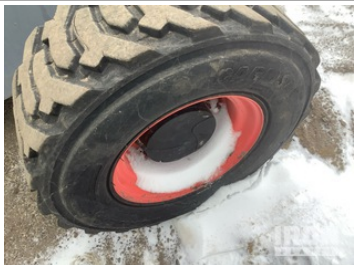
Right Front Final Drive	★★★★☆

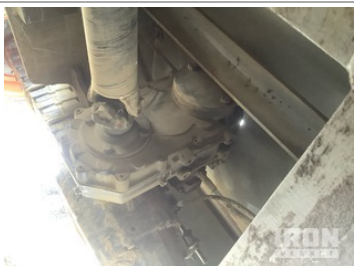
Front Center Drive Motor	★★★★☆

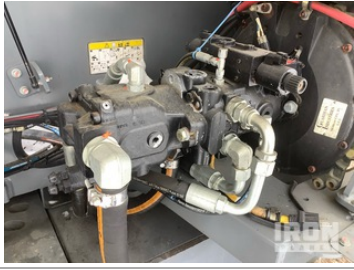
<b>Hydraulics</b>		
See photos for condition		
<b>Item</b>	<b>Assessment</b>	<b>Photo</b>
Pumps (Hydraulics)	★★★★☆

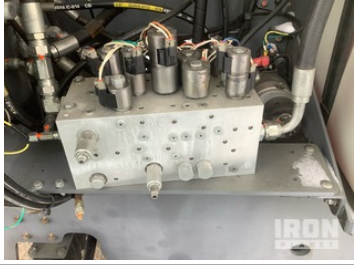
Valves	★★★★☆

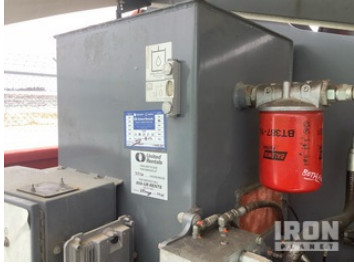
Hydraulic Tank	★★★★☆

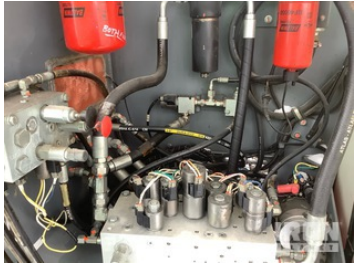
Hoses (Hydraulic)	★★★★☆

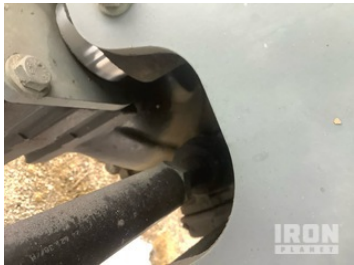
Steering Cylinders	★★★★☆

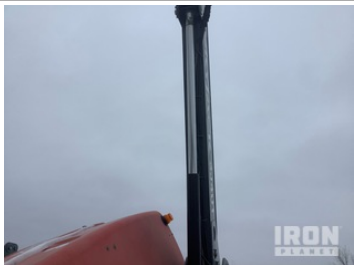
Boom Lift Cylinder	★★★★☆

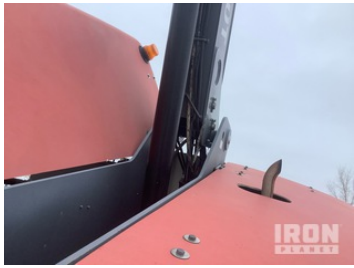
Secondary Boom Cylinder	★★★★☆

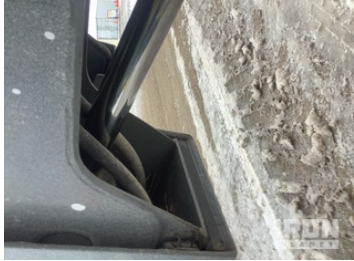
Boom Extension Cylinder	★★★★☆	
Basket Tilt Cylinder	★★★★☆

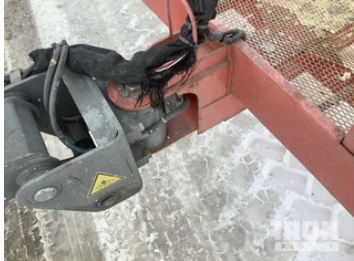
Basket Rotator Motor	★★★★☆

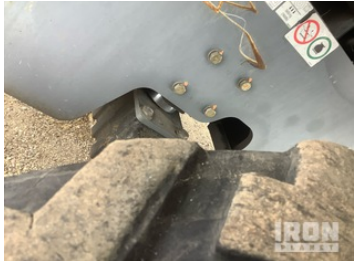
Frame Leveling Cylinders	★★★★☆

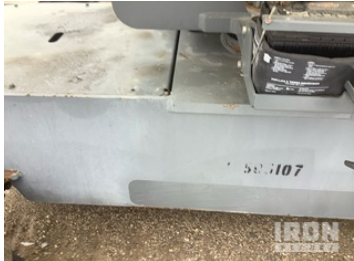
Frame Condition	☆☆☆☆

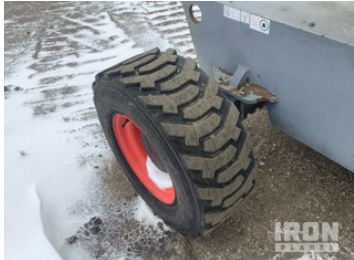
Brake System	☆☆☆☆ The brake system functioned, stopping and holding the machine.	
Left Front Tire	No visible defects

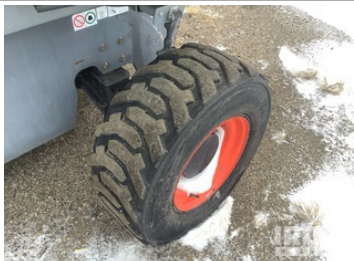
Left Rear Tire	No visible defects

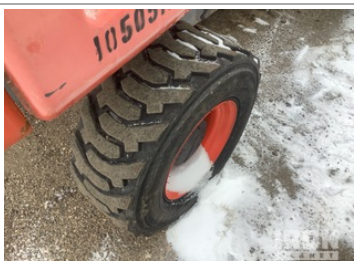
Right Rear Tire	No visible defects

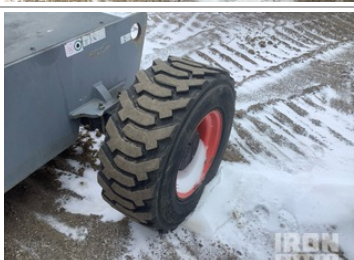
Right Front Tire	No visible defects

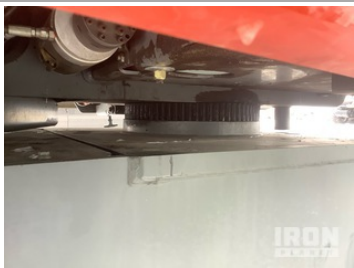
Wheel Condition	No visible damage or missing components	
Turntable Bearing	★★★★☆

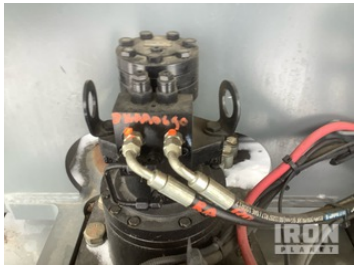
Swing Motor	★★★★☆

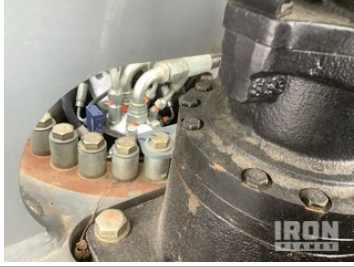
Hydraulic Center Swivel	★★★★☆

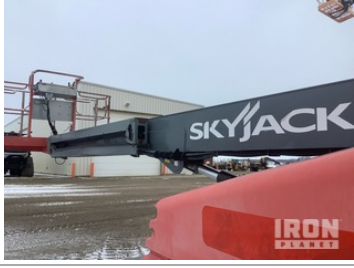
Boom Condition	★★★★☆

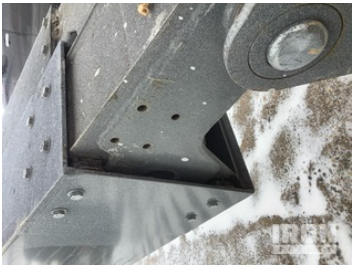
Boom Wear Guides	★★★★☆
