## Item #14787074 - 2017 JLG 600S 4WD Diesel Telescopic Boom Lift

# Inspection Report

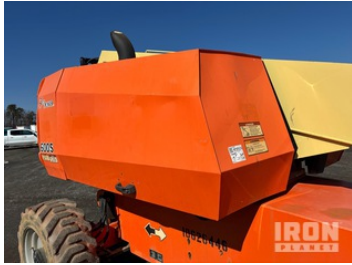
<p>Body Panels</p>	<p>Engine compartment door damaged, Hydraulic compartment door damaged</p>

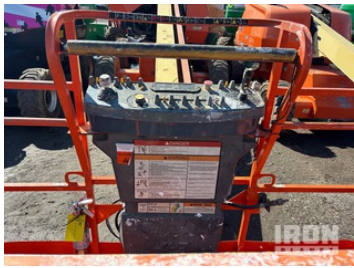
<b>Control Station</b>		
Pin connection pivot point wear inspections are limited to sound, sight and feel observations. Dial indicator testing is not performed.		
<b>Item</b>	<b>Assessment</b>	<b>Photo</b>
Control Console	Material buildup Lower housing damaged

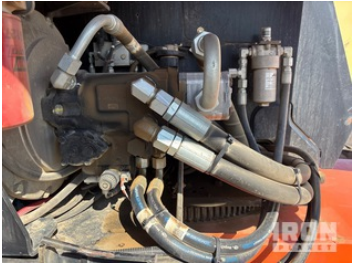
<b>Hydraulics</b>		
See photos for condition		
<b>Item</b>	<b>Assessment</b>	<b>Photo</b>
Pumps (Hydraulics)	★★☆☆☆ Dripping leak

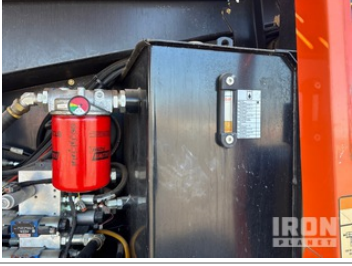
Hydraulic Tank	★★☆☆☆ Dripping leak, Tank filter has dripping leak

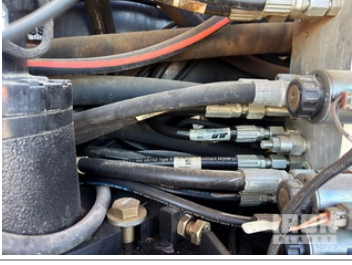
Hoses (Hydraulic)	★★☆☆☆ Some hoses have dripping leak see additional photos

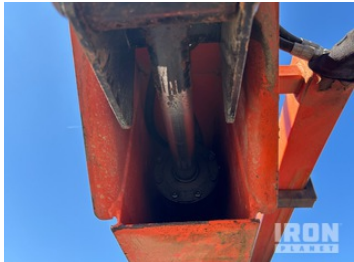
<p>Boom Extension Cylinder</p>	<p>★★★★☆</p>	
<p>Basket Tilt Cylinder</p>	<p>★★★☆☆ Dripping leak</p>

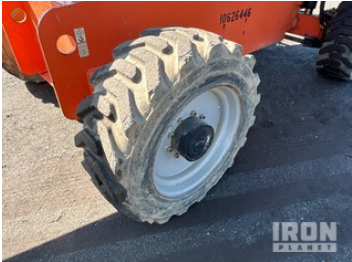
Brake System	★★★☆☆ The brake system functioned, stopping and holding the machine.	
Left Front Tire	Tears

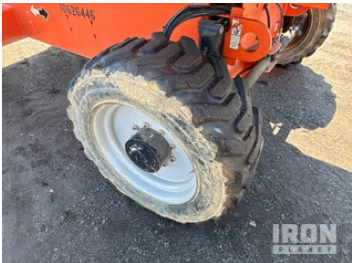
Left Rear Tire	Cracks, Chunks missing, Tears

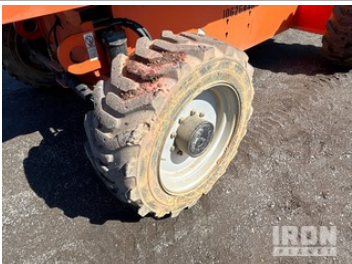
Right Rear Tire	Cracks, Chunks missing, Tears

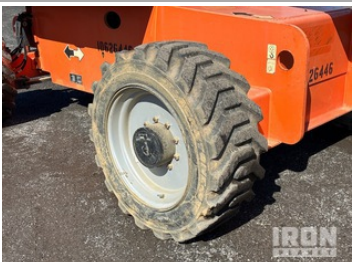
Right Front Tire	Cracks, Chunks missing, Tears

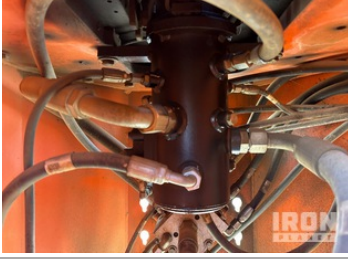
Hydraulic Center Swivel	★★★★☆ Hydraulic oil dripping from lift cylinder onto swivel
