## Item #14786806 - 2017 JLG 8042 Telehandler

# Inspection Report

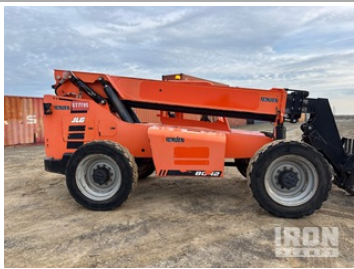
Paint	No visible damage

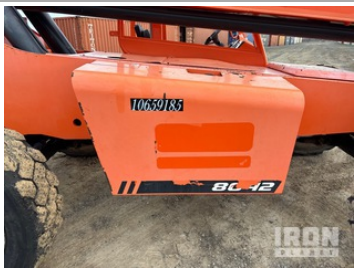
Body Panels	No visible damage or missing components

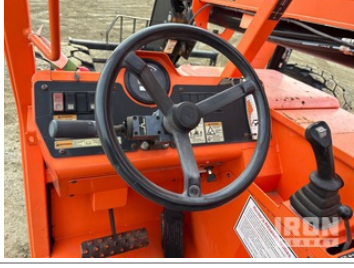
Steering Control	★★★★☆

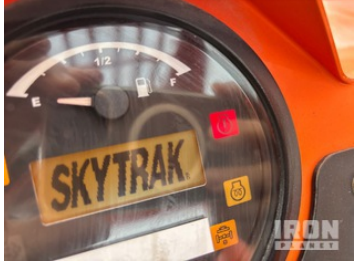
Engine Oil Pressure	The fault indicator shuts off after the engine oil pressure rises.

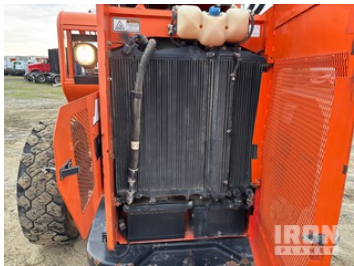
Radiator	★★★★☆

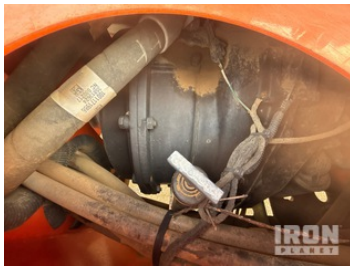
Item	Assessment	Photo
Transmission	★★☆☆ Operational

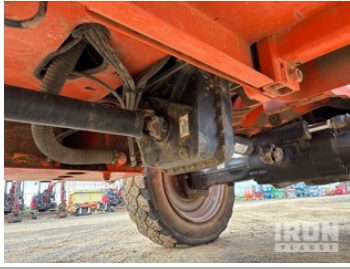
Transfer Case / Drop Box	★★☆☆ Operational

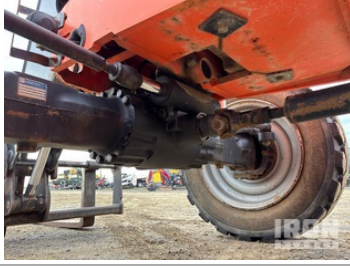
Front Drive Axle	★★☆☆

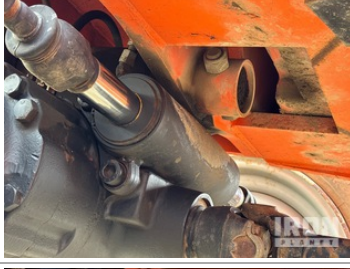
Front Axle Oscillating Pin	★★☆☆

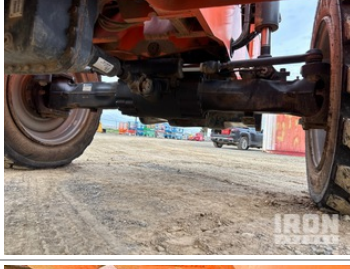
Rear Drive Axle	★★☆☆

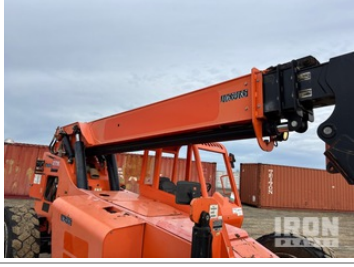
Boom Condition	☆☆☆☆

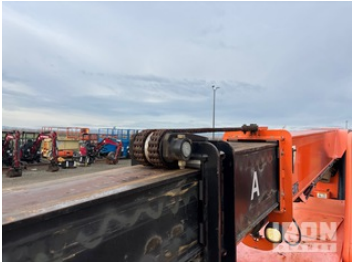
Chain / Tensioners	☆☆☆☆

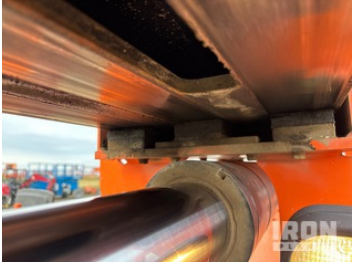
Boom Wear Guides	☆☆☆☆
