Item #14786807 - 2017 SkyTrak 8042 Telehandler

Inspection Report

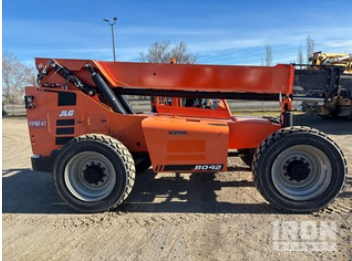
<p>Paint</p>	<p>No visible damage</p>

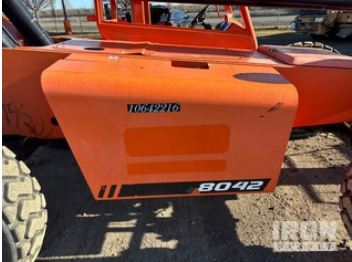
<p>Body Panels</p>	<p>No visible damage or missing components</p>

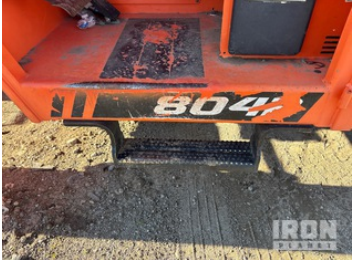
<p>Steps</p>	<p>No visible damage or missing components</p>

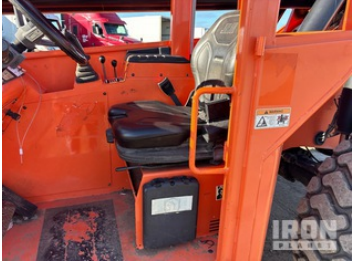
<p>Hand Rails</p>	<p>No visible damage or missing components</p>

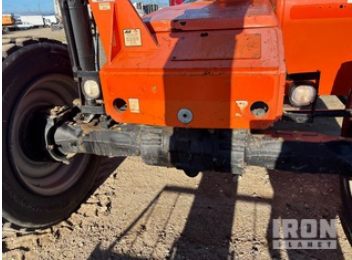
<p>Exterior Lights</p>	<p>All lights operational</p>

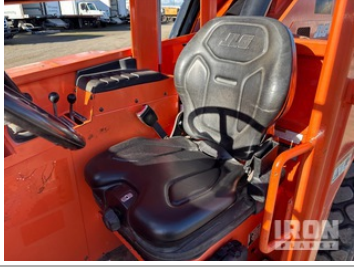
Seat/Armrests	No visible damage or missing components

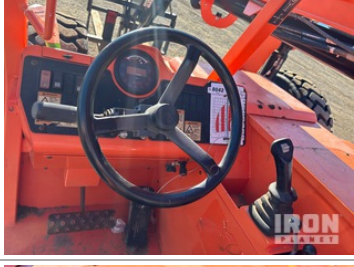
Steering Control	★★★★☆

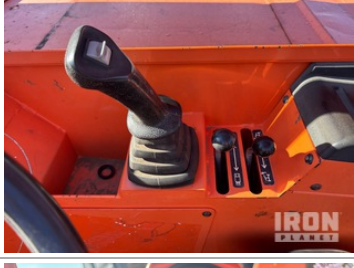
Hydraulic Controls	★★★★☆

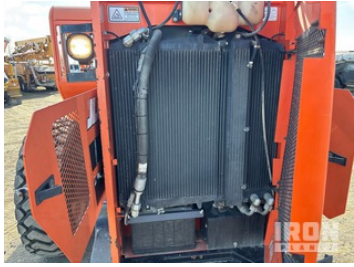
Radiator	★★★★☆

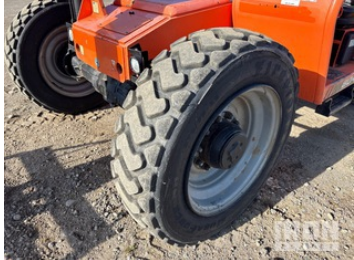
Brake Lines/Hoses	★★★★☆	
Park Brake	★★★★☆	
Limited Function Check - Brakes	The service brakes are operational, The park brake is operational.	
Left Front Tire	Size: 370/75-28 Brand: Firestone Tread Depth: 25/32

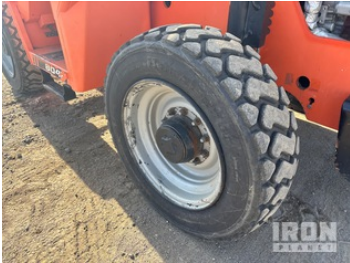
<p>Left Rear Tire</p>	<p>Size: 370/75-28 Brand: Firestone Tread Depth: 25/32</p>

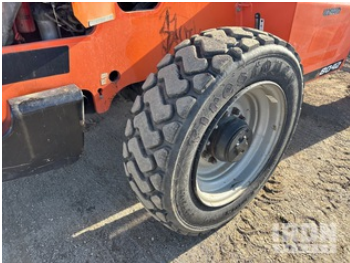
<p>Right Rear Tire</p>	<p>Size: 370/75-28 Brand: Firestone Tread Depth: 25/32</p>

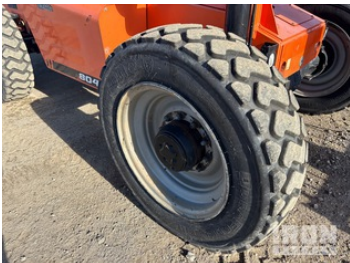
<p>Right Front Tire</p>	<p>Size: 370/75-28 Brand: Firestone Tread Depth: 25/32</p>

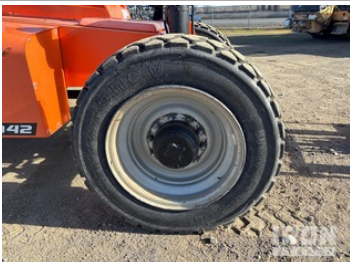
<p>Wheel Condition</p>	<p>No visible damage or missing components</p>

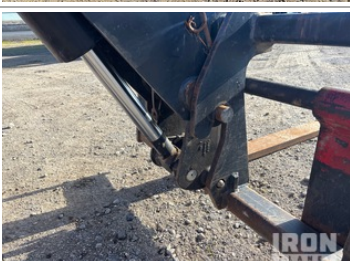
Loader Quick Coupler	★★★★☆ Operational

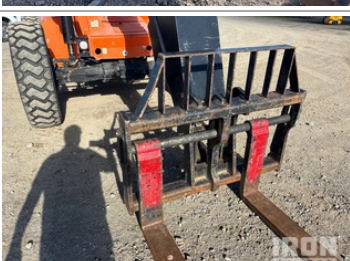
Load Back Rest	★★★★☆

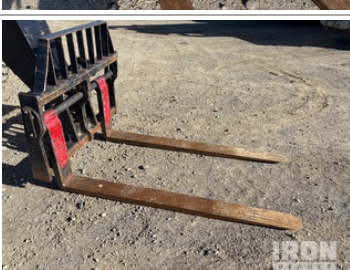
Forks	★★★★☆
