Item #14855866 - 2016 SkyTrak 6042 Telehandler

Inspection Report

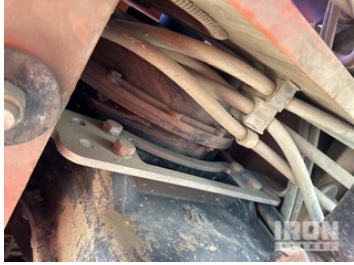
Drivetrain		
Operational test is limited to low speed in a confined flat area without load. Differential interlocks, full transmission shifting and functionality of all drive axles cannot be fully verified. Inspector listens for abnormal noises, observes leaks and notes physical damage.		
Item	Assessment	Photo
Transmission	★★☆☆ Operational

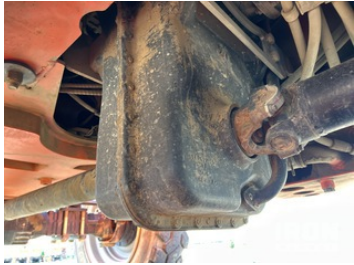
Transfer Case / Drop Box	★★☆☆ Operational

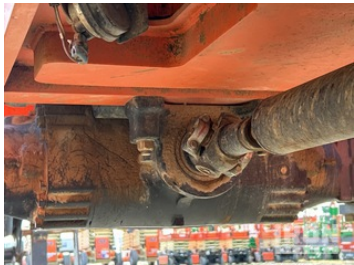
Front Drive Axle	★★☆☆

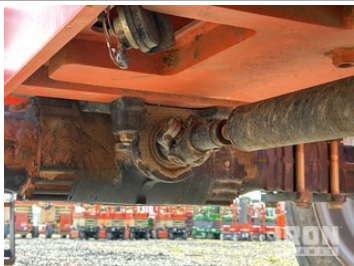
Front Axle Oscillating Pin	★★☆☆

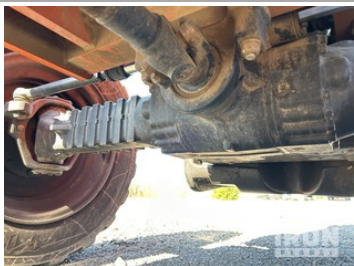
Rear Drive Axle	★★☆☆

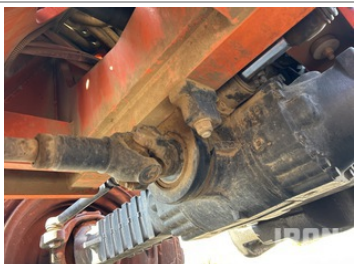
Rear Axle Oscillating Pin	★★☆☆

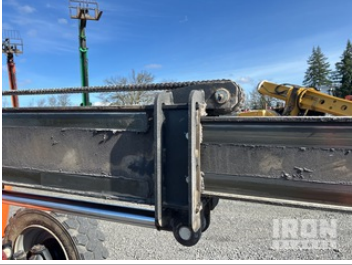
Chain / Tensioners	★★★★☆ Heavy wear

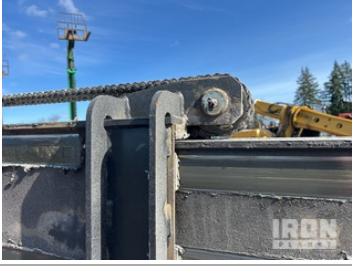
Rollers and Guides	★★★★☆ Heavy wear

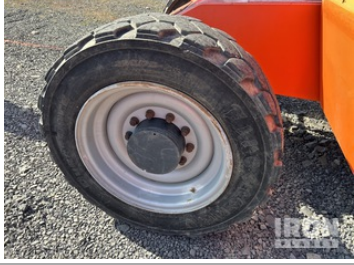
Park Brake	★★★☆☆ Stopped from a slow roll	
Limited Function Check - Brakes	The service brakes are operational, The park brake is operational.	
Left Front Tire	Size: 370/75-28 Brand: Firestone Model: DuraForce Tread Depth: 19/32
