Item #14786755 - 2017 JLG 4069LE Electric Scissor Lift

Inspection Report

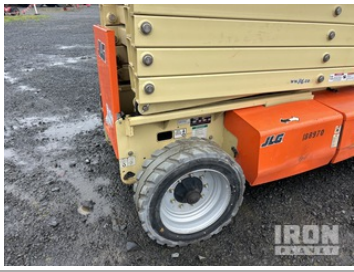
<p>Paint</p>	<p>No visible damage</p>

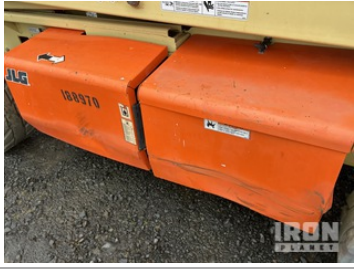
<p>Body Panels</p>	<p>Battery compartment door damaged, Hydraulic compartment door damaged</p>

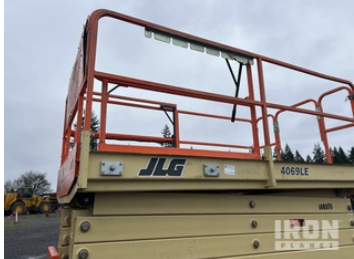
<p>Basket / Safety Railing</p>	<p>No visible damage or missing components</p>	
<p>General Appearance #1</p>

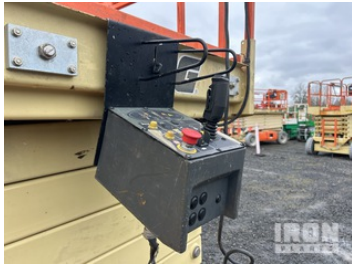
Item	Assessment	Photo
Control Console	No visible damage or missing components

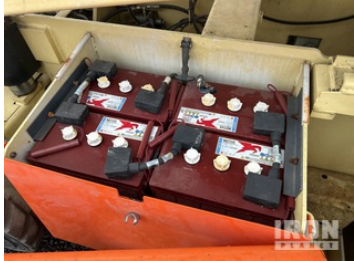
Electrical Operating System		
Item	Assessment	Photo
Operating Voltage	48 Volts	
Battery Condition	Functioned during the inspection	
Cables and Connections	No visible damage or missing components

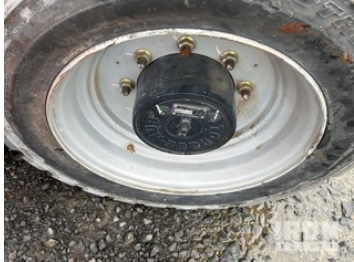
Item	Assessment	Photo
Drive Motors	★★☆☆ Covered	
Final Drives	★★☆☆

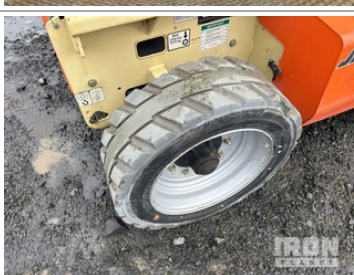
Left Front Tire	No visible defects

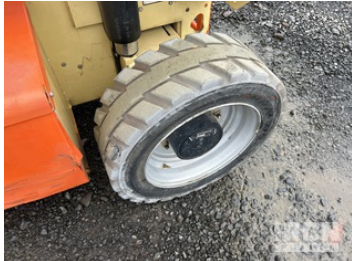
Left Rear Tire	No visible defects

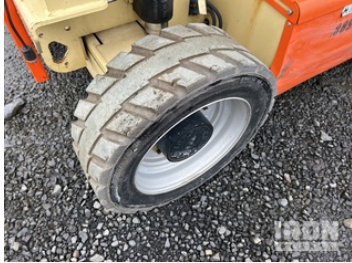
Right Rear Tire	No visible defects

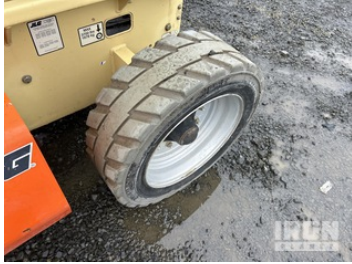
Right Front Tire	No visible defects

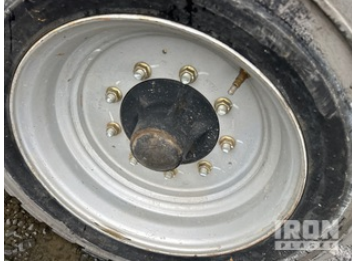
Wheel Condition	No visible damage or missing components
