Item #14786757 - 2018 JLG 4069LE Electric Scissor Lift

Inspection Report

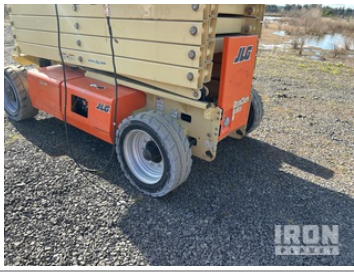
<p>Paint</p>	<p>No visible damage</p>

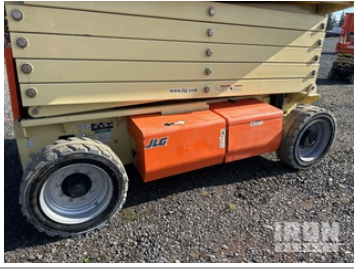
<p>Body Panels</p>	<p>No visible damage or missing components</p>

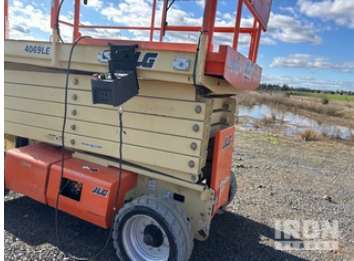
<p>Basket / Safety Railing</p>	<p>No visible damage or missing components</p>	
<p>General Appearance #1</p>

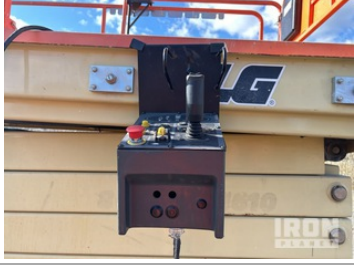
Control Station Upper		
Pin connection pivot point wear inspections are limited to sound, sight and feel observations. Dial indicator testing is not performed.		
Item	Assessment	Photo
Control Console	No visible damage or missing components

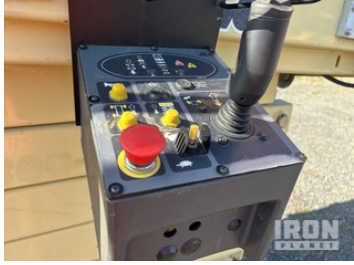
Emergency Shut Off Switch	Operational

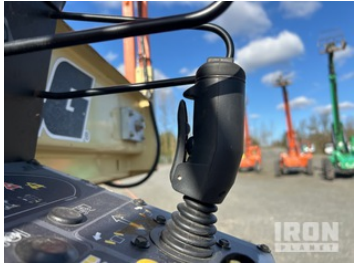
Safety Control Hand/Foot Switch	★★★★☆ Operational

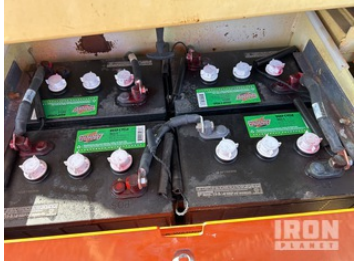
Electrical Operating System		
Item	Assessment	Photo
Operating Voltage	48 Volts	
Battery Condition	Functioned during the inspection	
Cables and Connections	No visible damage or missing components

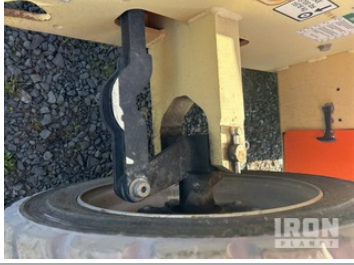
Chassis		
IronPlanet pin connection pivot point wear inspections are limited to sound, sight and feel observations. Dial indicator testing is not performed.		
Item	Assessment	Photo
Steering Linkage	★★★☆☆

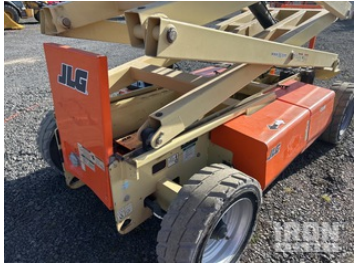
Frame Condition	★★★☆☆

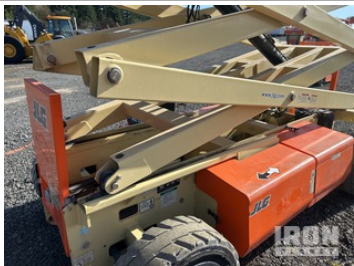
Scissor Linkage	★★★☆☆

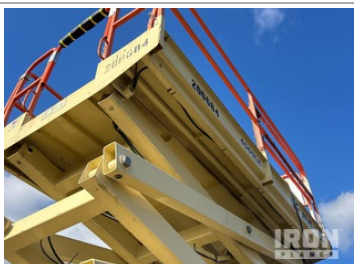
Platform Condition	★★★☆☆

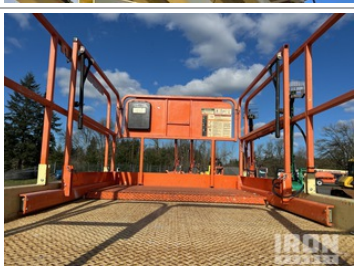
Platform Extension	★★★☆☆

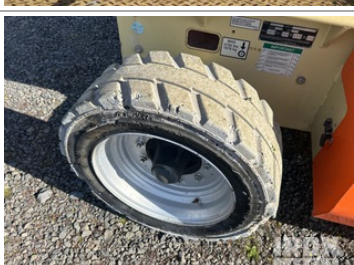
Left Front Tire	No visible defects

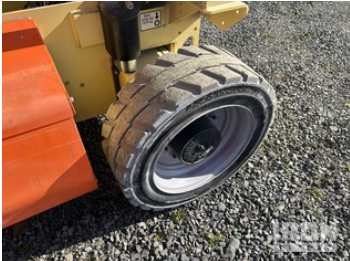
Left Rear Tire	No visible defects

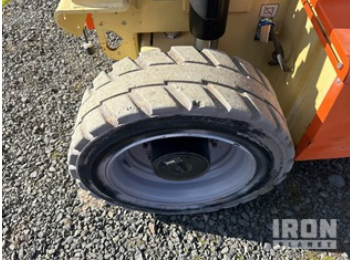
Right Rear Tire	No visible defects

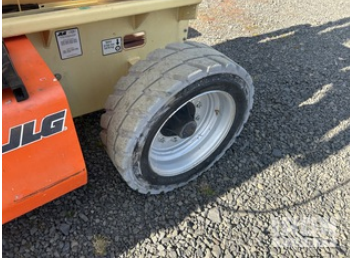
Right Front Tire	No visible defects

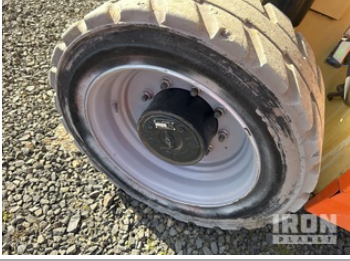
Wheel Condition	No visible damage or missing components
