## Item #14786826 - 2019 JLG 4069LE Electric Scissor Lift

# Inspection Report

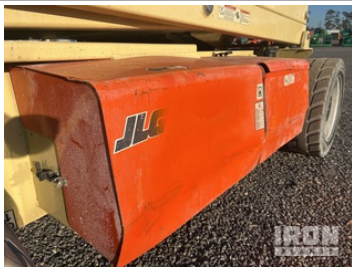
<p>Body Panels</p>	<p>Hydraulic compartment door damaged</p>

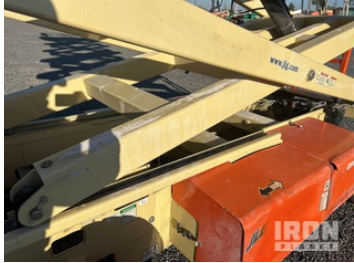
Frame Condition	★★☆☆

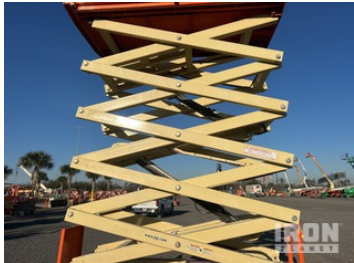
Scissor Linkage	★★☆☆

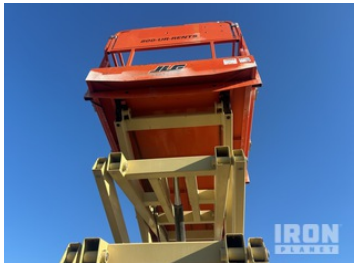
Platform Condition	★★☆☆

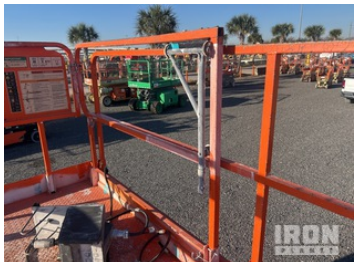
Platform Extension	★★☆☆ Couldn't get extension to slid out

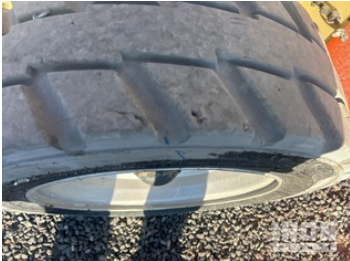
Left Front Tire	Cracks, Chunks missing

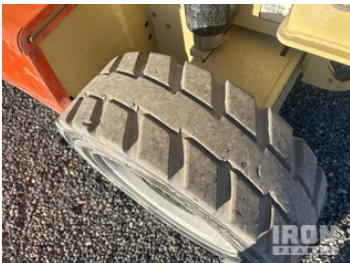
Left Rear Tire	Cracks, Chunks missing

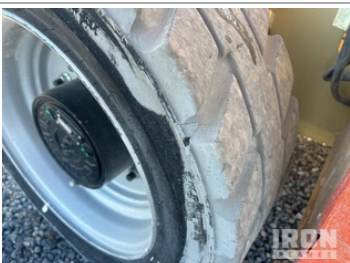
Right Rear Tire	Cracks, Chunks missing

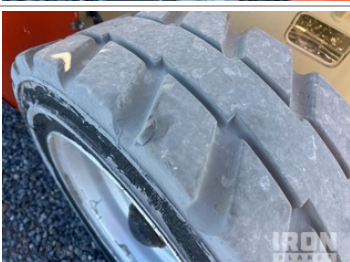
Right Front Tire	Cracks, Chunks missing
