## Item #14786824 - 2019 JLG 4045R Electric Scissor Lift

# Inspection Report

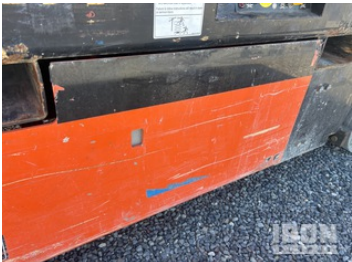
Paint	Other unknown material	 
Body Panels	Battery compartment door damaged, Hydraulic compartment door damaged

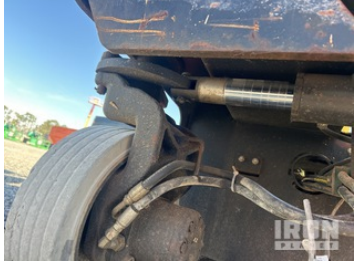
<b>Chassis</b>		
IronPlanet pin connection pivot point wear inspections are limited to sound, sight and feel observations. Dial indicator testing is not performed.		
<b>Item</b>	<b>Assessment</b>	<b>Photo</b>
Brake System	★★☆☆ The brake system functioned, stopping and holding the machine., Could not get pictures of braking system	
Steering Linkage	★★☆☆

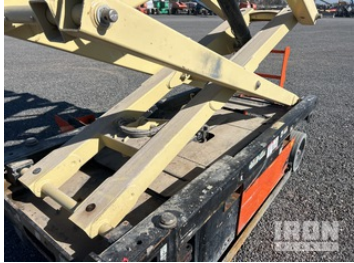
Frame Condition	★★☆☆

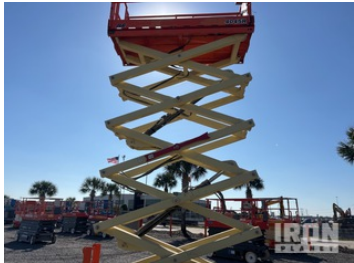
Scissor Linkage	★★☆☆

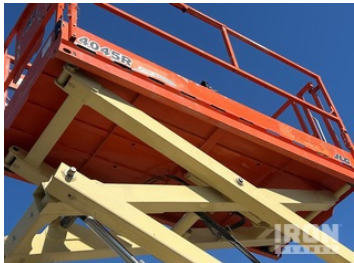
Platform Condition	★★☆☆

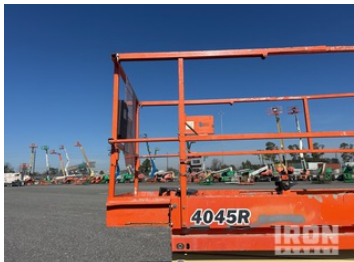
Platform Extension	★★☆☆

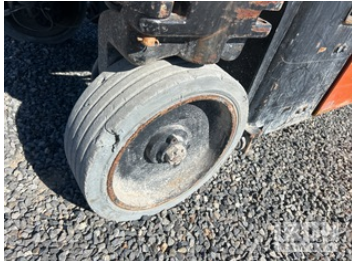
Left Front Tire	Cracks, Chunks missing

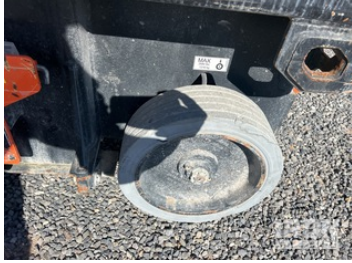
Left Rear Tire	Cracks, Chunks missing

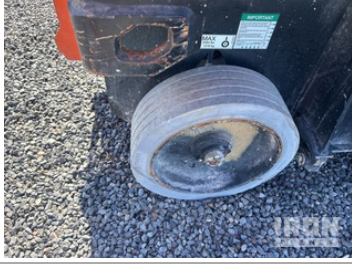
Right Rear Tire	Cracks, Chunks missing

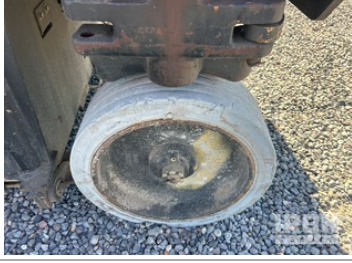
Right Front Tire	Cracks, Chunks missing
