Item #14786823 - 2019 JLG 4045R Electric Scissor Lift

- Features: Platform Extension, Power to Platform, Solid Non-Marking Tires, Upper Control Box
- Meter Reading: 467 Hours
- Serial # : 0200269371
- Inspection Completed: 2/24/26

Inspection Report

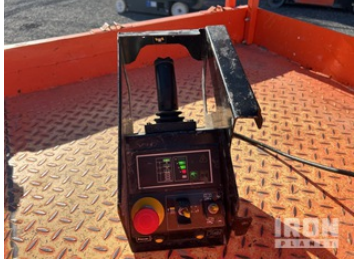
Item	Assessment	Photo
Control Console	No visible damage or missing components

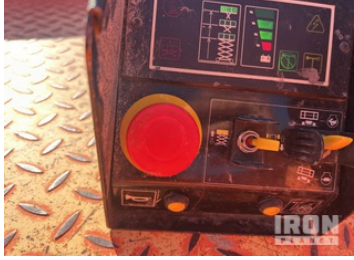
Emergency Shut Off Switch	Operational

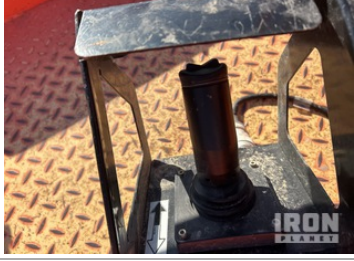
Upper Function Controls	★★★★☆

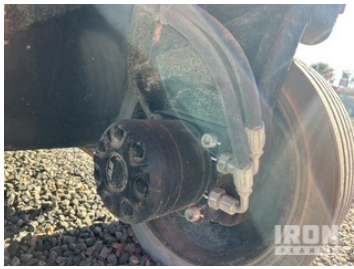
Drivetrain		
Operational test is limited to low speed in a confined flat area without load. Differential interlocks, full transmission shifting and functionality of all drive axles cannot be fully verified. Inspector listens for abnormal noises, observes leaks and notes physical damage.		
Item	Assessment	Photo
Drive Motors	★ ★ ★ ☆

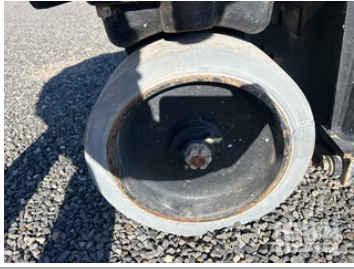
Final Drives	★ ★ ★ ☆

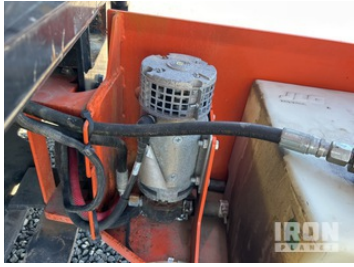
Hydraulics		
Item	Assessment	Photo
Pumps (Hydraulics)	★★★★☆

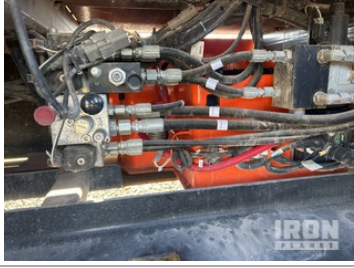
Valves	★★★★☆

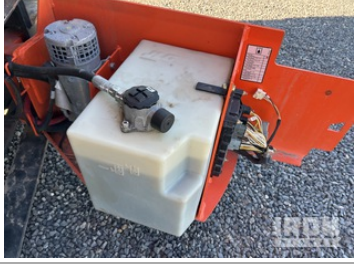
Hydraulic Tank	★★★★☆

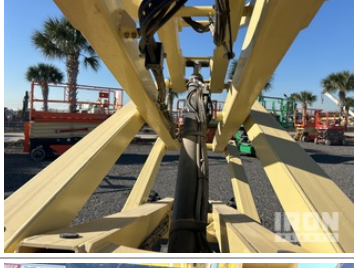
Lift Cylinders	★★★★☆

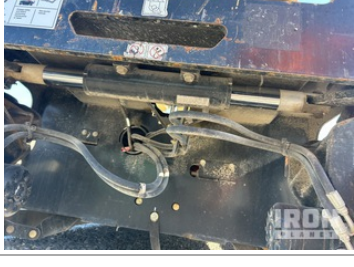
Steering Cylinder	★★★★☆

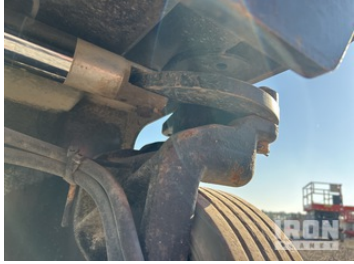
Chassis		
IronPlanet pin connection pivot point wear inspections are limited to sound, sight and feel observations. Dial indicator testing is not performed.		
Item	Assessment	Photo
Brake System	The brake system functioned, stopping and holding the machine.	
Steering Linkage	★★★★☆

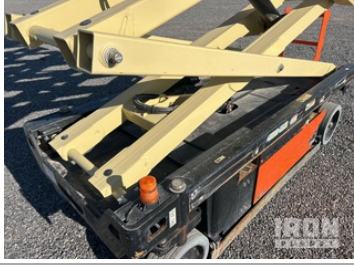
Frame Condition	★★★★☆

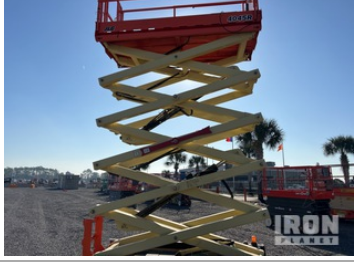
Scissor Linkage	★★★★☆

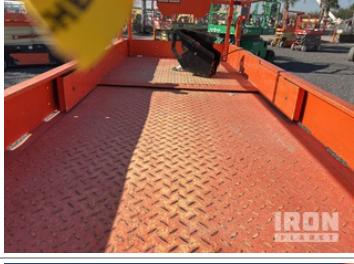
Platform Condition	★★★★☆

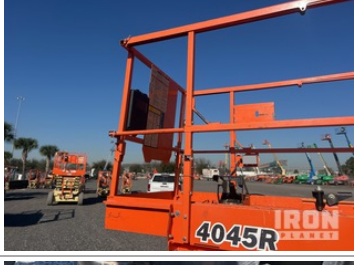
Platform Extension	★★★★☆
