Item #14786756 - 2018 JLG 4069LE Electric Scissor Lift

Inspection Report

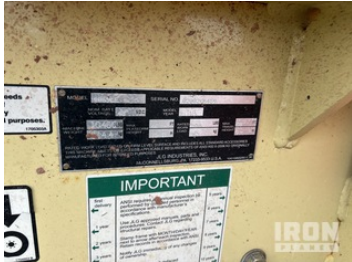
<p>Serial Number / VIN</p>	<p>0200266459</p>

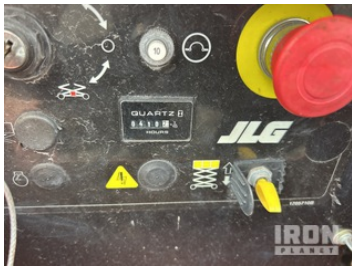
<p>Hour Meter / Odometer</p>	<p>410 hrs</p>

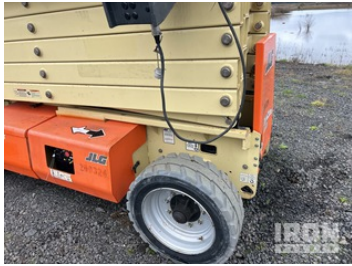
<p>Paint</p>	<p>No visible damage</p>

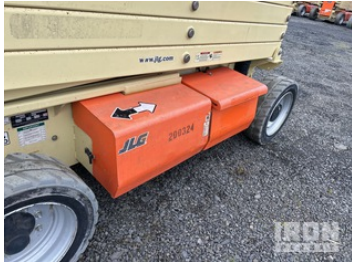
<p>Body Panels</p>	<p>No visible damage or missing components</p>

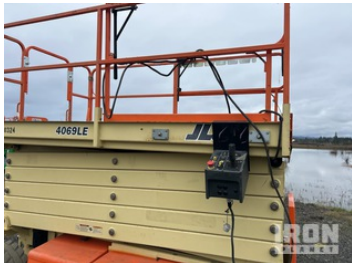
<p>Basket / Safety Railing</p>	<p>No visible damage or missing components</p>	
<p>General Appearance #1</p>

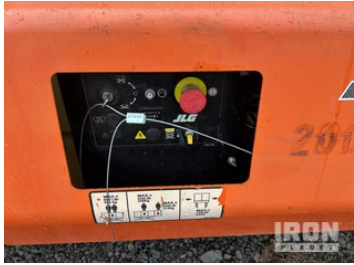
Control Station Ground		
Item	Assessment	Photo
Function Controls	★ ★ ★ ☆

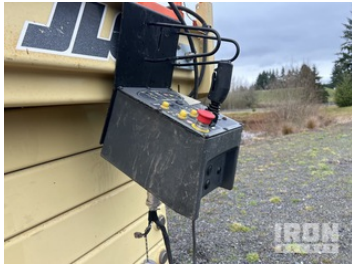
Item	Assessment	Photo
Control Console	No visible damage or missing components

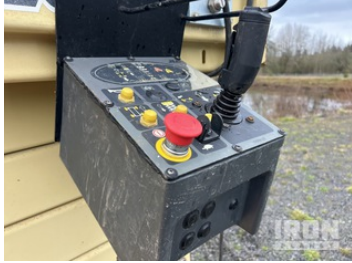
Emergency Shut Off Switch	Operational

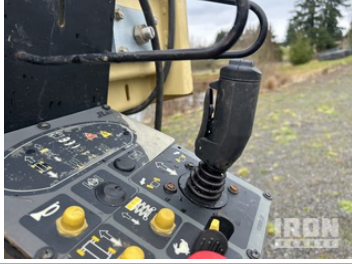
Safety Control Hand/Foot Switch	★★☆☆ Operational

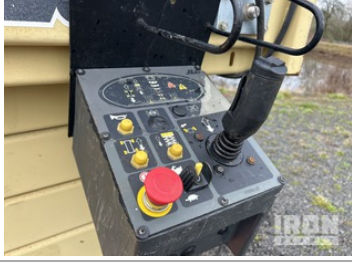
Upper Function Controls	★★☆☆

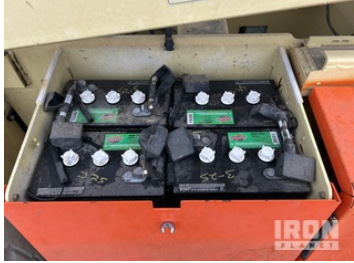
Electrical Operating System		
Item	Assessment	Photo
Operating Voltage	48 Volts	
Battery Condition	Functioned during the inspection	
Cables and Connections	No visible damage or missing components

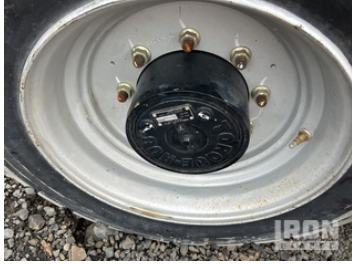
Item	Assessment	Photo
Drive Motors	Covered	
Final Drives	★★★☆☆

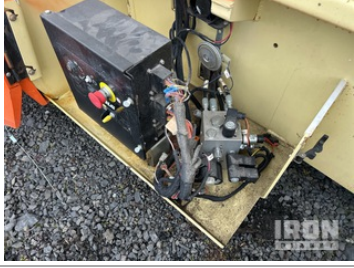
Hydraulics		
Item	Assessment	Photo
Pumps (Hydraulics)	★★★★☆	 
Valves	★★★★☆

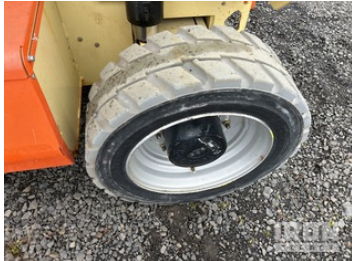
Left Rear Tire	No visible defects

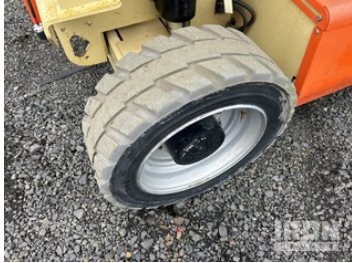
Right Rear Tire	No visible defects

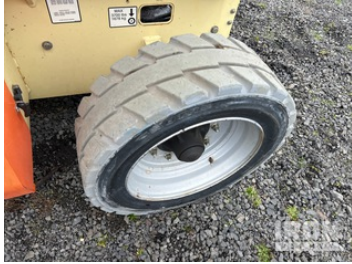
Right Front Tire	No visible defects

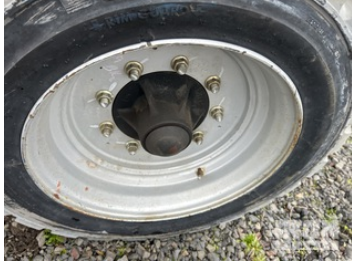
Wheel Condition	No visible damage or missing components

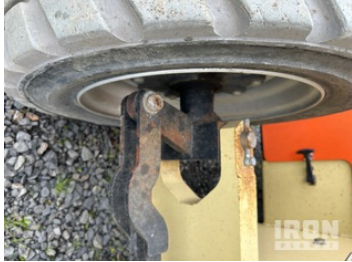
Wheel Studs	★★★★☆	
Limited Function Check (Scissor-lift)	The main components appear to be in place and operational.	
Chassis #1
