Item #14301794 - 2016 JLG 800S 4WD Diesel Telescopic Boom Lift

Inspection Report

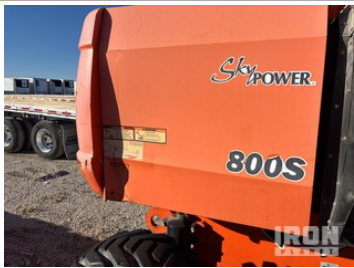
Body Panels	Right rear panel is damaged.

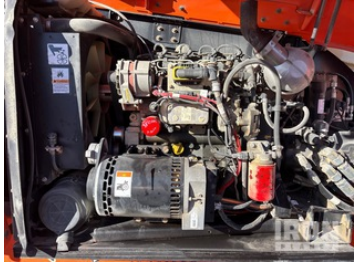
Engine - Left Side

Limited Function Check	After jump starting, the engine ran.

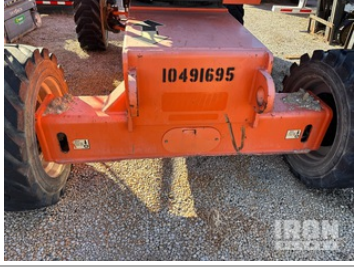
Brake System	★★★☆☆ The brake system functioned, stopping and holding the machine.

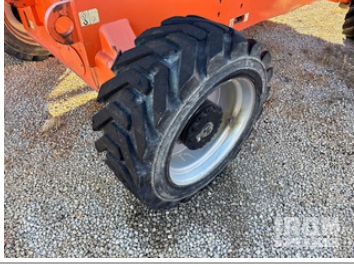
Left Front Tire	Cracks, Chunks missing, Tears

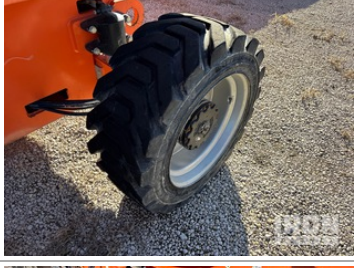
Left Rear Tire	Cracks, Chunks missing, Tears

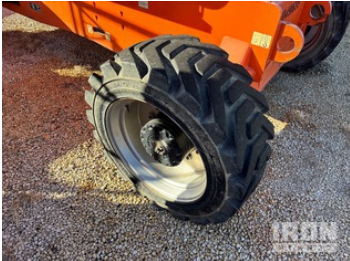
Right Front Tire	Cracks, Chunks missing, Tears
