## Item #14787257 - 2019 JLG 4069LE Electric Scissor Lift

- Features: 40 ft Max Platform Height, 800 lb Max Weight Capacity, Platform Extension, Power to Platform, Foam Filled Tires, Upper Control Box
- Meter Reading: 439 Hours
- Serial # : M200033953
- Inspection Completed: 3/5/26

# Inspection Report

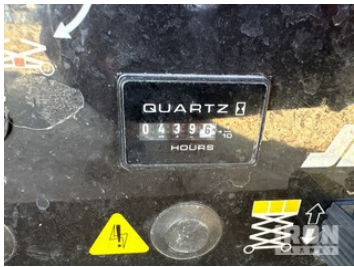
| Hour Meter / Odometer | 439 hrs | |

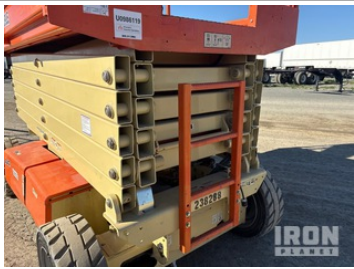
| Body Panels | Hydraulic compartment door damaged | |

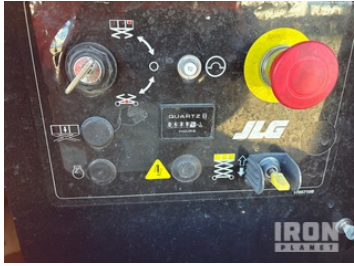
| <b>Control Station Ground</b> | | |
|---|--|--|
| Function Controls | ★ ★ ★ ☆ | |

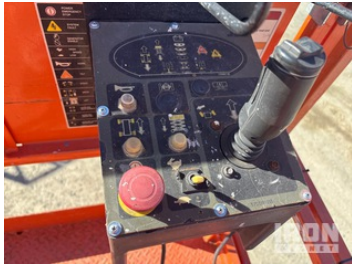
| Item | Assessment | Photo |
|---|--|--|
| Control Console | No visible damage or missing components | |

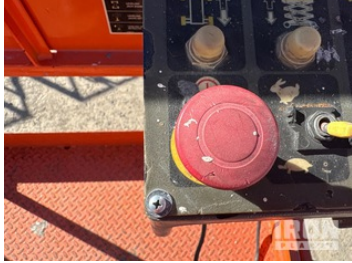
| Item | Assessment | Photo |
|---|--|--|
| Emergency Shut Off Switch | Operational | |

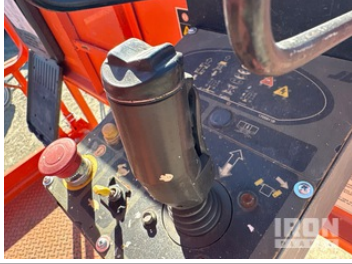
| Item | Assessment | Photo |
|---|--|--|
| Safety Control Hand/Foot Switch | ★★★★☆ | |

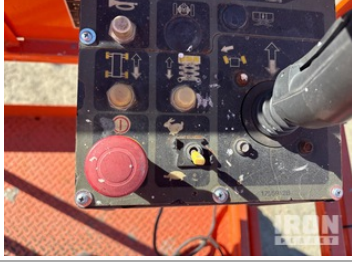
| Item | Assessment | Photo |
|---|--|--|
| Upper Function Controls | ★★★★☆ | |

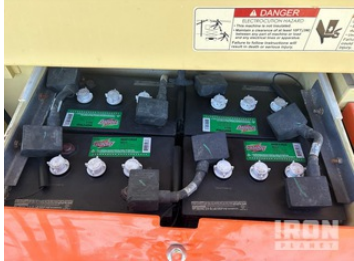
| <b>Electrical Operating System</b> | | |
|---|---|--|
| Cables and Connections | No visible damage or missing components | |

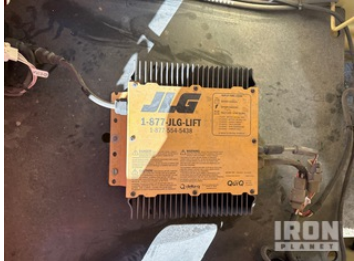
| <b>Electrical Operating System</b> | | |
|---|---|--|
| Battery Charger | Included 24 Volt | |

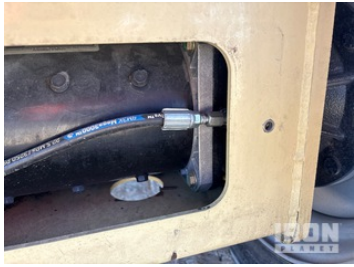
| <b>Drivetrain</b> | | |
|--|---|--|
| Drive Motors | ★★★☆☆ | |

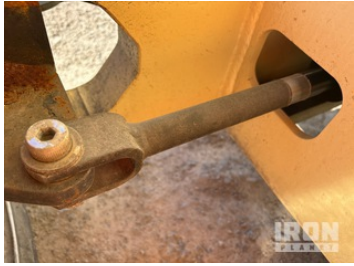
| <b>Drivetrain</b> | | |
|--|---|--|
| Front Drive Axle | ★★★☆☆ | |

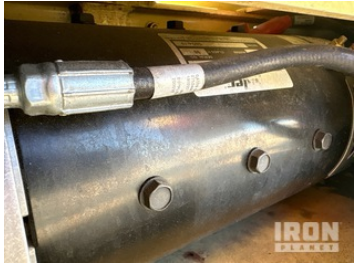
| <b>Drivetrain</b> | | |
|--|---|--|
| Rear Drive Axle | ★★★☆☆ | |

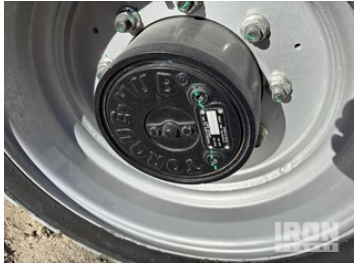
| <b>Drivetrain</b> | | |
|--|---|--|
| Final Drives | ★★★☆☆ | |

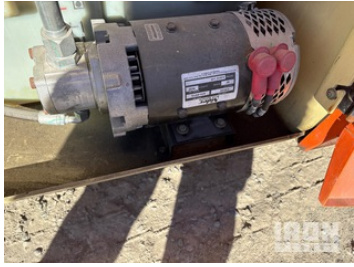
| Hydraulics | | |
|---|---|--|
| Pumps (Hydraulics) | ★★★★☆ | |

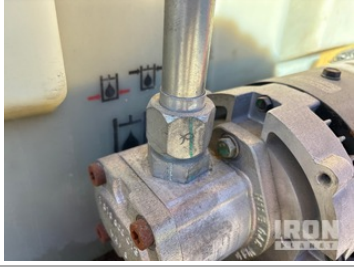
| Hydraulics | | |
|---|---|--|
| Valves | ★★★★☆ | |

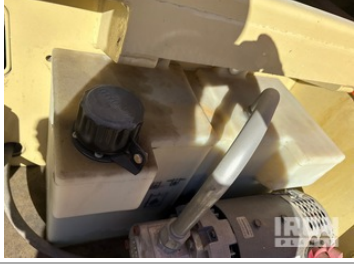
| Hydraulics | | |
|---|---|--|
| Hydraulic Tank | ★★★★☆ | |

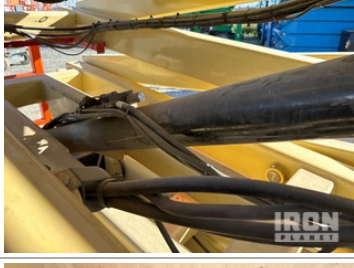
| Hydraulics | | |
|---|---|--|
| Lift Cylinders | ★★★★☆ | |

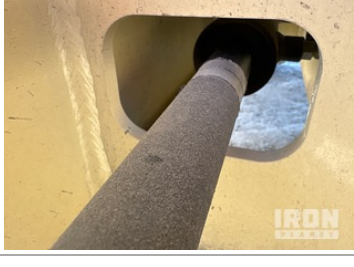
| Hydraulics | | |
|---|---|--|
| Steering Cylinder | ★★★★☆ | |

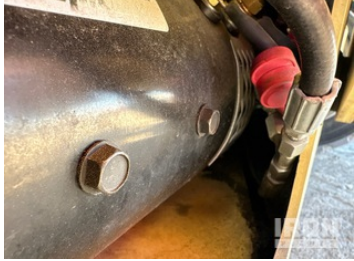
| <b>Chassis</b> | | |
|--|--|--|
| Brake System | ★★☆☆<br>The brake system functioned, stopping and holding the machine. | |

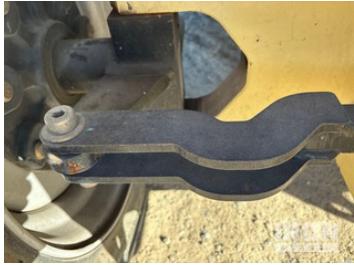
| <b>Chassis</b> | | |
|--|--|--|
| Steering Linkage | ★★☆☆ | |

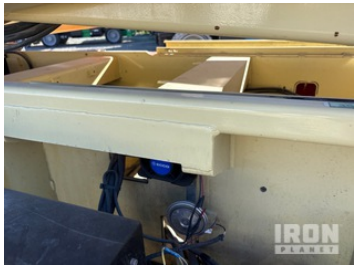
| <b>Chassis</b> | | |
|--|--|--|
| Frame Condition | ★★☆☆ | |

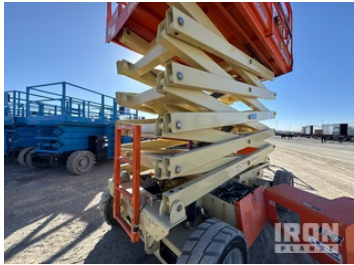
| <b>Chassis</b> | | |
|--|--|--|
| Scissor Linkage | ★★☆☆ | |

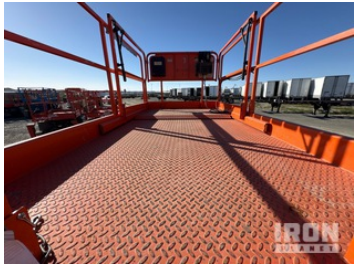
| <b>Chassis</b> | | |
|--|--|--|
| Platform Condition | ★★☆☆ | |

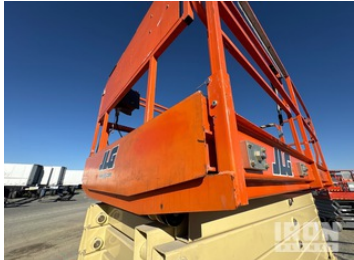
| <b>Chassis</b> | | |
|--|--|--|
| Platform Extension | ★★☆☆ | |

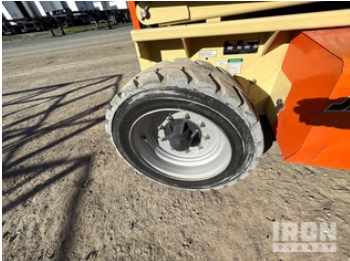
| Left Front Tire | No visible defects | |

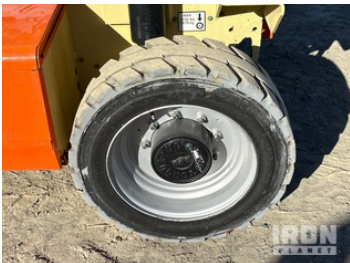
| Left Rear Tire | No visible defects | |

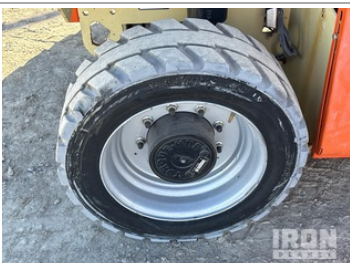
| Right Rear Tire | No visible defects | |

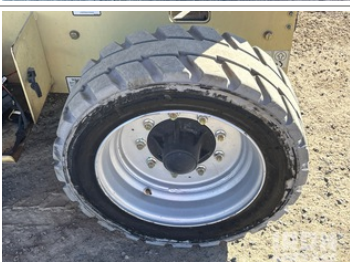
| Right Front Tire | No visible defects | |

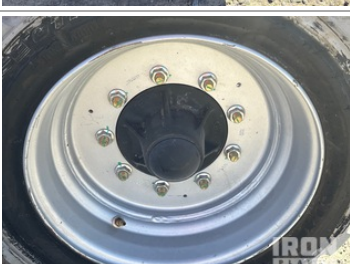
| Wheel Condition | No visible damage or missing components | |

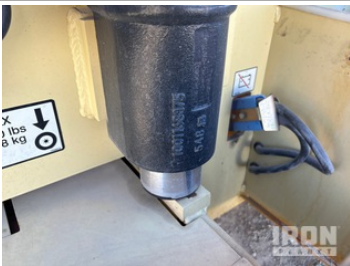
| Outriggers / Stabilizers | ★★★★☆ | |
