Item #14787236 - 2018 JLG 4045R Electric Scissor Lift

Inspection Report

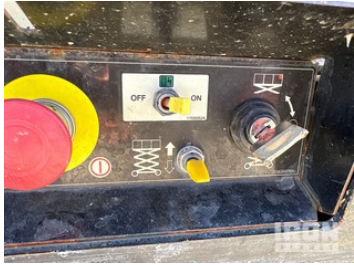
| Control Station Ground | | |
|---|--|--|
| Function Controls | ★★★☆☆ | |

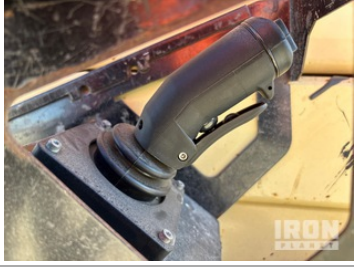
| Control Station Upper | | |
|---|--|--|
| Safety Control Hand/Foot Switch | ★★★★☆ | |

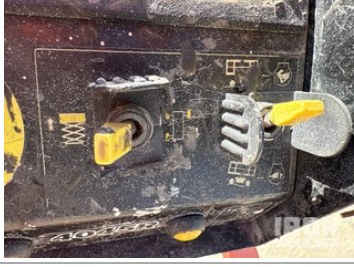
| Control Station Upper | | |
|---|--|--|
| Upper Function Controls | ★★★★☆ | |

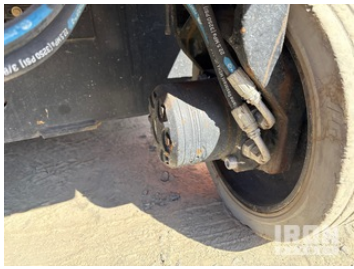
| Drivetrain | | |
|--|---|--|
| Drive Motors | ★ ★ ★ ☆ | |

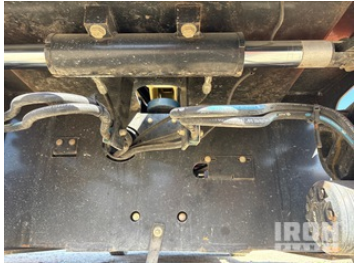
| Drivetrain | | |
|--|---|--|
| Front Drive Axle | ★ ★ ★ ☆ | |

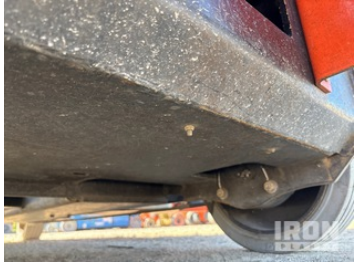
| Drivetrain | | |
|--|---|--|
| Rear Drive Axle | ★ ★ ★ ☆ | |

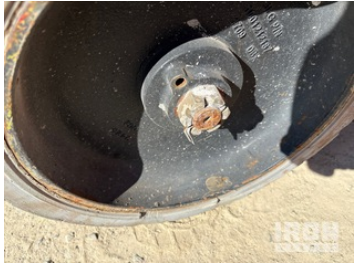
| Drivetrain | | |
|--|---|--|
| Final Drives | ★ ★ ★ ☆ | |

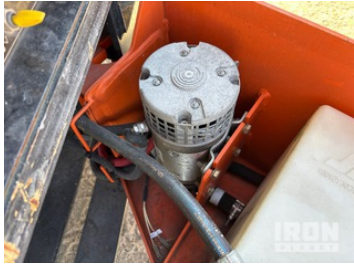
| Hydraulics | | |
|---|---|--|
| Pumps (Hydraulics) | ★★★★☆ | |

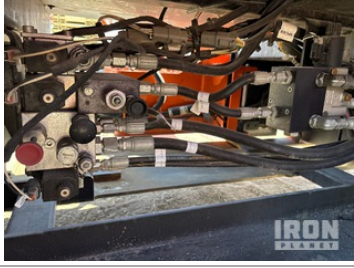
| Hydraulics | | |
|---|---|--|
| Valves | ★★★★☆ | |

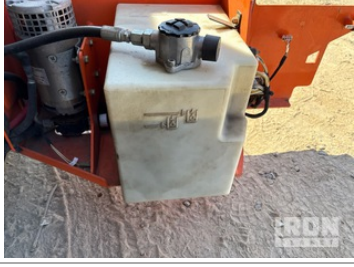
| Hydraulics | | |
|---|---|--|
| Hydraulic Tank | ★★★★☆ | |

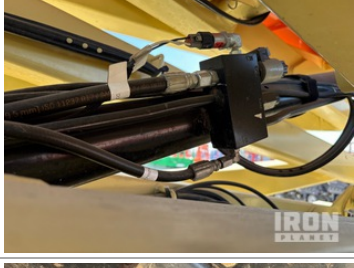
| Hydraulics | | |
|---|---|--|
| Lift Cylinders | ★★★★☆ | |

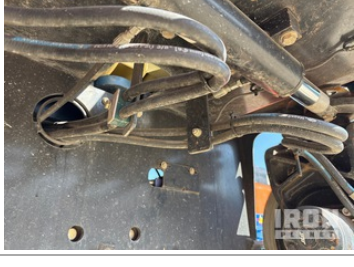
| Hydraulics | | |
|---|---|--|
| Steering Cylinder | ★★★★☆ | |

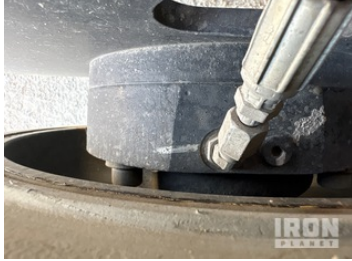
| Item | Assessment | Photo |
|---|---|--|
| Brake System | ★★★★☆ | |

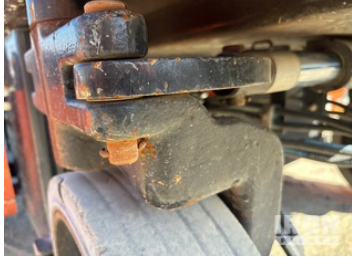
| Item | Assessment | Photo |
|---|---|--|
| Steering Linkage | ★★★★☆ | |

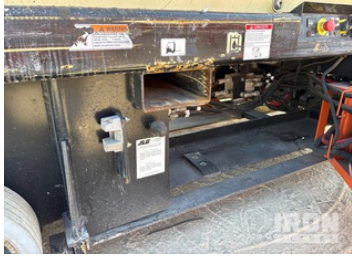
| Item | Assessment | Photo |
|---|---|--|
| Frame Condition | ★★★★☆ | |

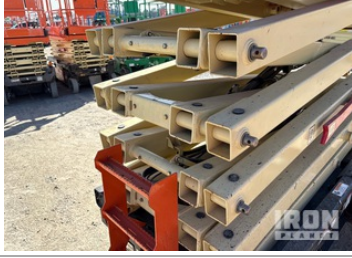
| Item | Assessment | Photo |
|---|---|--|
| Scissor Linkage | ★★★★☆ | |

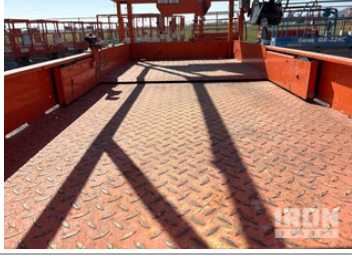
| Item | Assessment | Photo |
|---|---|--|
| Platform Condition | ★★★★☆ | |

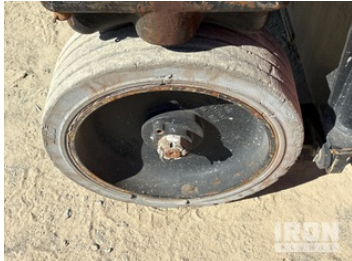
| Left Front Tire | Cracks, Chunks missing | |

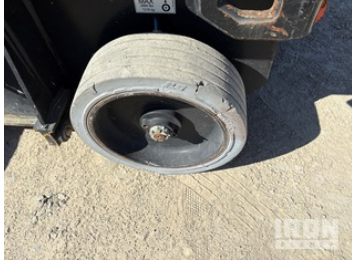
| Left Rear Tire | Cracks, Tears | |

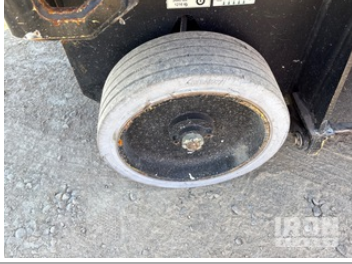
| Right Rear Tire | Chunks missing, Tears | |

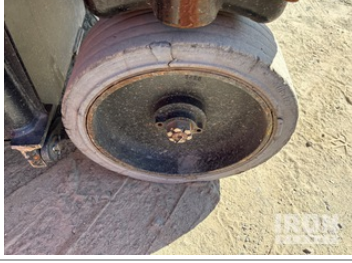
| Right Front Tire | Cracks, Tears | |

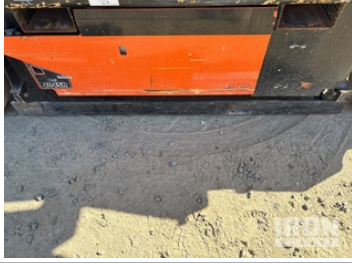
| Pothole Protection Bars | ★★★★☆ Functional | |
