Item #14787245 - 2019 JLG 4045R Electric Scissor Lift

Inspection Report

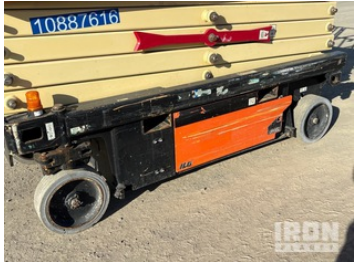
<p>Paint</p>	<p>No visible damage, Scrapes scuffs and commercial paint residue</p>

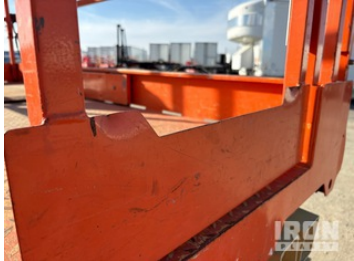
<p>Body Panels</p>	<p>Gate door bent</p>

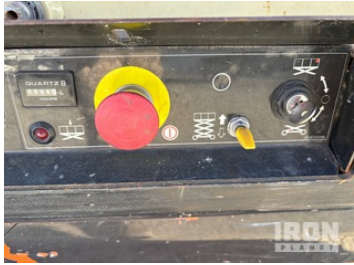
Control Station Ground		
Item	Assessment	Photo
Function Controls	★★★☆☆

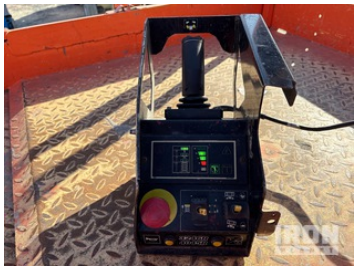
Control Station Upper		
Pin connection pivot point wear inspections are limited to sound, sight and feel observations. Dial indicator testing is not performed.		
Item	Assessment	Photo
Control Console	No visible damage or missing components

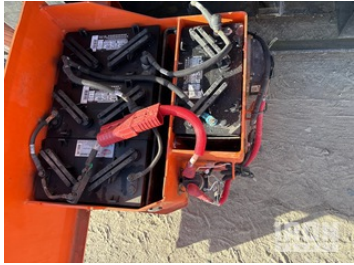
Electrical Operating System		
Item	Assessment	Photo
Operating Voltage	24 Volts	
Battery Condition	Functioned during the inspection	
Cables and Connections	No visible damage or missing components

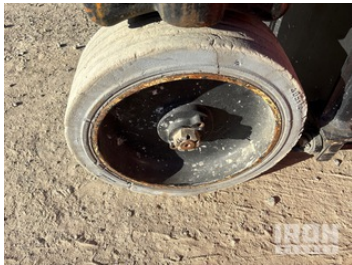
Left Front Tire	Cracks, Tears

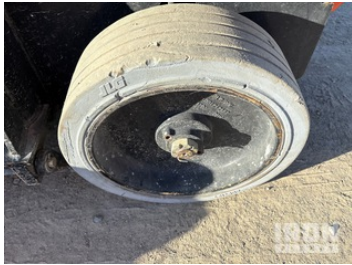
Left Rear Tire	Cracks, Tears

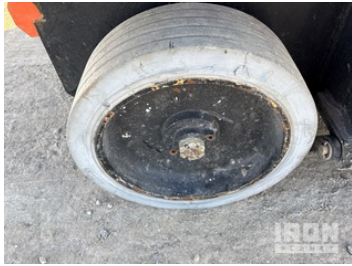
Right Rear Tire	Tears

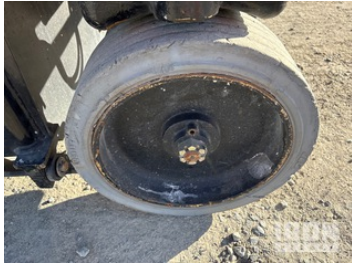
Right Front Tire	Cracks, Tears

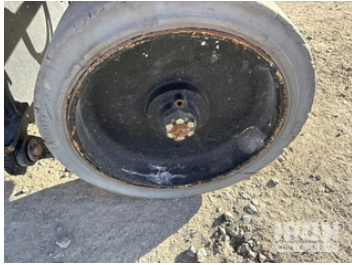
Wheel Condition	No visible damage or missing components
