Item #14786974 - 2017 Skyjack SJ85AJ 4WD Diesel Articulating Boom Lift

Inspection Report

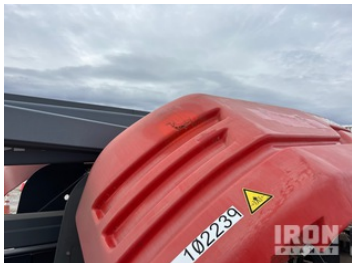
Paint	No visible damage	
Body Panels	Engine compartment door damaged, Hydraulic compartment door damaged

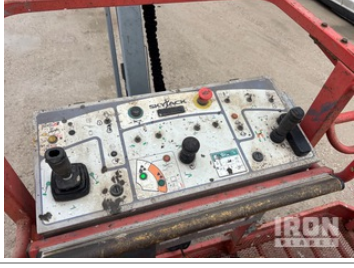
Function Controls	★★★☆☆ Left control stick is damaged. inoperable

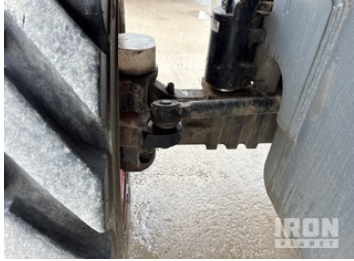
Chassis		
IronPlanet pin connection pivot point wear inspections are limited to sound, sight and feel observations. Dial indicator testing is not performed.		
Item	Assessment	Photo
Steering Linkage	★★★☆☆

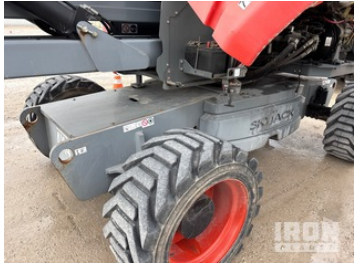
Frame Condition	★★★☆☆

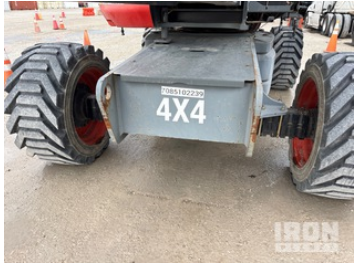
Brake System	★★★☆☆ The brake system functioned, stopping and holding the machine.

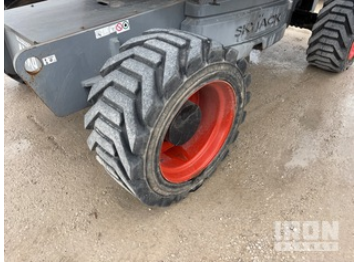
Left Front Tire	Cracks

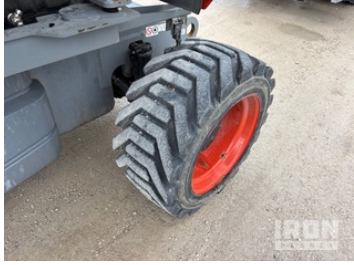
Left Rear Tire	Cracks, Tears, Screws in the tire.

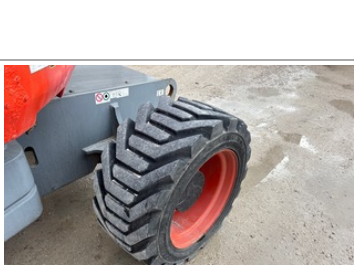
Right Rear Tire	Cracks, Chunks missing, Tears, Screws in the tire.
