Item #14855864 - 2017 Skyjack SJ45T 4WD Diesel Telescopic Boom Lift

Inspection Report

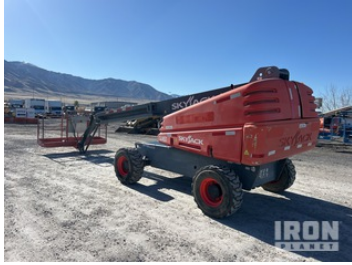
General Appearance		
Item	Assessment	Photo
Picture, Left Front Corner		 
Picture, Left Rear Corner

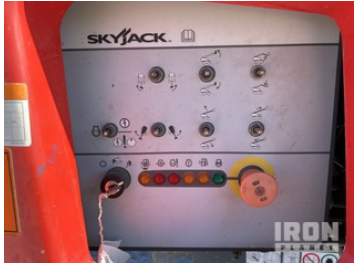
Control Station Ground		
Item	Assessment	Photo
Function Controls	★★★☆☆

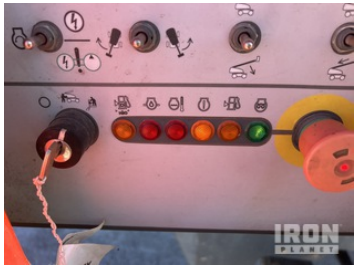
Oil Pressure	The fault indicator shuts off after the engine oil pressure rises.

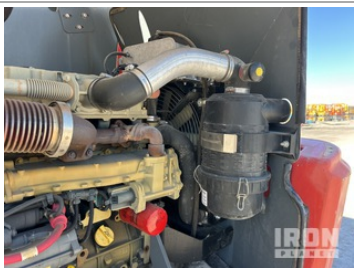
Engine		
Item	Assessment	Photo
Emissions Status	2016 US EPA Label	
Emission Label		 
Blow-by (subjective visual observation)	No noticeable vapor or pressure	
Starter	Operational	
Fuel System	Operational	 
Exhaust System	No visible damage or missing components	 
Radiator	★★★★☆

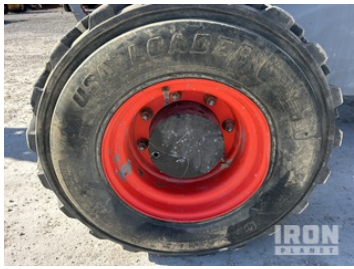
Drivetrain		
Operational test is limited to low speed in a confined flat area without load. Differential interlocks, full transmission shifting and functionality of all drive axles cannot be fully verified. Inspector listens for abnormal noises, observes leaks and notes physical damage.		
Item	Assessment	Photo
Left Front Final Drive	★ ★ ★ ☆

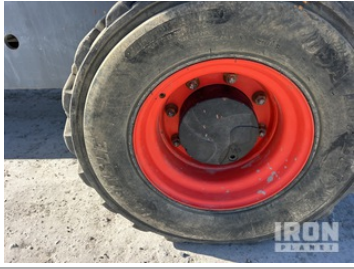
Left Rear Final Drive	★ ★ ★ ☆

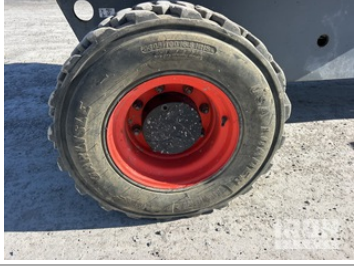
Right Rear Final Drive	★ ★ ★ ☆

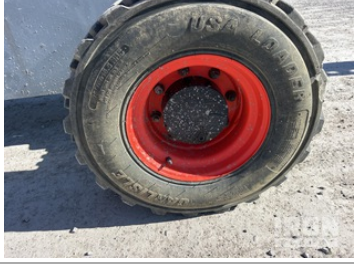
Right Front Final Drive	★ ★ ★ ☆

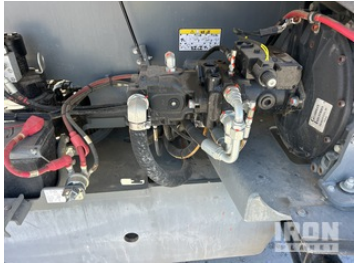
Hydraulics		
See photos for condition		
Item	Assessment	Photo
Pumps (Hydraulics)	★★★★☆

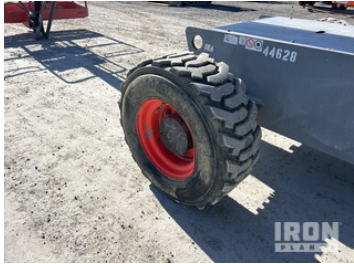
Brake System	★★★★☆ The brake system functioned, stopping and holding the machine.	
Left Front Tire	No visible defects

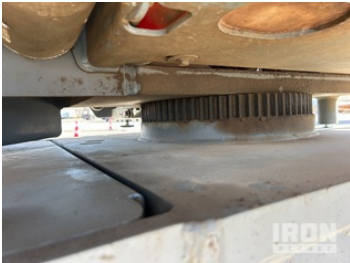
Turntable Bearing	★★★★☆

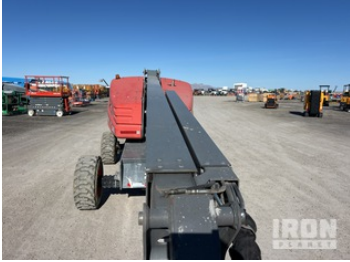
Boom Condition	★★★★☆
