## Item #14786825 - 2019 JLG 4069LE Electric Scissor Lift

# Inspection Report

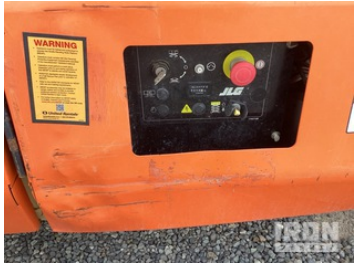
<b>Control Station Ground</b>		
<b>Item</b>	<b>Assessment</b>	<b>Photo</b>
Function Controls	★ ★ ★ ☆

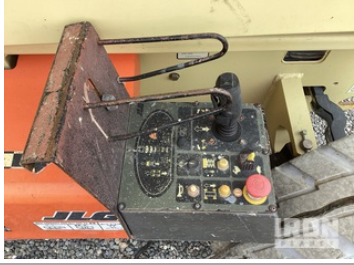
<b>Control Station Upper</b>		
Pin connection pivot point wear inspections are limited to sound, sight and feel observations. Dial indicator testing is not performed.		
<b>Item</b>	<b>Assessment</b>	<b>Photo</b>
Control Console	No visible damage or missing components

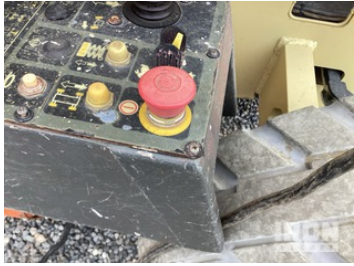
Emergency Shut Off Switch	Operational

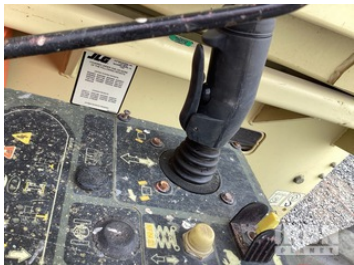
Safety Control Hand/Foot Switch	★★★★☆ Operational

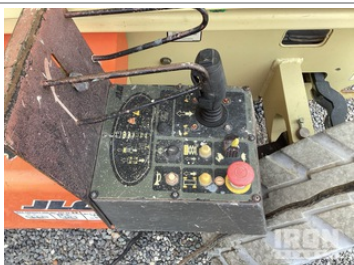
Upper Function Controls	★★★★☆

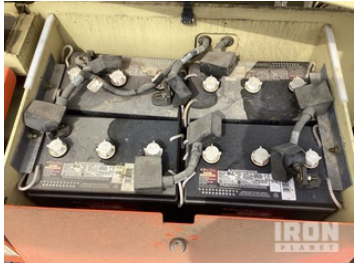
<b>Electrical Operating System</b>		
<b>Item</b>	<b>Assessment</b>	<b>Photo</b>
Operating Voltage	48 Volts	
Battery Condition	Weak or under-charged	
Cables and Connections	No visible damage or missing components

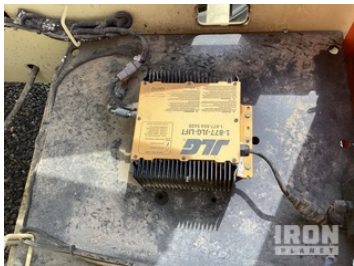
Battery Charger	Appears normal - Not operationally checked

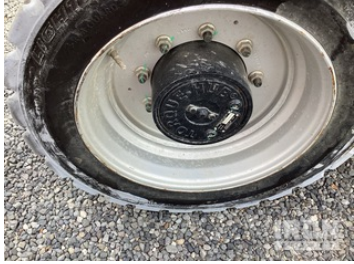
Item	Assessment	Photo
Drive Motors	★★★★☆	
Final Drives	★★★★☆

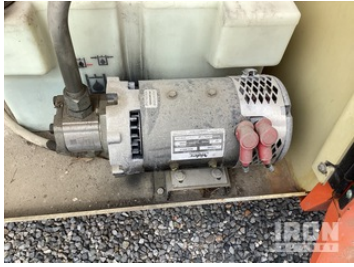
Hydraulics		
Item	Assessment	Photo
Pumps (Hydraulics)	★★★★☆

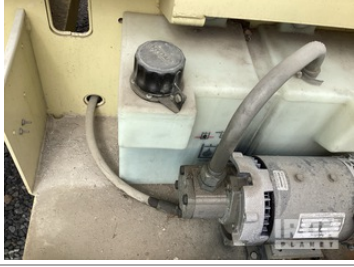
Valves	★★★★☆	
Hydraulic Tank	★★★★☆

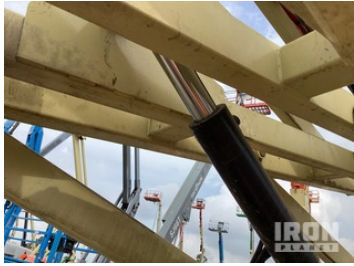
Lift Cylinders	★★★★☆

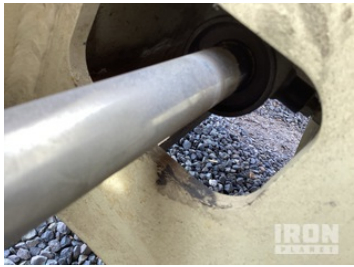
Steering Cylinder	★★★★☆

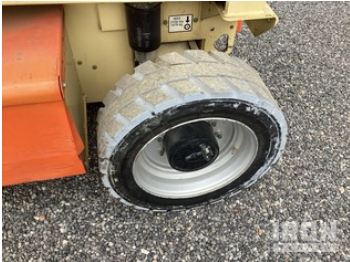
Left Rear Tire	No visible defects

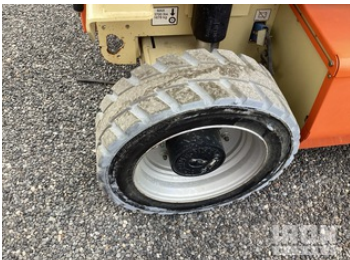
Right Rear Tire	No visible defects

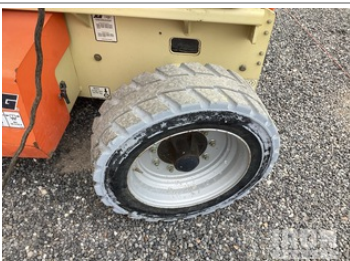
Right Front Tire	No visible defects

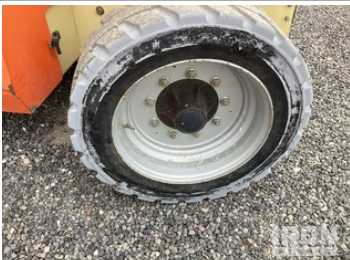
Wheel Condition	No visible damage or missing components
