## Item #14787005 - 2017 JLG 600S 4WD Diesel Telescopic Boom Lift

- Features: 60 ft Max Platform Height, 1000 lb Max Weight Capacity, Power to Platform, Onboard Generator, 2017 US EPA Label, Deutz TD 2.9 L4 4 Cylinder 67 hp 2.925 L Diesel Engine, 39x15-22.5 Foam-Filled Tires
- Meter Reading: 4,476 Hours
- Serial # : 300230369
- Inspection Completed: 3/11/26

# Inspection Report

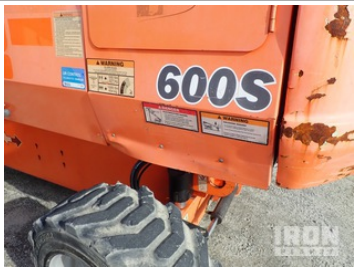
Body Panels	Engine compartment door damaged, Hydraulic compartment door damaged, Panel under control panel damaged

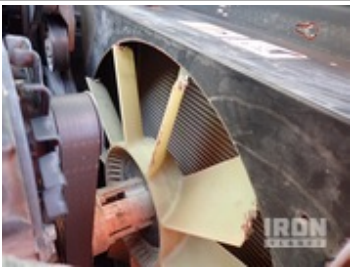
Radiator	<p>★ ★ ☆ ☆</p> <p>Damaged fan</p>

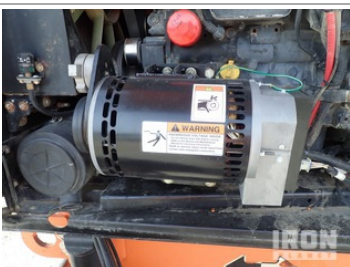
Oil Leaks	No dripping leaks	
Fuel Leaks	No dripping leaks	
Cooling System Leaks	No dripping leaks	
Onboard Generator	Not operationally checked, Belt is not on all the way

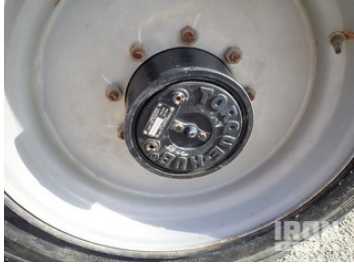
Left Rear Final Drive	★★★☆☆ Dripping leak, Dripping leak rear side of final drive, see additional photos

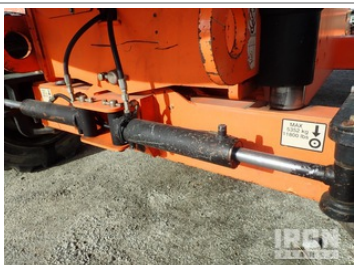
Steering Cylinders	★★★☆☆ Dripping leak on the right cylinder

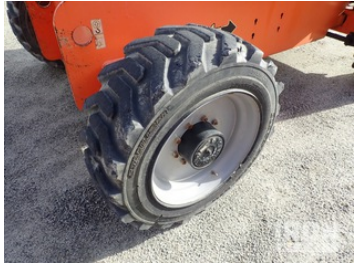
Brake System	★ ★ ★ ☆ The brake system functioned, stopping and holding the machine.	
Left Front Tire	Cracks, Chunks missing, Tears

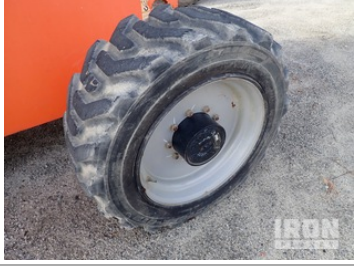
Left Rear Tire	Cracks, Chunks missing, Tears

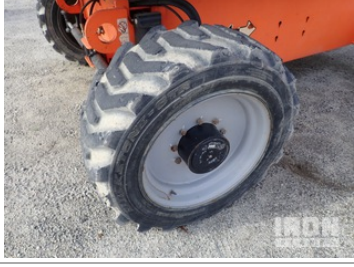
Right Rear Tire	Cracks, Chunks missing, Tears

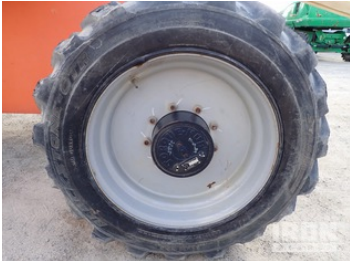
Wheel Condition	Left front damaged, Right front bent

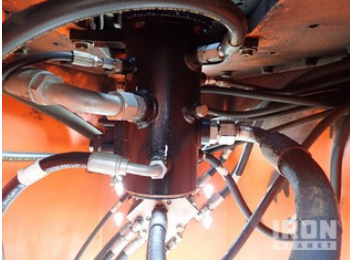
Hydraulic Center Swivel	★★★☆☆ Dripping leak

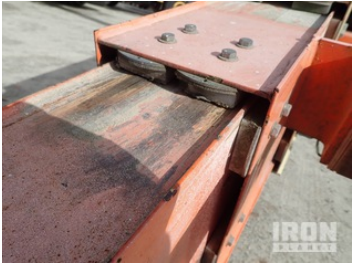
Boom Wear Guides	★★☆☆ Cracked guides
